Remove 597 lf of 8" Pipe
 Install 597 lf of 8" Pipe
 Estimated 21 Service Reconnections (4")

Video Inspection Master Report

US Structure: 5347-155 407 N FERN Date Insp: 6/5/2013 Basin: C07B
 DS Structure: 5347-152 340 N MILLWOOD AVE Dir Televised: Upstream To Downstream

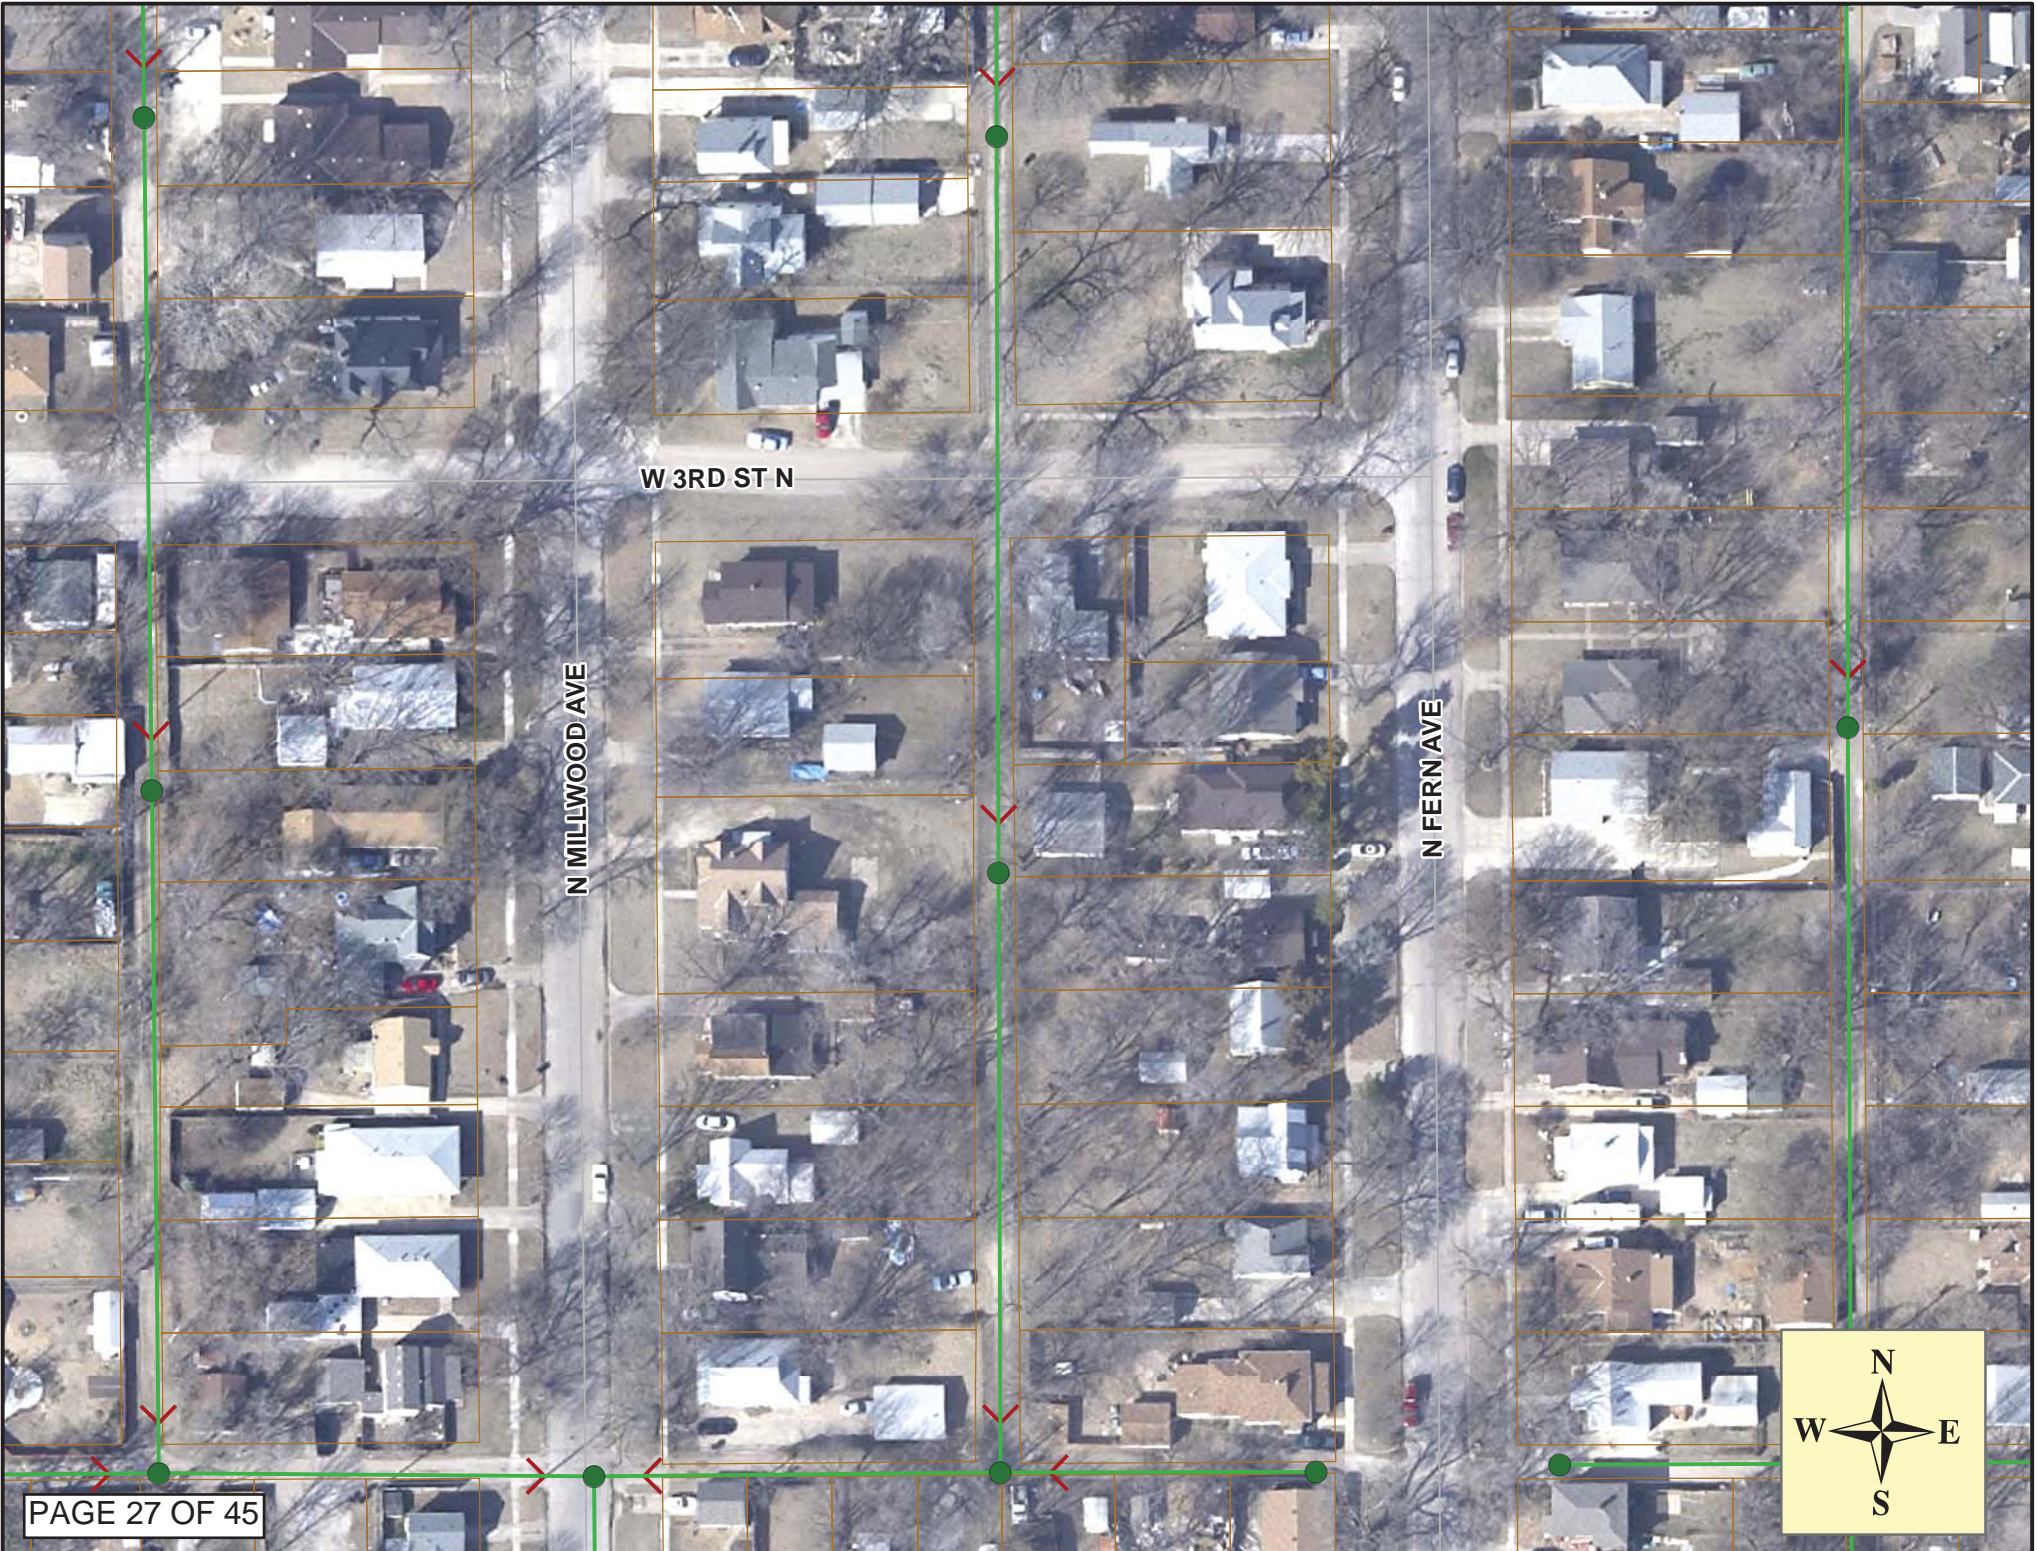
MH 5347-155
 Remove Manhole
 Construct Shallow Manhole
 Approx depth = 3.6 ft

3rd Street is not paved.
 No water or storm water
 to cross in 3rd Street.

MH 5347-152
 Remove Manhole
 Construct Shallow Manhole
 Approx depth = 4.4 ft

MH 5347-149
 Remove Manhole
 Construct Shallow Manhole
 Approx depth = 5.0 ft
