**SITE 2**

Sheet 8 of 22

## Video Inspection Master Report

US Structure: 5650-272                      2351 N CHAUTAUQUA AVE    Date Insp: 7/30/2013                      Basin: EC02D  
 DS Structure: 5650-271                      2331 N CHAUTAUQUA ST    Dir Televised: Downstream To Upstream

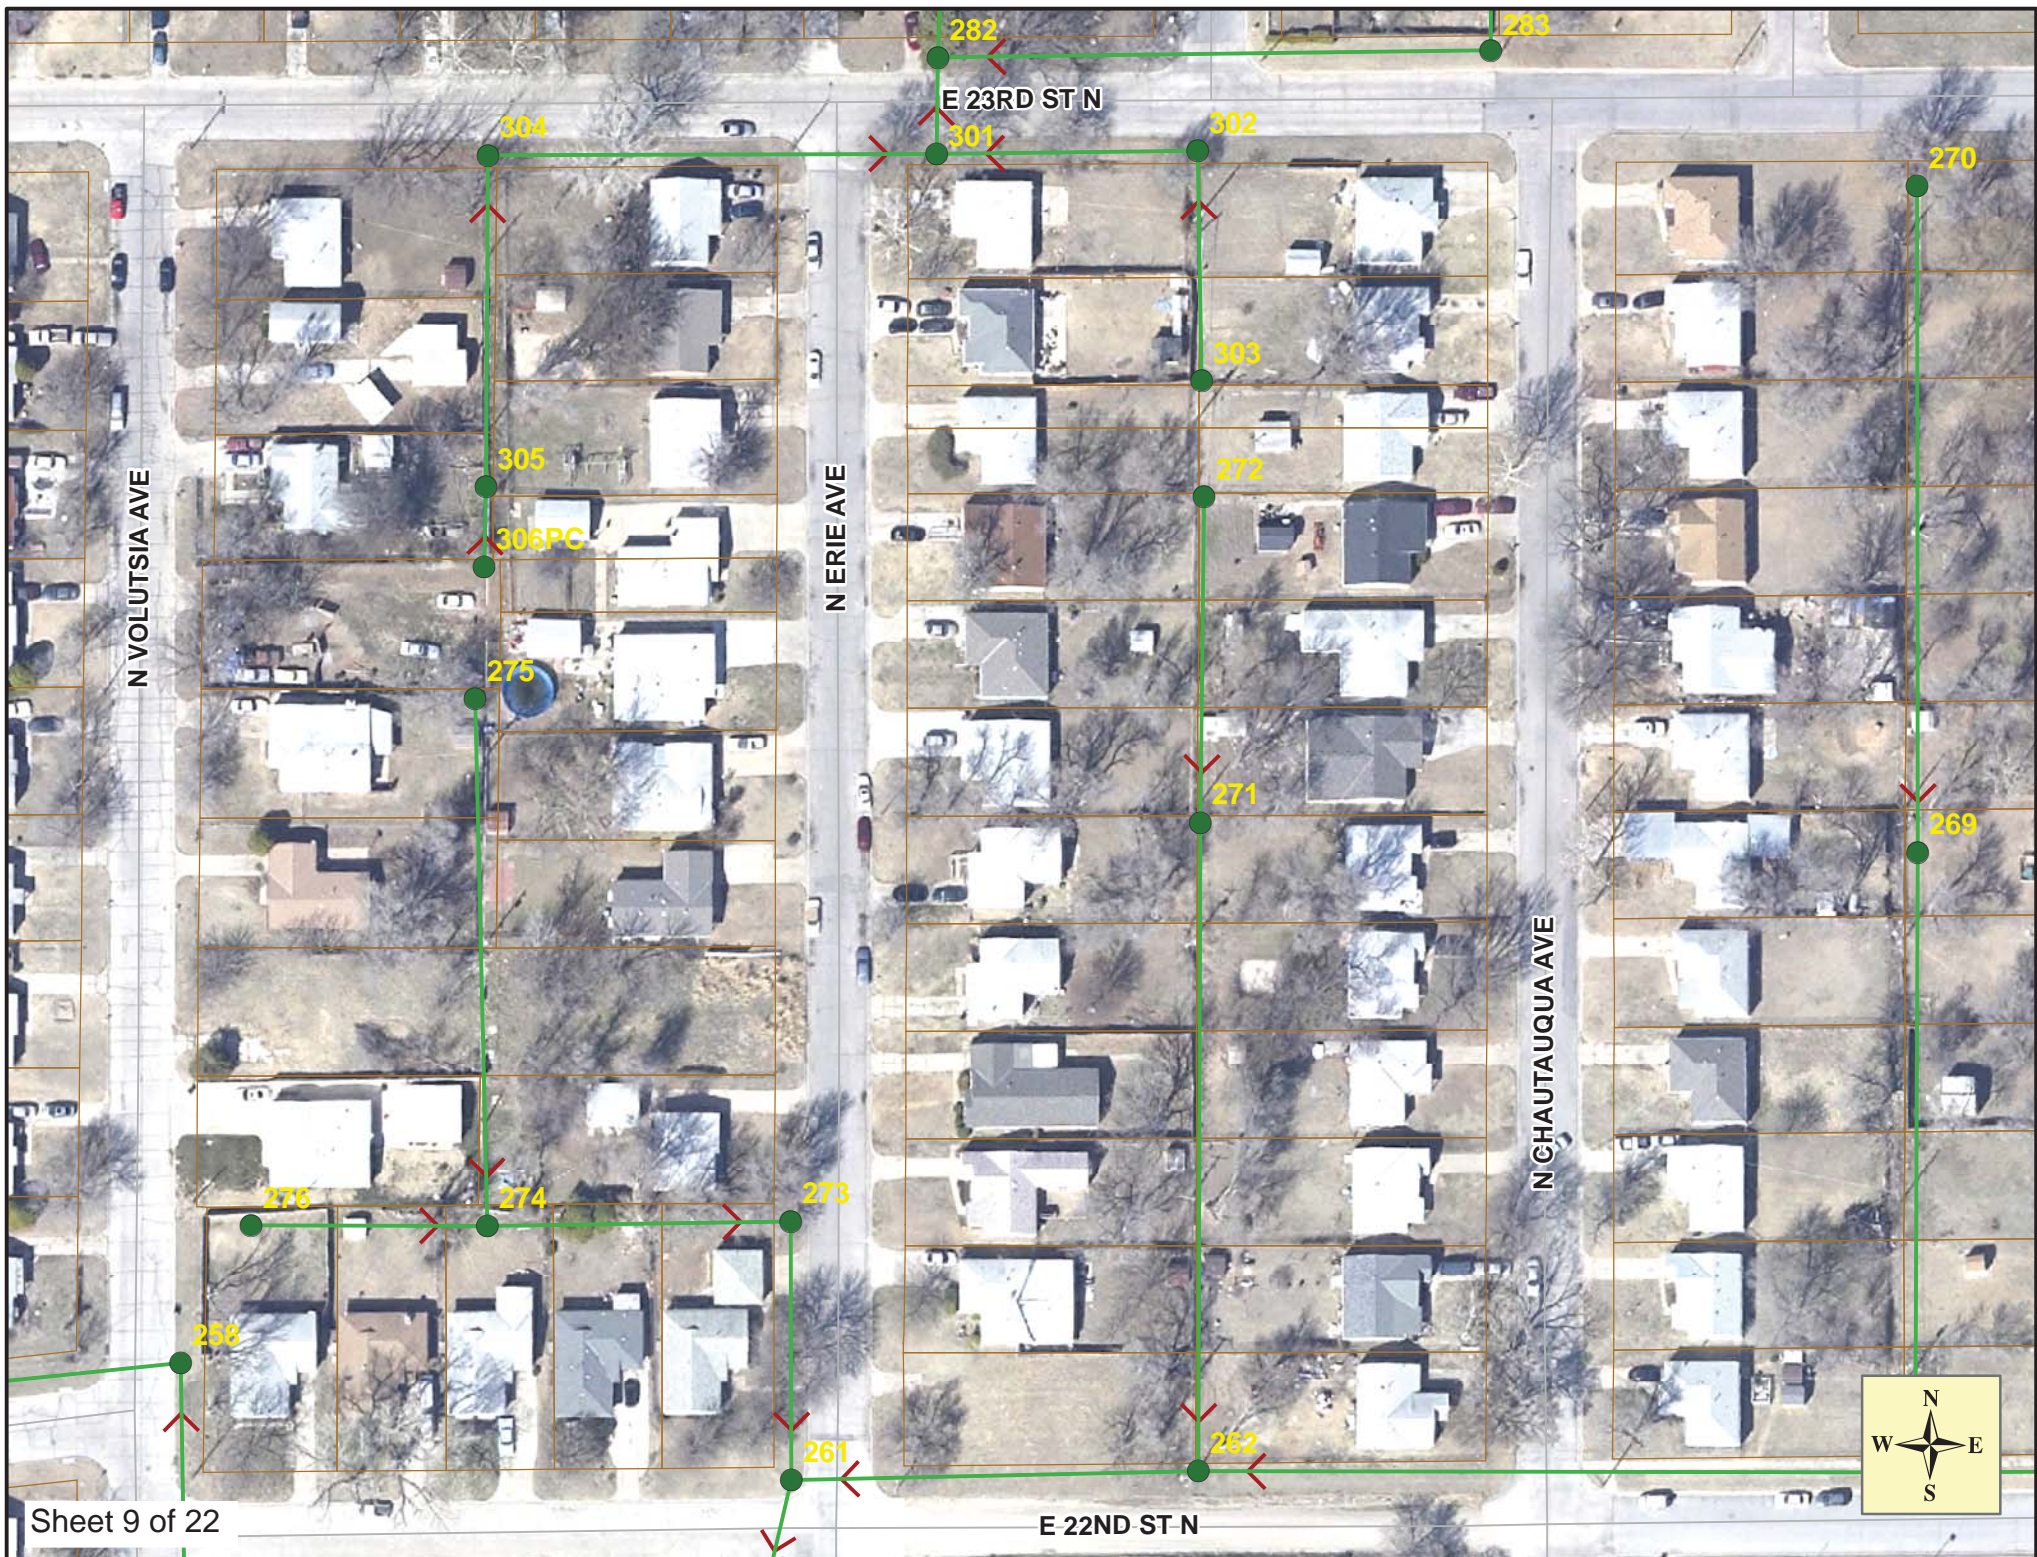
MH 5650-272  
 Replace Manhole Frame & Cover  
 Remove & Replace Manhole Bench & Invert  
 2351 N. Chautauqua  
 Not measured / est. depth = 11.5 ft  
 (2 taps located on manhole wall)

MH 5650-271  
 Remove & Replace Manhole Bench & Invert  
 2331 N. Chautauqua  
 Approx MH depth = 9.4 ft

MH 5650-262  
 Replace Manhole Frame & Cover  
 Remove & Replace Manhole Bench & Invert  
 Not measured / est. depth = 11.5 ft

188' (unpaved road) 22nd Street North

313'

Remove 456 lf of 8" Pipe  
 Install 456 lf of 8" Pipe  
 Estimated 17 Service Reconnections (4")  
 Easement is 16 ft wide

Estimated 20 lf Back of Curb Protection  
 Estimated 30 sy Erosion Control Mat  
 Estimated 20 lf Silt Fence
