**SITE 4**

## Video Inspection Master Report

US Structure: 5546-586                      1117 S IDA AVE                      Date Insp: 9/13/2011                      Basin: C02B  
 DS Structure: 5546-585                      1125 S IDA AVE                      Dir Televised: Upstream To Downstream

Project No. : D-024                      Dia: 8                      Material: VCP                      Length: 192.6                      Slope: 0.002                      Surface: Unpaved alley

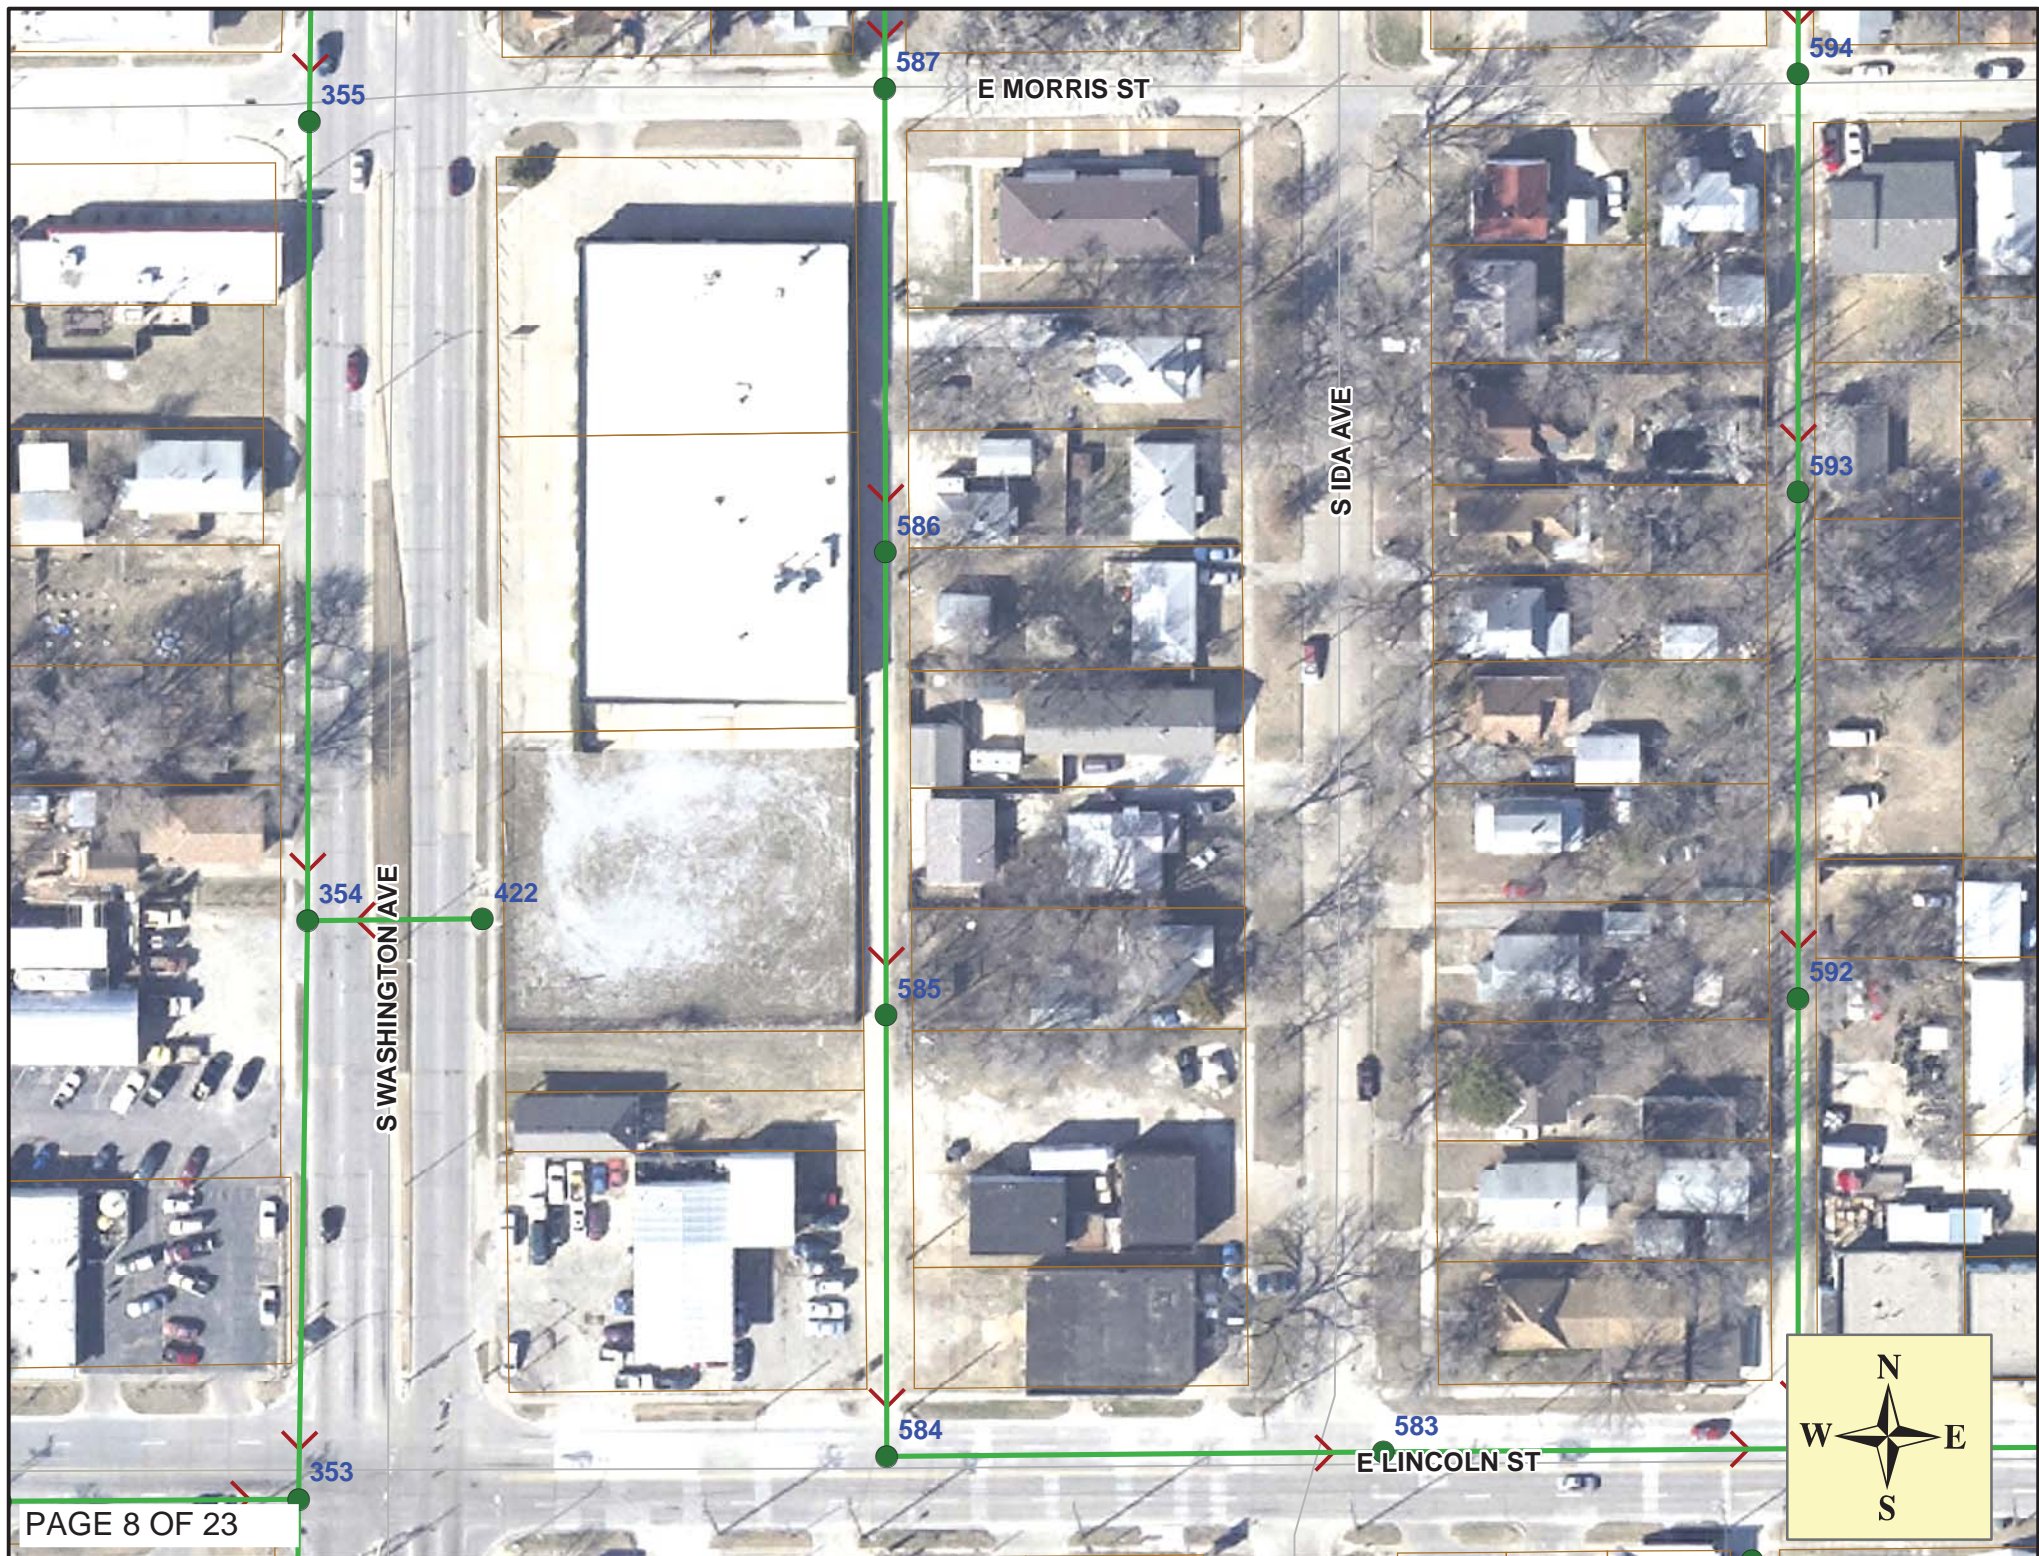
Manhole 5546-585 is a rectangular shaped brick structure and is approx 6 feet wide (west to east). The pipe from the north comes in on the west side of the structure and the pipe going out to the south exits on the east side of the structure. Contractor shall construct the new manhole over the outgoing pipe.

MH 5546-586  
 Remove Manhole  
 Construct Standard Manhole (4")  
 Approx MH depth = 7.4 ft

Remove 193 lf of Pipe  
 Install 195 lf of Pipe  
 (slight relocation - see note on this page)  
 Estimated 4 Service Reconnections (4")

MH 5546-585  
 Remove Manhole (oversized)  
 (see note on this page)  
 Construct Standard Manhole (4")  
 Approx MH depth = 6.9 ft

Contractor shall relocate the new pipe slightly to the east as necessary to lay pipe in a straight line between MH 5546-586 and the new MH 5546-585.

MH 5546-584  
 Remove & Replace  
 Manhole Bench & Invert  
 Approx MH depth = 5.3 ft
