# Television Inspection Master Report

US Manhole: 5744-724  
DS Manhole: 5744-723 3537 E SUNNYBROOK ST

US Manhole: 5744-723  
DS Manhole: 5744-684

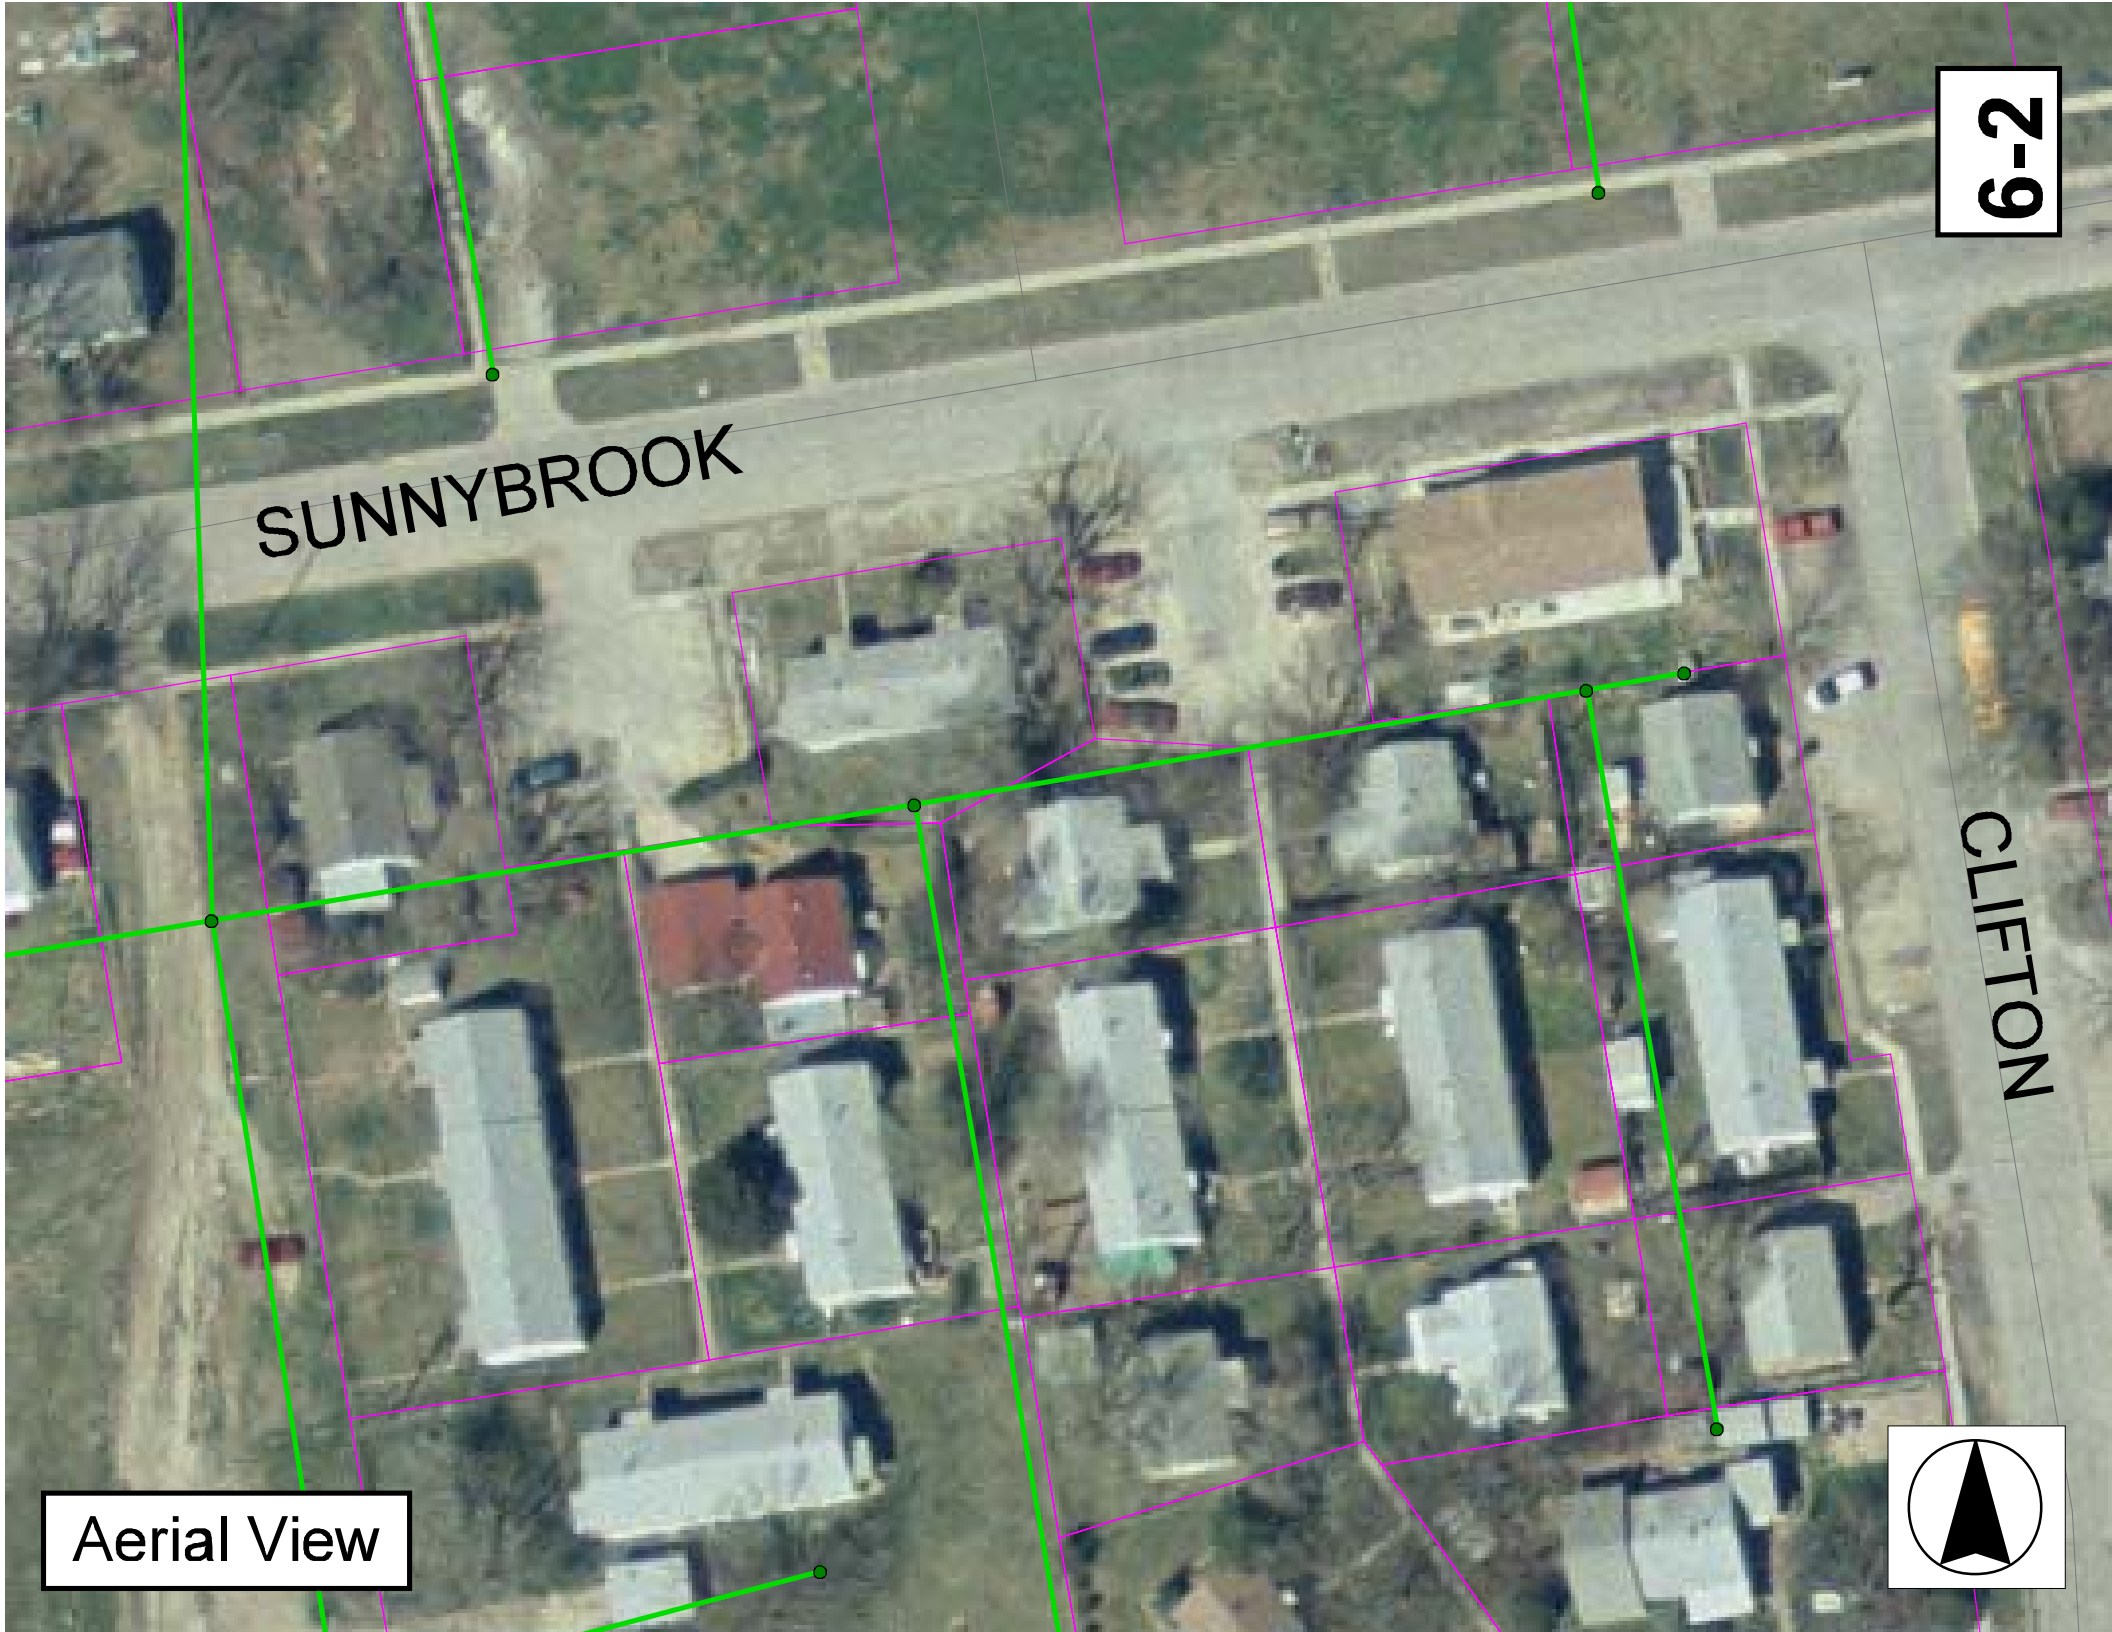
Aerial View

Between 5744-724 and 5744-723:  
Remove 175 lf of 6" pipe / Install 175 lf of 8" pipe  
Remove and replace 27 lf of Concrete Sidewalk

Between 5744-723 and 5744-684:  
Remove 182 lf of 6" pipe / Install 182 lf of 8" pipe  
Remove and replace 20 lf of Concrete Drive Approach  
Remove and replace 5 lf of Concrete Sidewalk

MH # 5744-684  
Approx depth = 12.0 ft

MH # 5744-723  
Replace Manhole Frame & Cover  
Rework Manhole Bench & Invert  
Approx depth = 11.0 ft

Cleanout / not found

Construct Outside Drop for line coming into  
MH 5744-723 from the south. Contractor shall  
use a 6" to 8" PVC fitting and a non-shear  
coupling between the VCP and the fitting.
