# Television Inspection Master Report

US Manhole: 5947-121  
DS Manhole: 5947-120

20 E WILLOWBROOK ST  
15 E PEACH TREE ST

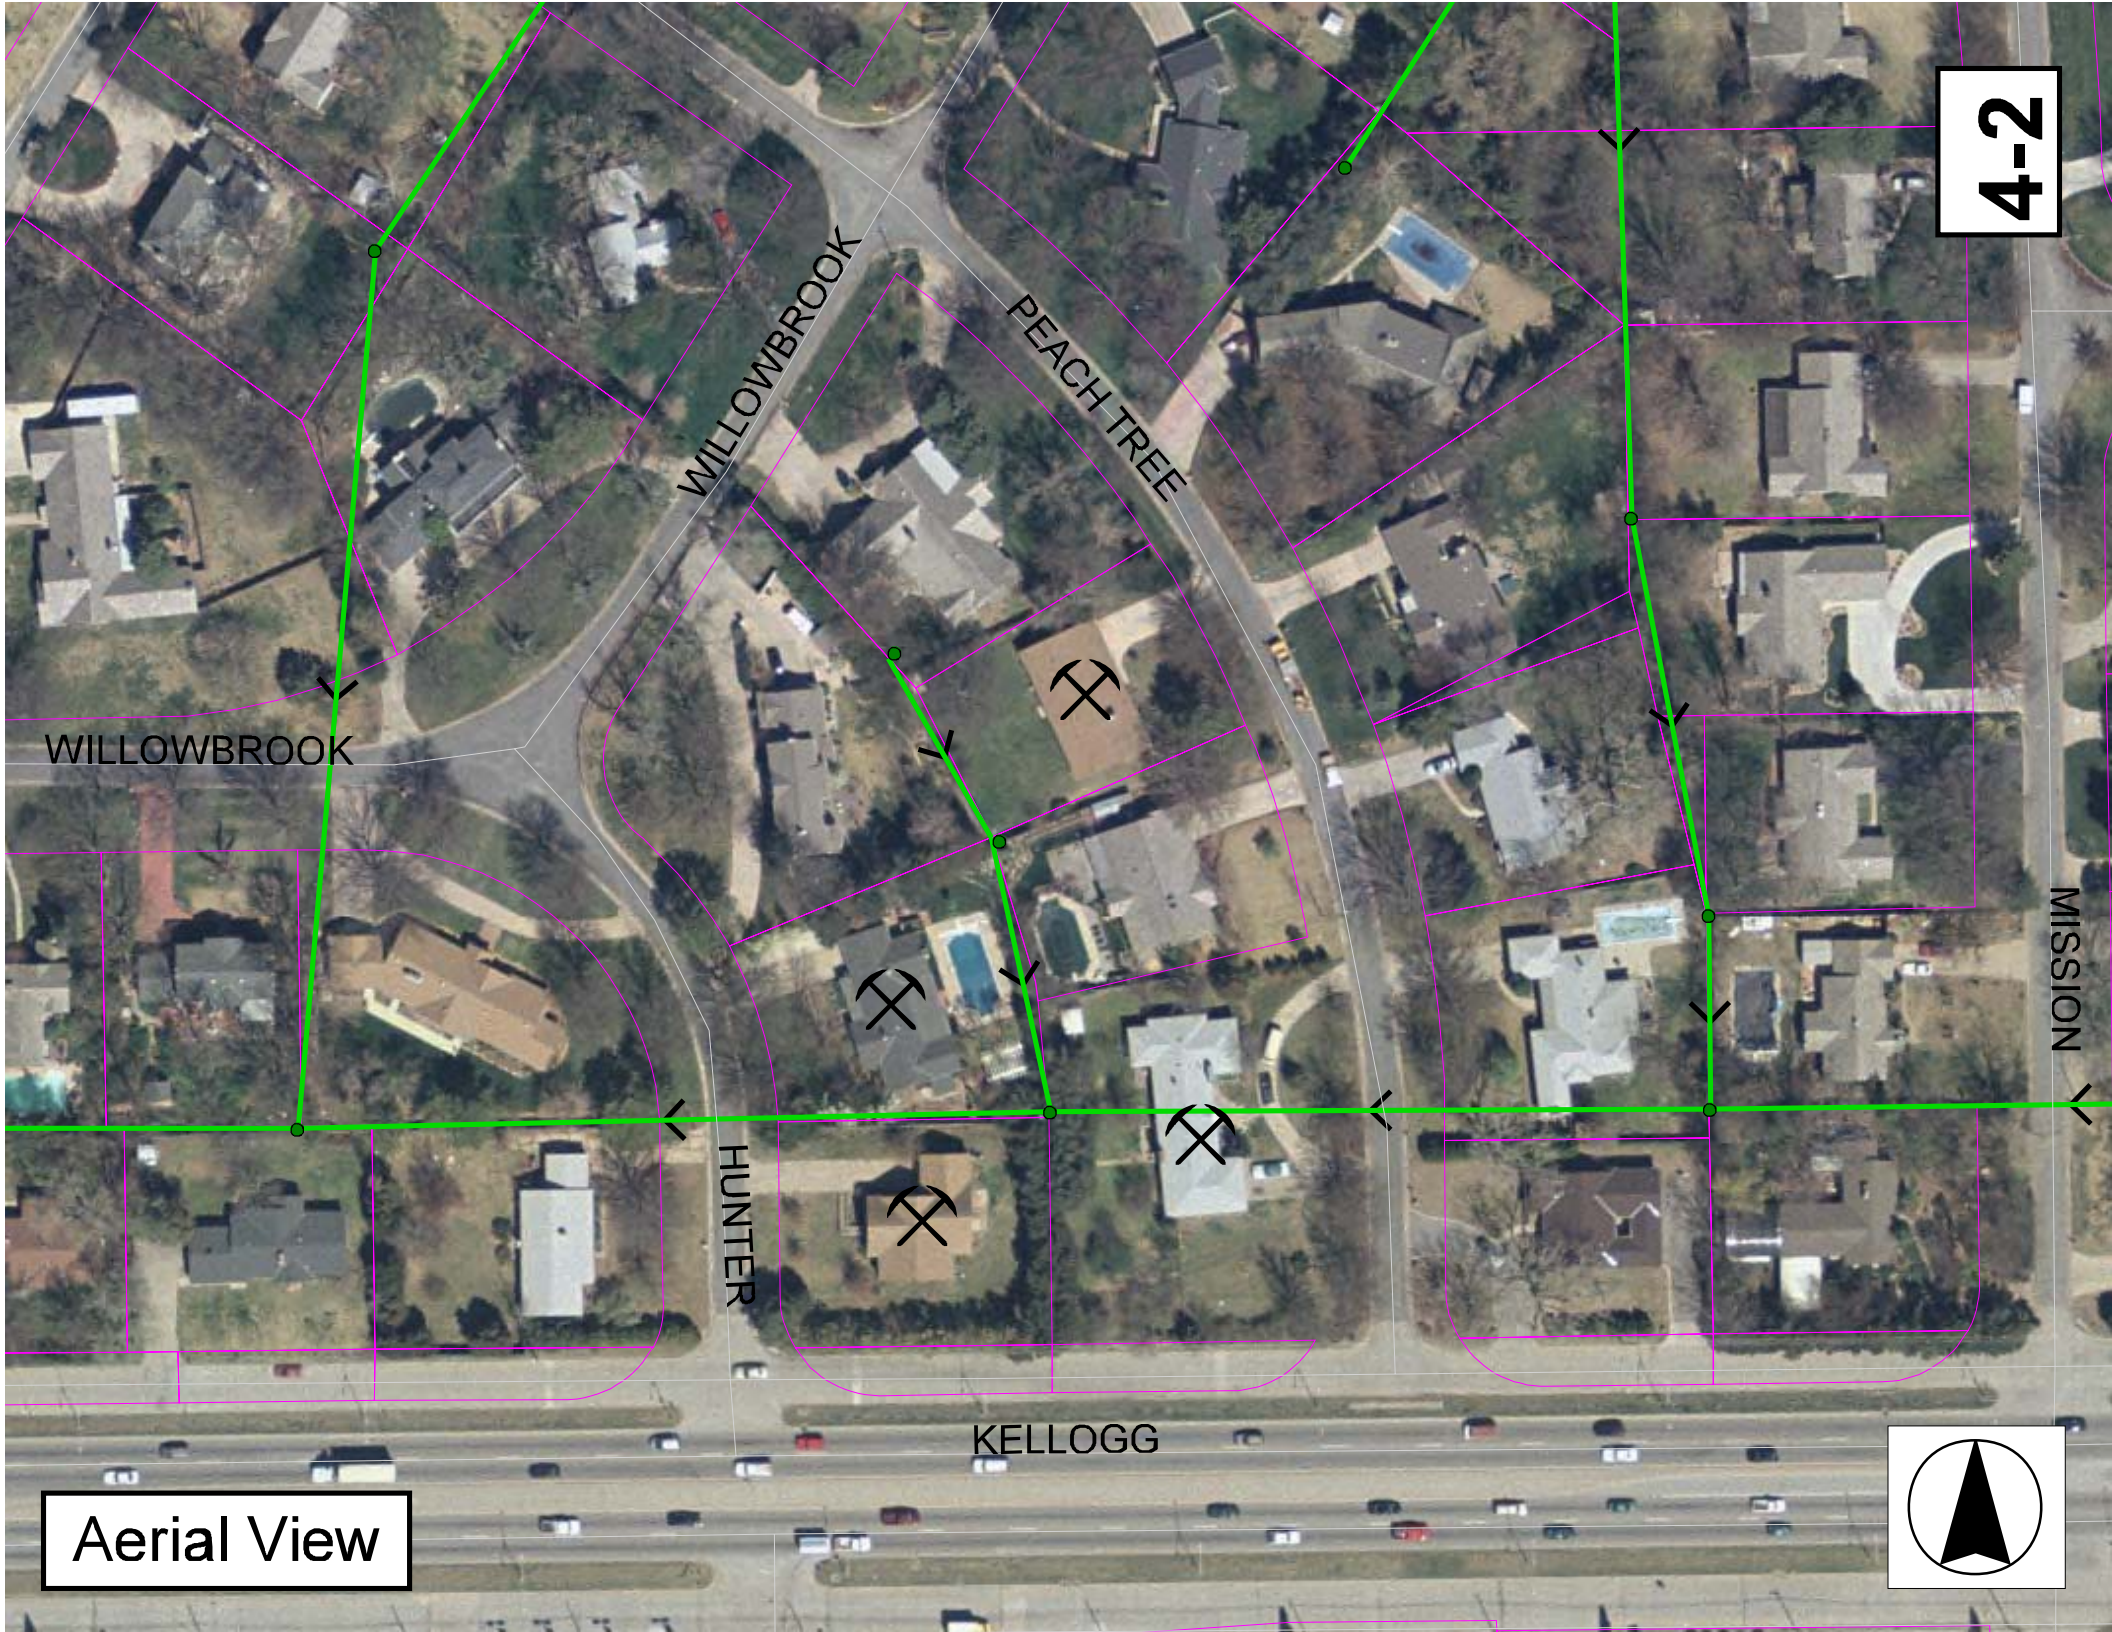
Aerial View

MH # 5947-121  
Approx depth = 9.3 ft

MH # 5947-120  
Approx depth = 10.9 ft

MH # 5947-119

**POINT REPAIR:**  
Remove and replace 5 lf of pipe from the wall of MH 5947-120 to 5 lf north of the manhole.
