**SITE 9**

# Television Inspection Master Report

US Manhole: 5449-342  
DS Manhole: 5449-341

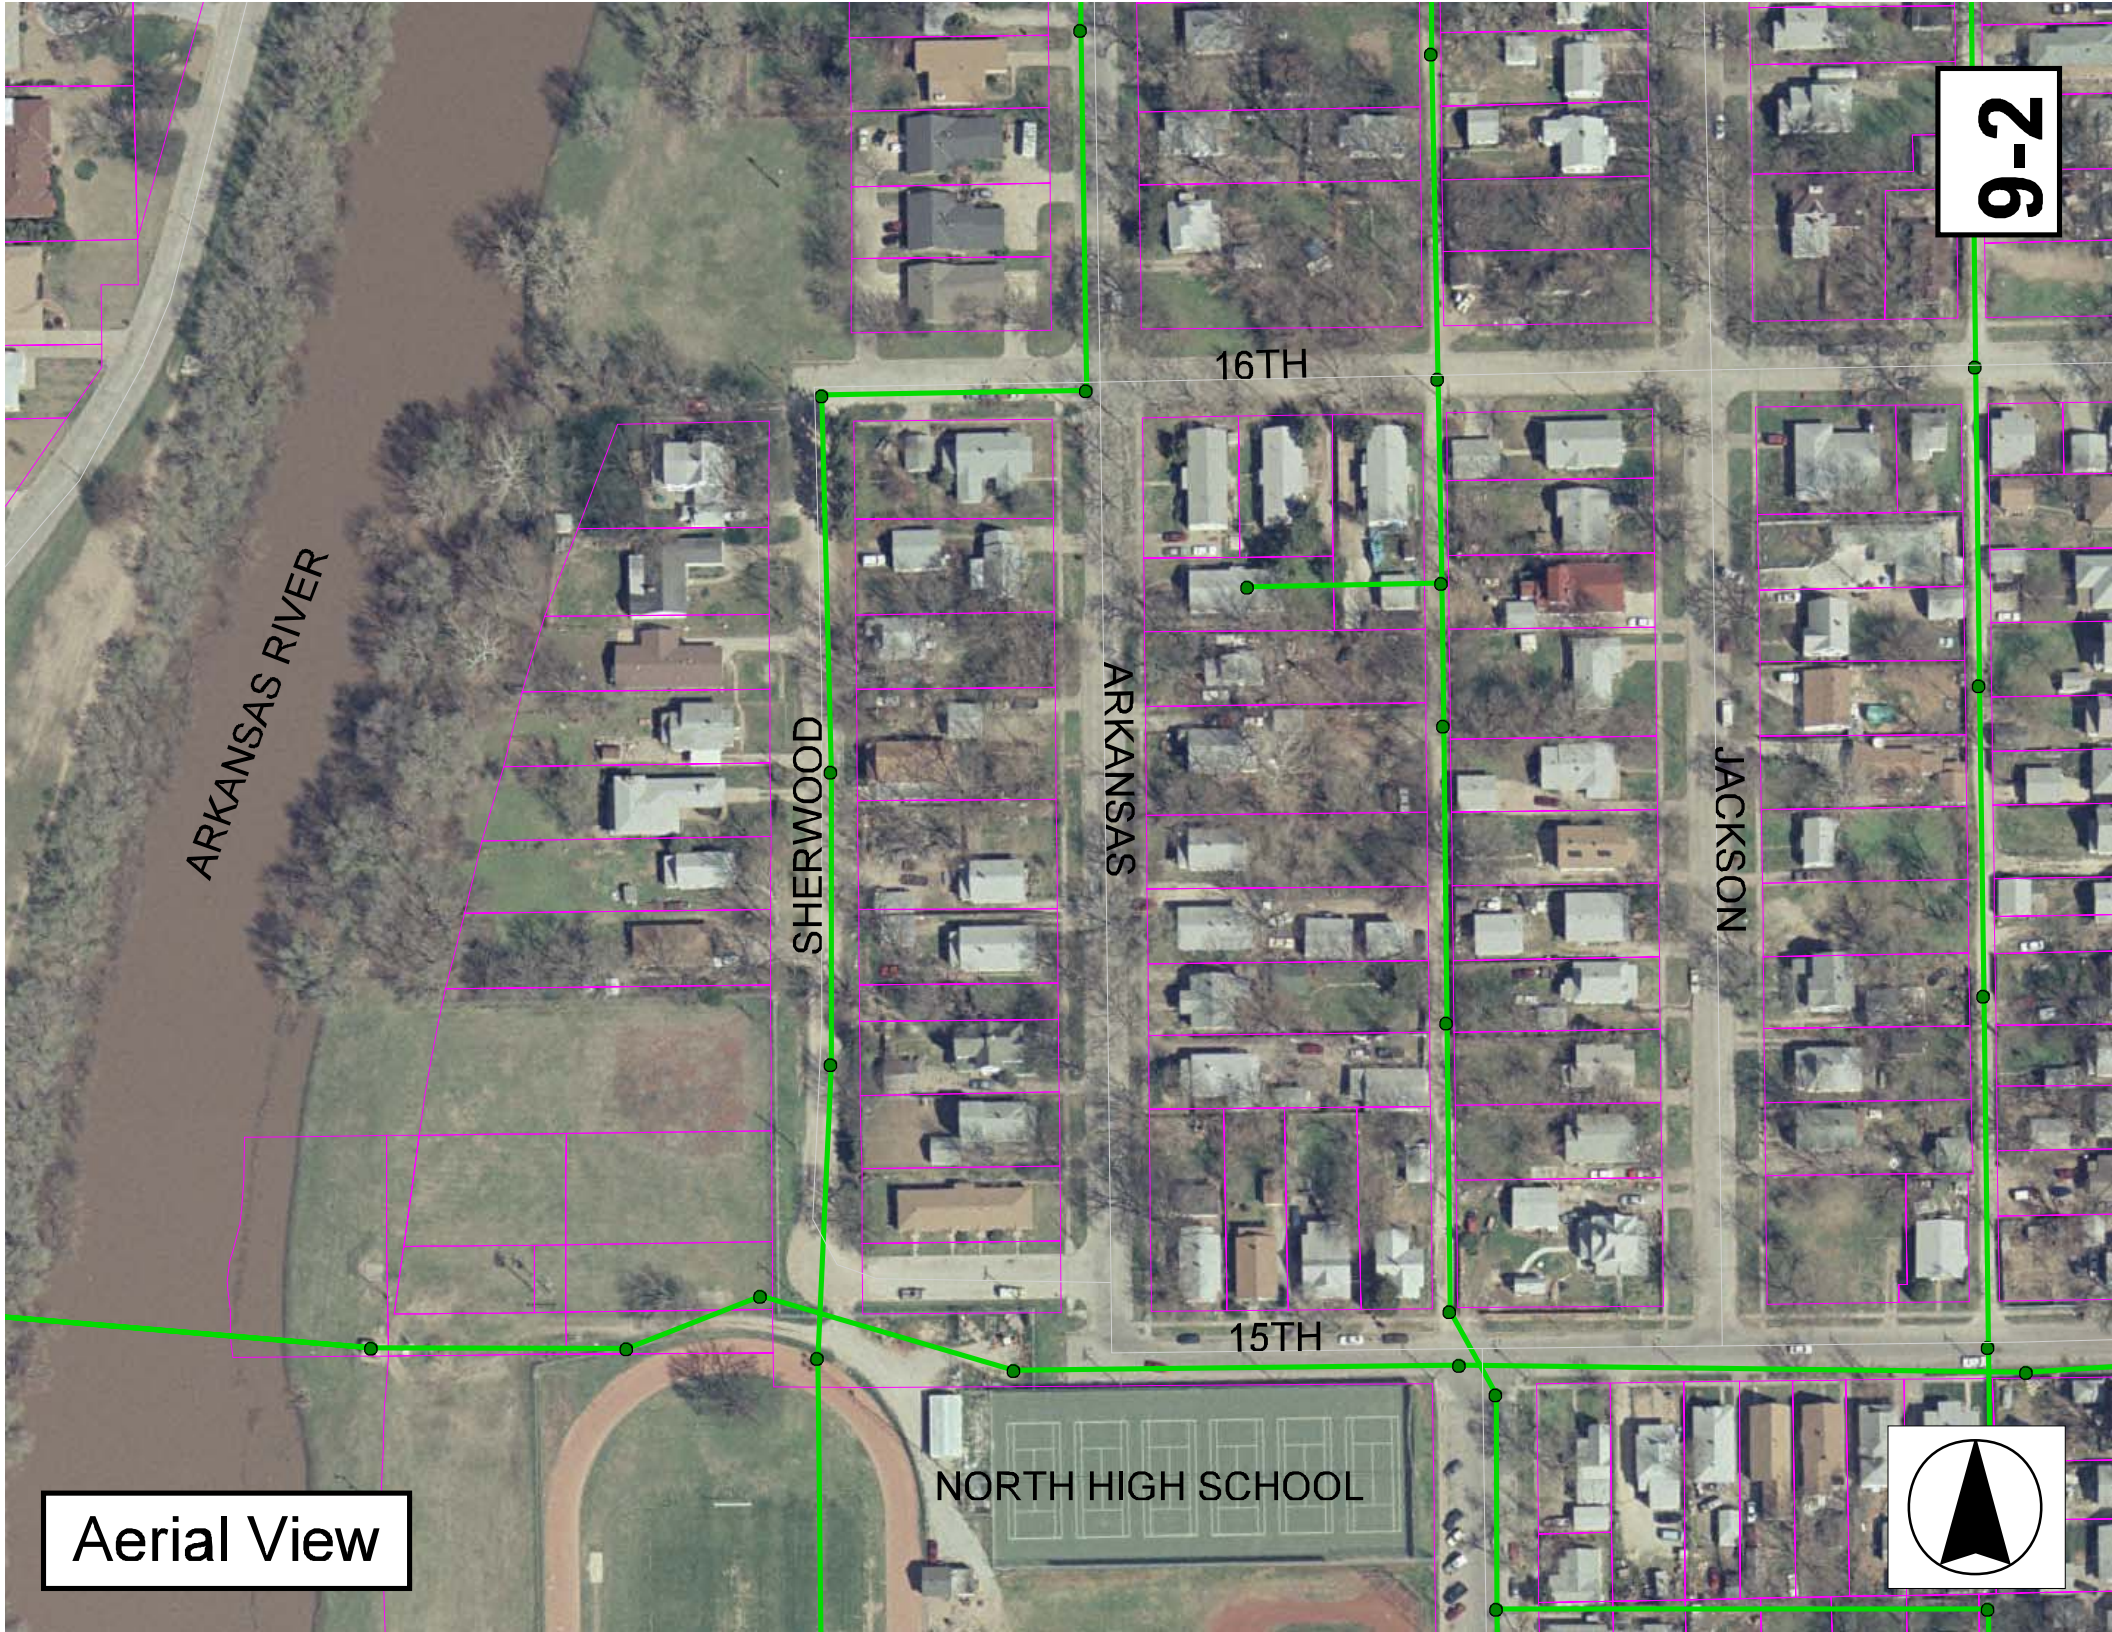
**MH # 5449-343**  
Replace Manhole Frame & Cover  
Rework Manhole Bench & Invert  
Approx depth = 5.9 ft

**MH # 5449-342**  
Replace Manhole Hole Frame & Cover  
Rework Manhole Bench & Invert  
Approx depth = 6.2 ft

**MH # 5449-346**  
Replace Manhole Frame & Cover  
Rework Manhole Bench & Invert  
Approx depth = 7.5 ft

**POINT REPAIR:**  
Remove and replace 20 lf of 8" pipe from the wall of MH 5449-342 to 20 lf north of MH 5449-342. Removal and replacement of concrete pavement shall be incidental.

**NOTE:** Removal and replacement of concrete pavement related to replacing the frame & cover on MH 5449-343 and MH 5449-342 shall be incidental.
