Television Inspection Master Report

US Manhole: 5545-257
DS Manhole: 5545-208

Project No.: B-101

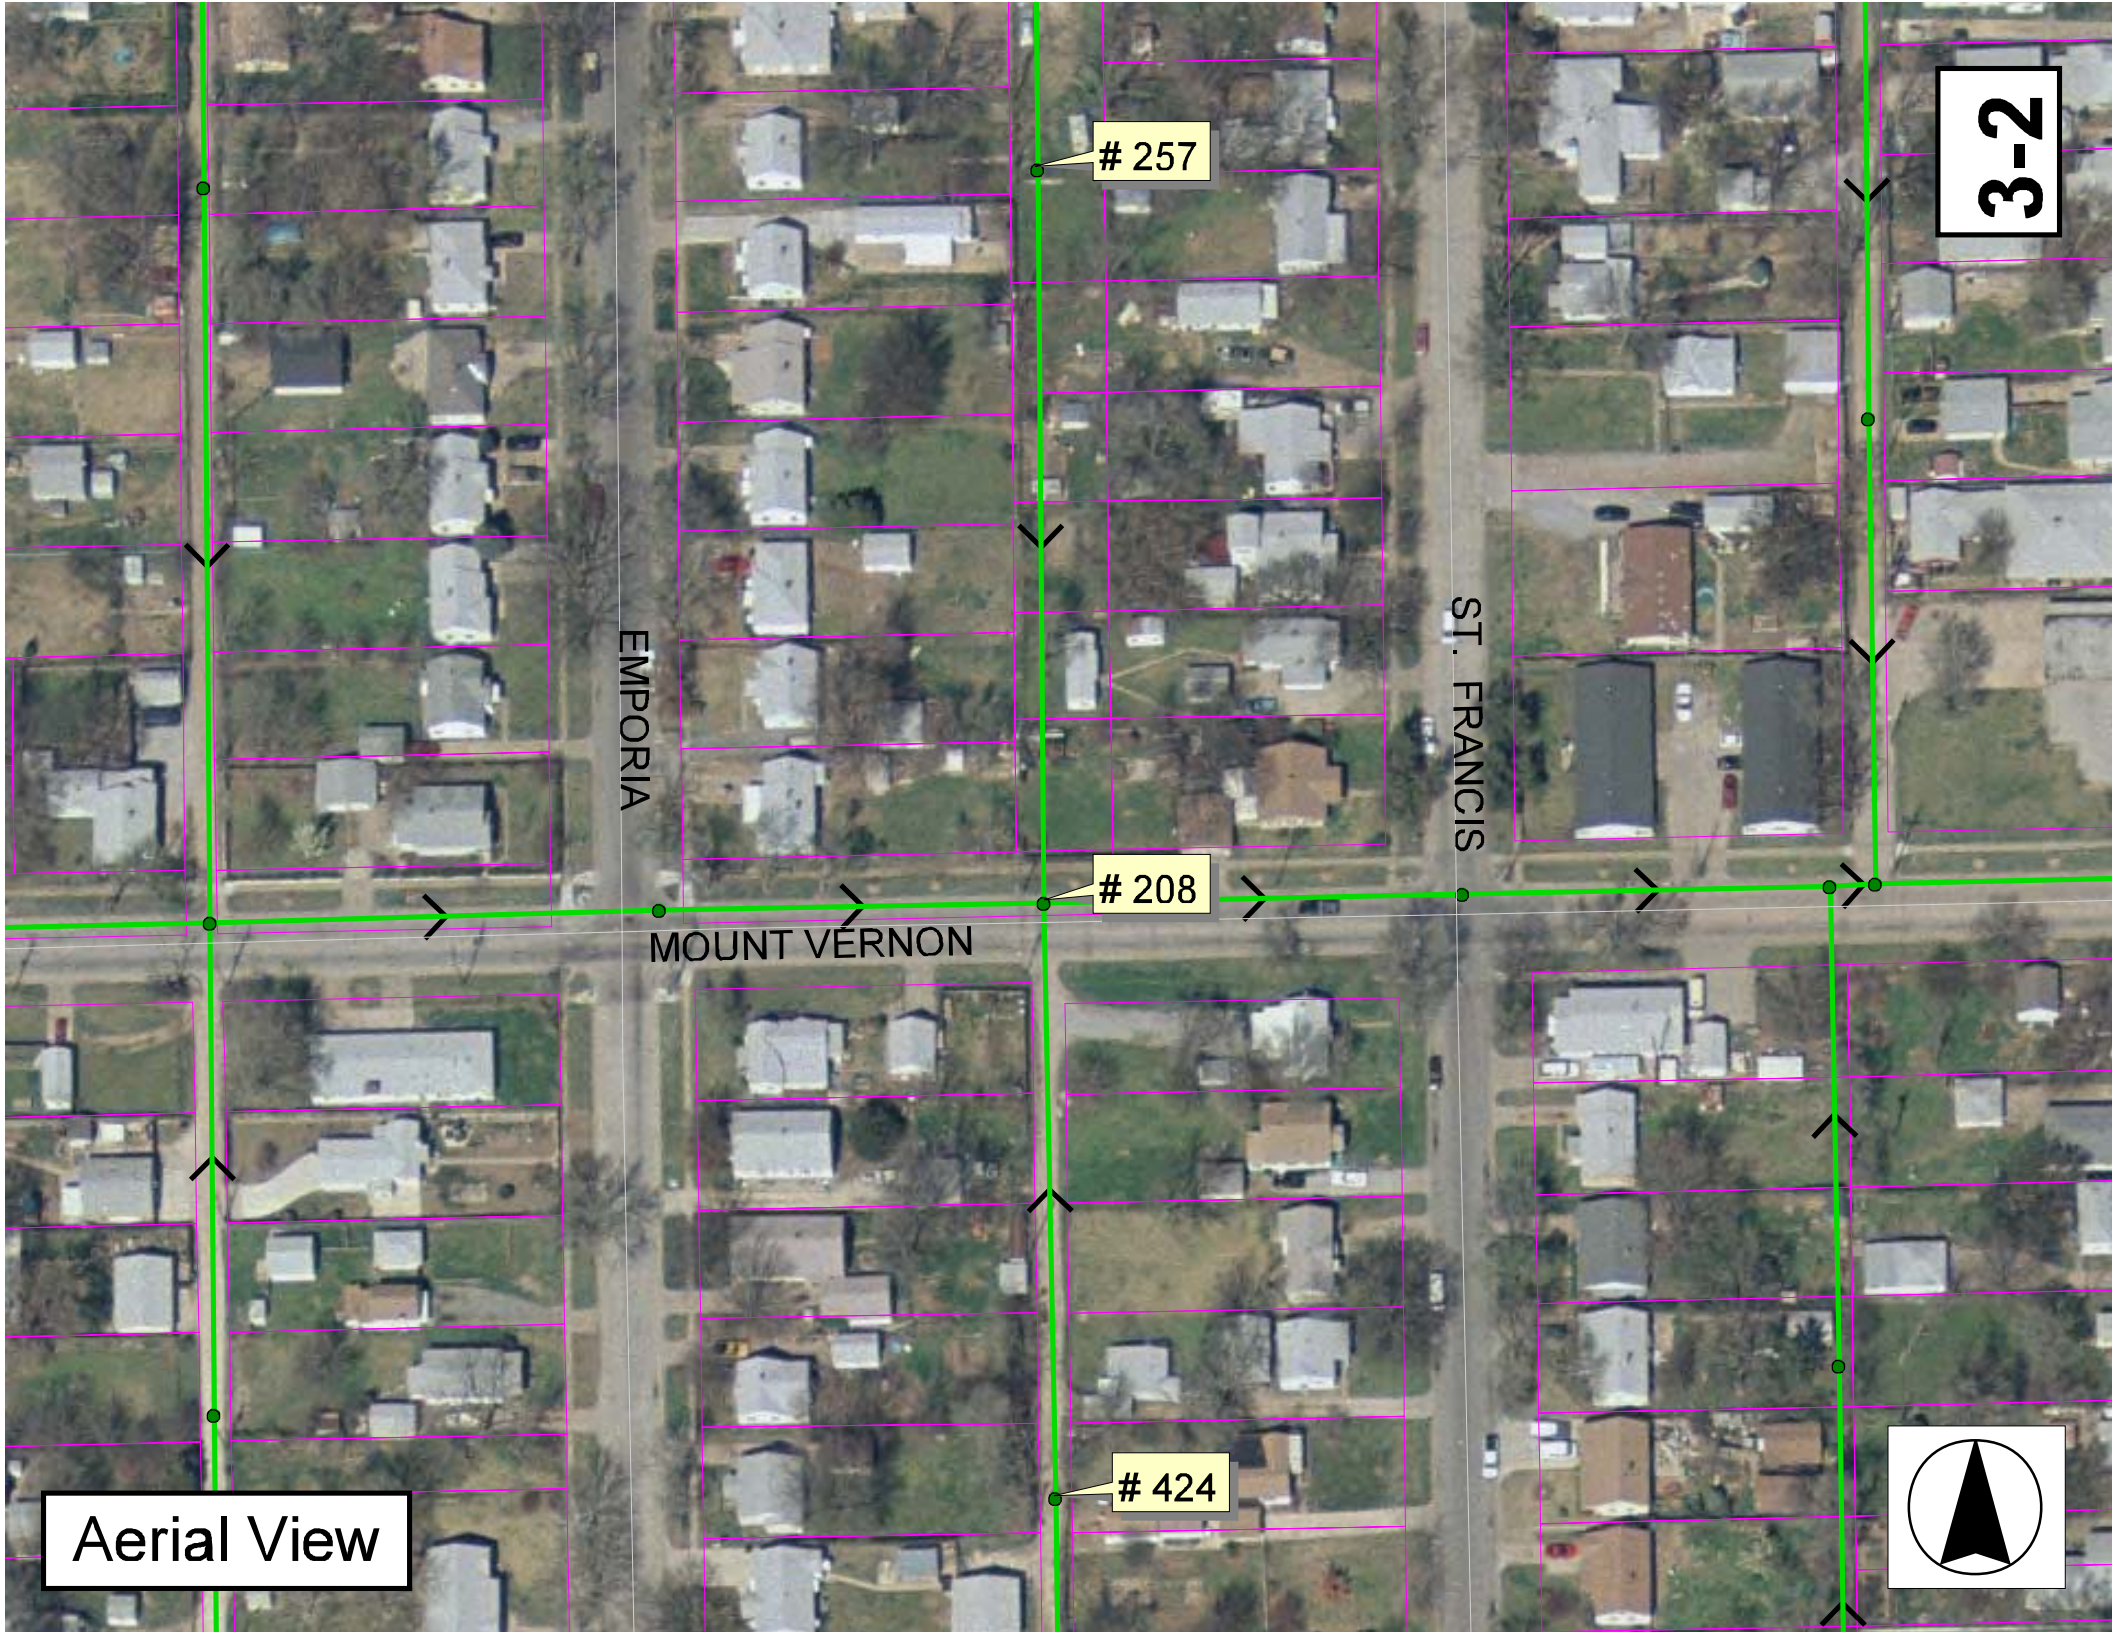
3-2

Install 269 lf of 8" Cured-in-Place Liner from MH 5545-424 to MH 5545-208

Install 334 lf of 8" Cured-in-Place Liner from MH 5545-257 to MH 5545-208

MH # 5545-257
Approx depth = 9.4 ft

MH # 5545-208
Approx depth = 8.8 ft

MH # 5545-424
Approx depth = 6.5
