Install 1019 lf of 12"
Cured-in-Place Liner
from MH 4848-036
to MH 4848-032

SITE 5

Television Inspection Master Report

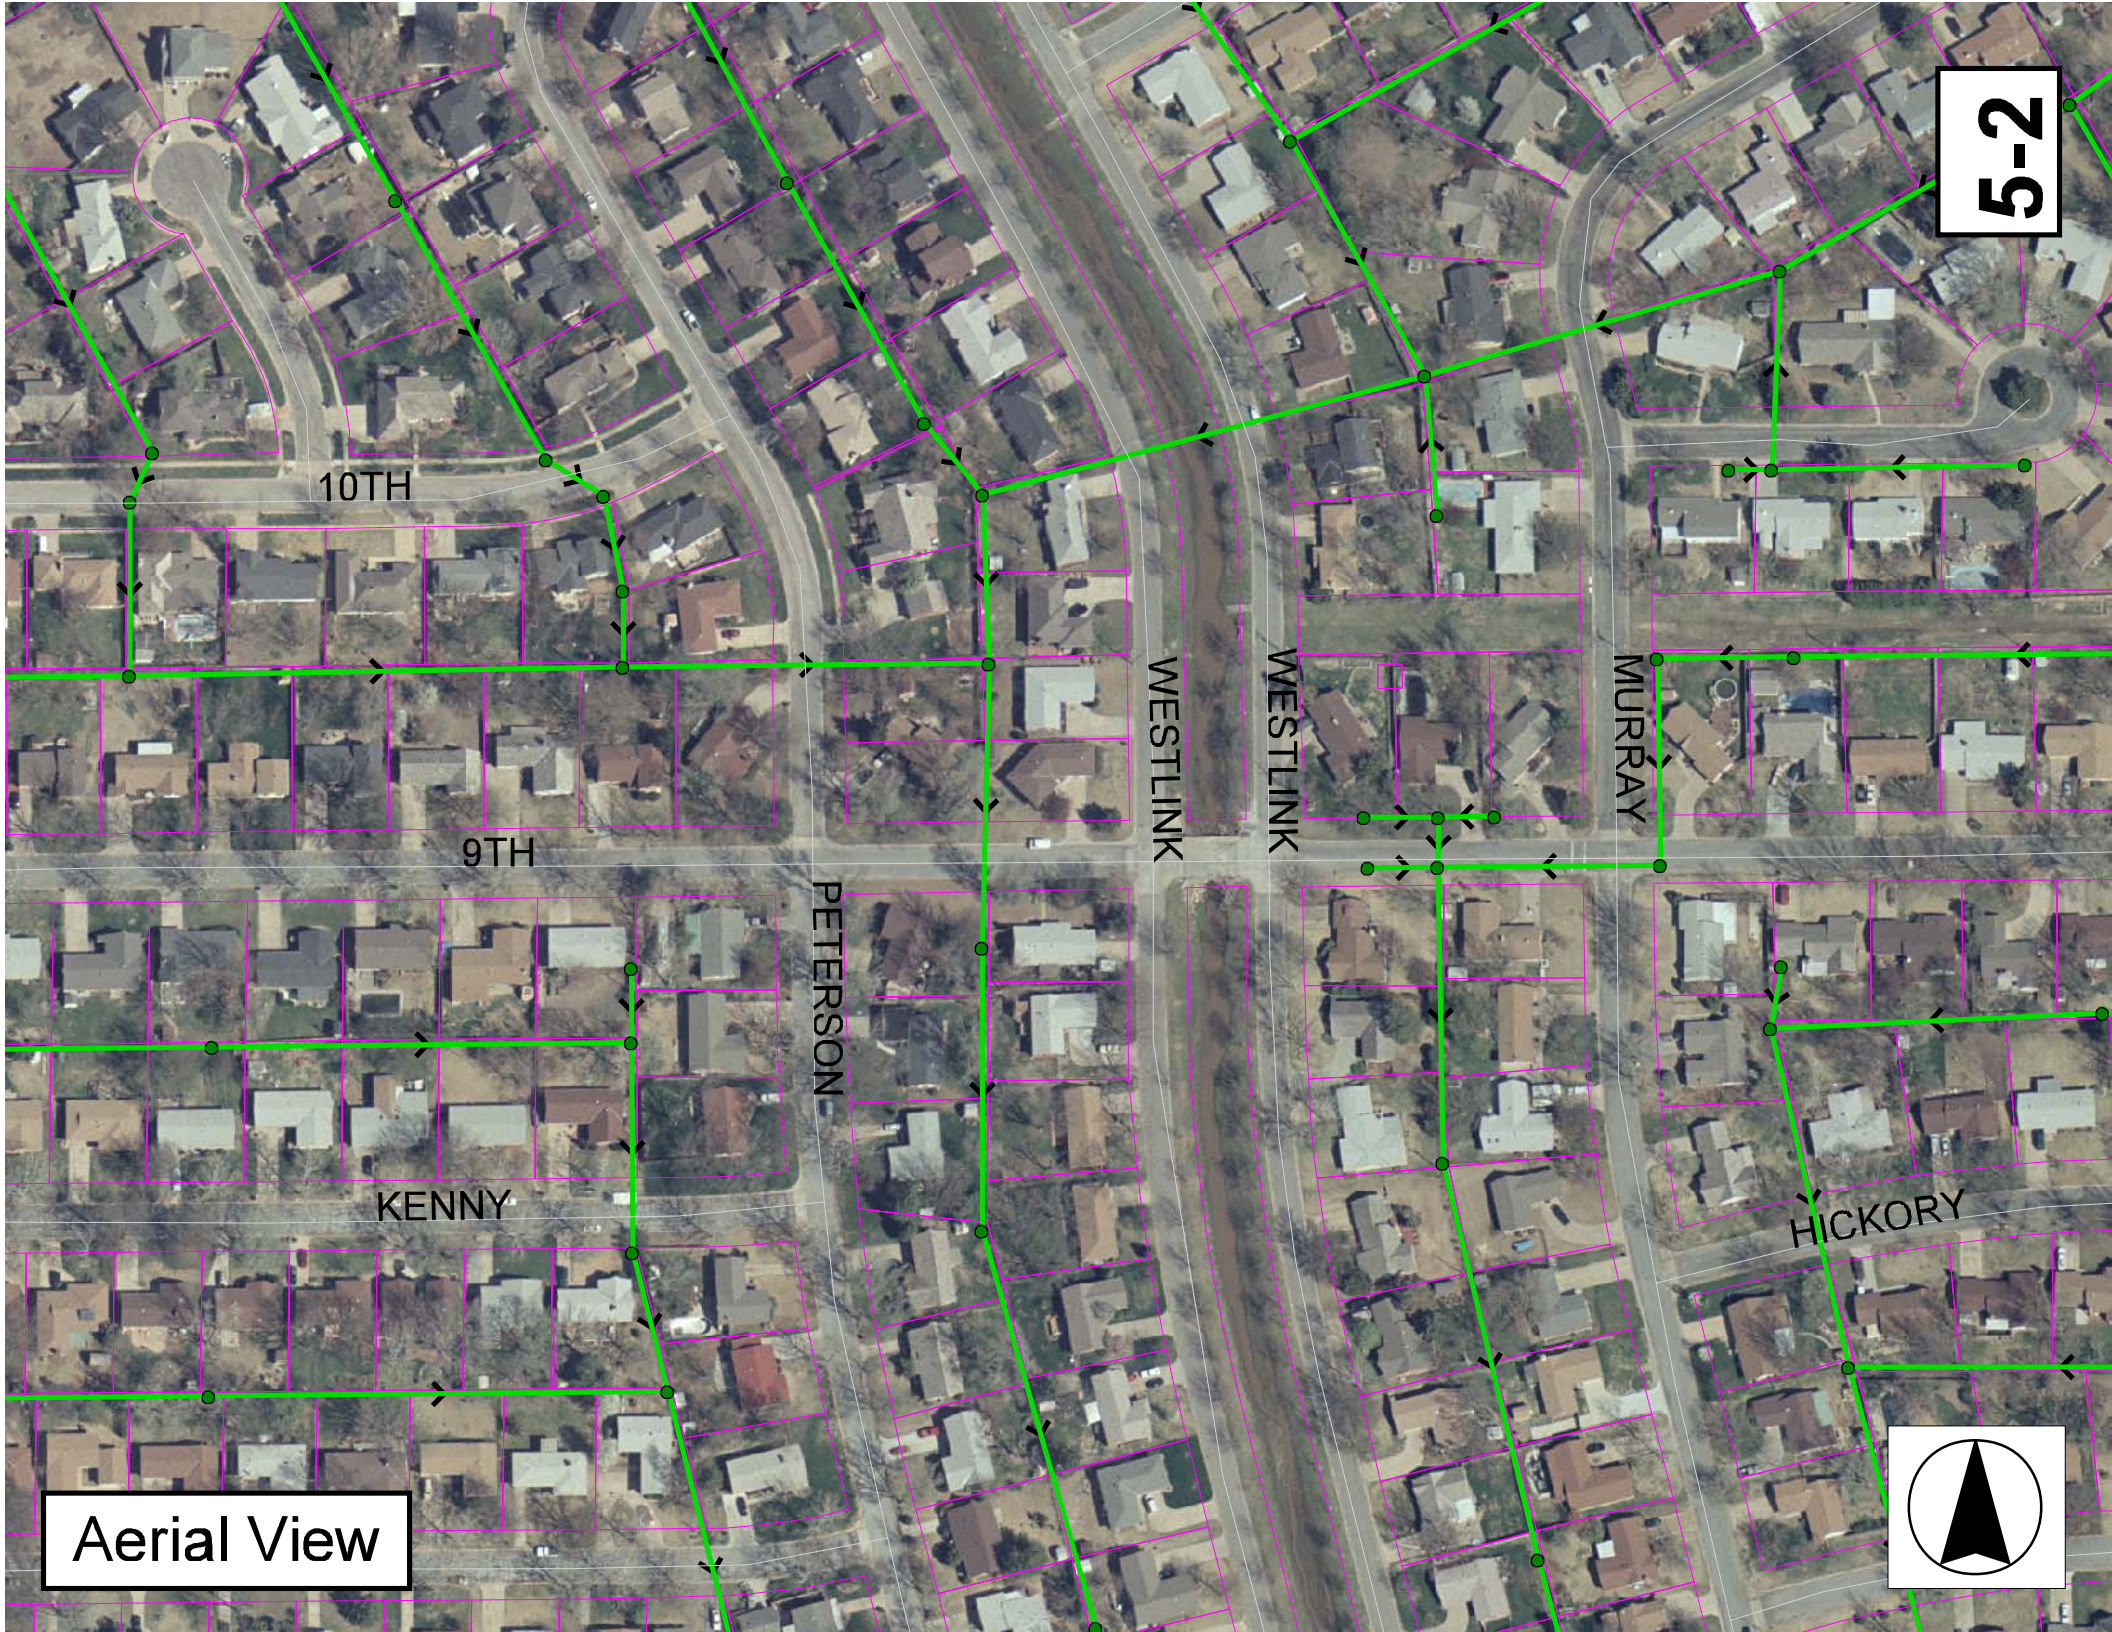
5-2

MH # 4848-036
Approx depth = 10.0 ft

MH # 4848-035
Approx depth = 11.6 ft

MH # 4848-034
Approx depth = 11.0 ft

MH # 4848-033
Approx depth = 11.7 ft

MH # 4848-032
Approx depth = 12.1 ft
