Install 412 lf of 8" Cured-in-Place Liner from MH 5846-501 to MH 5846-319

**SITE 5**

# Television Inspection Master Report

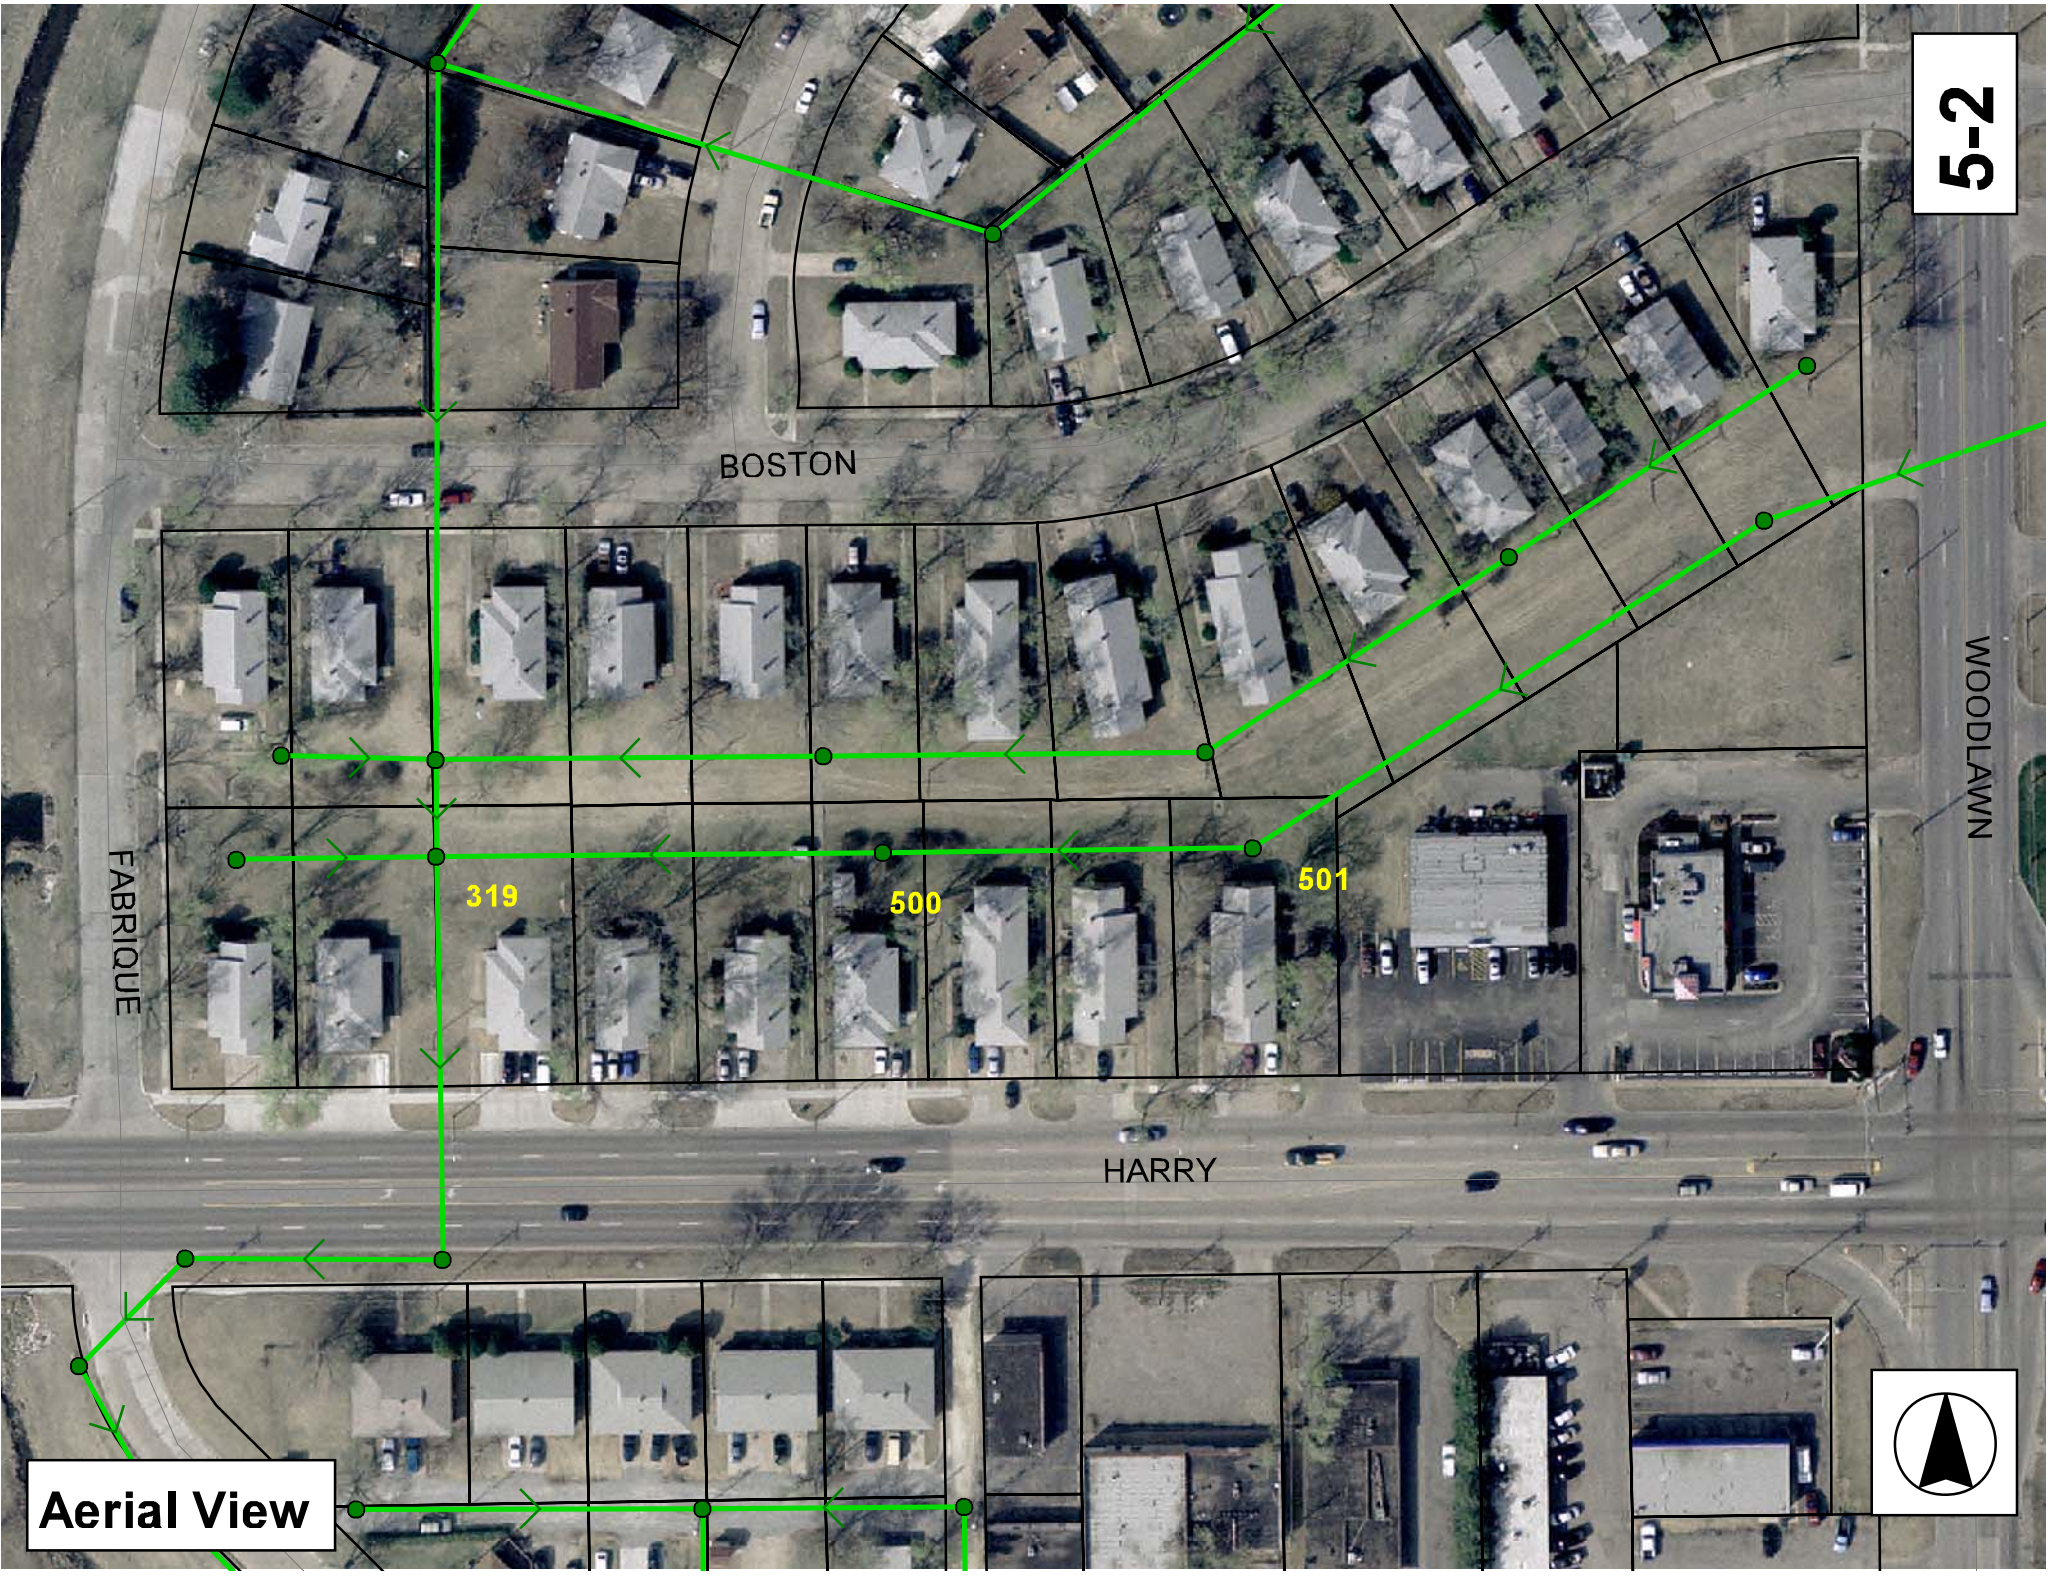
Aerial View

MH # 5846-319  
Approx depth = 11.5 ft

MH # 5846-500  
Approx depth = 9.8 ft

MH # 5846-501  
Approx depth = 10.7 ft
