Kansas Food Bank
Warehouse

SITE 4

Television Inspection Master Report

1916 E ENGLISH ST

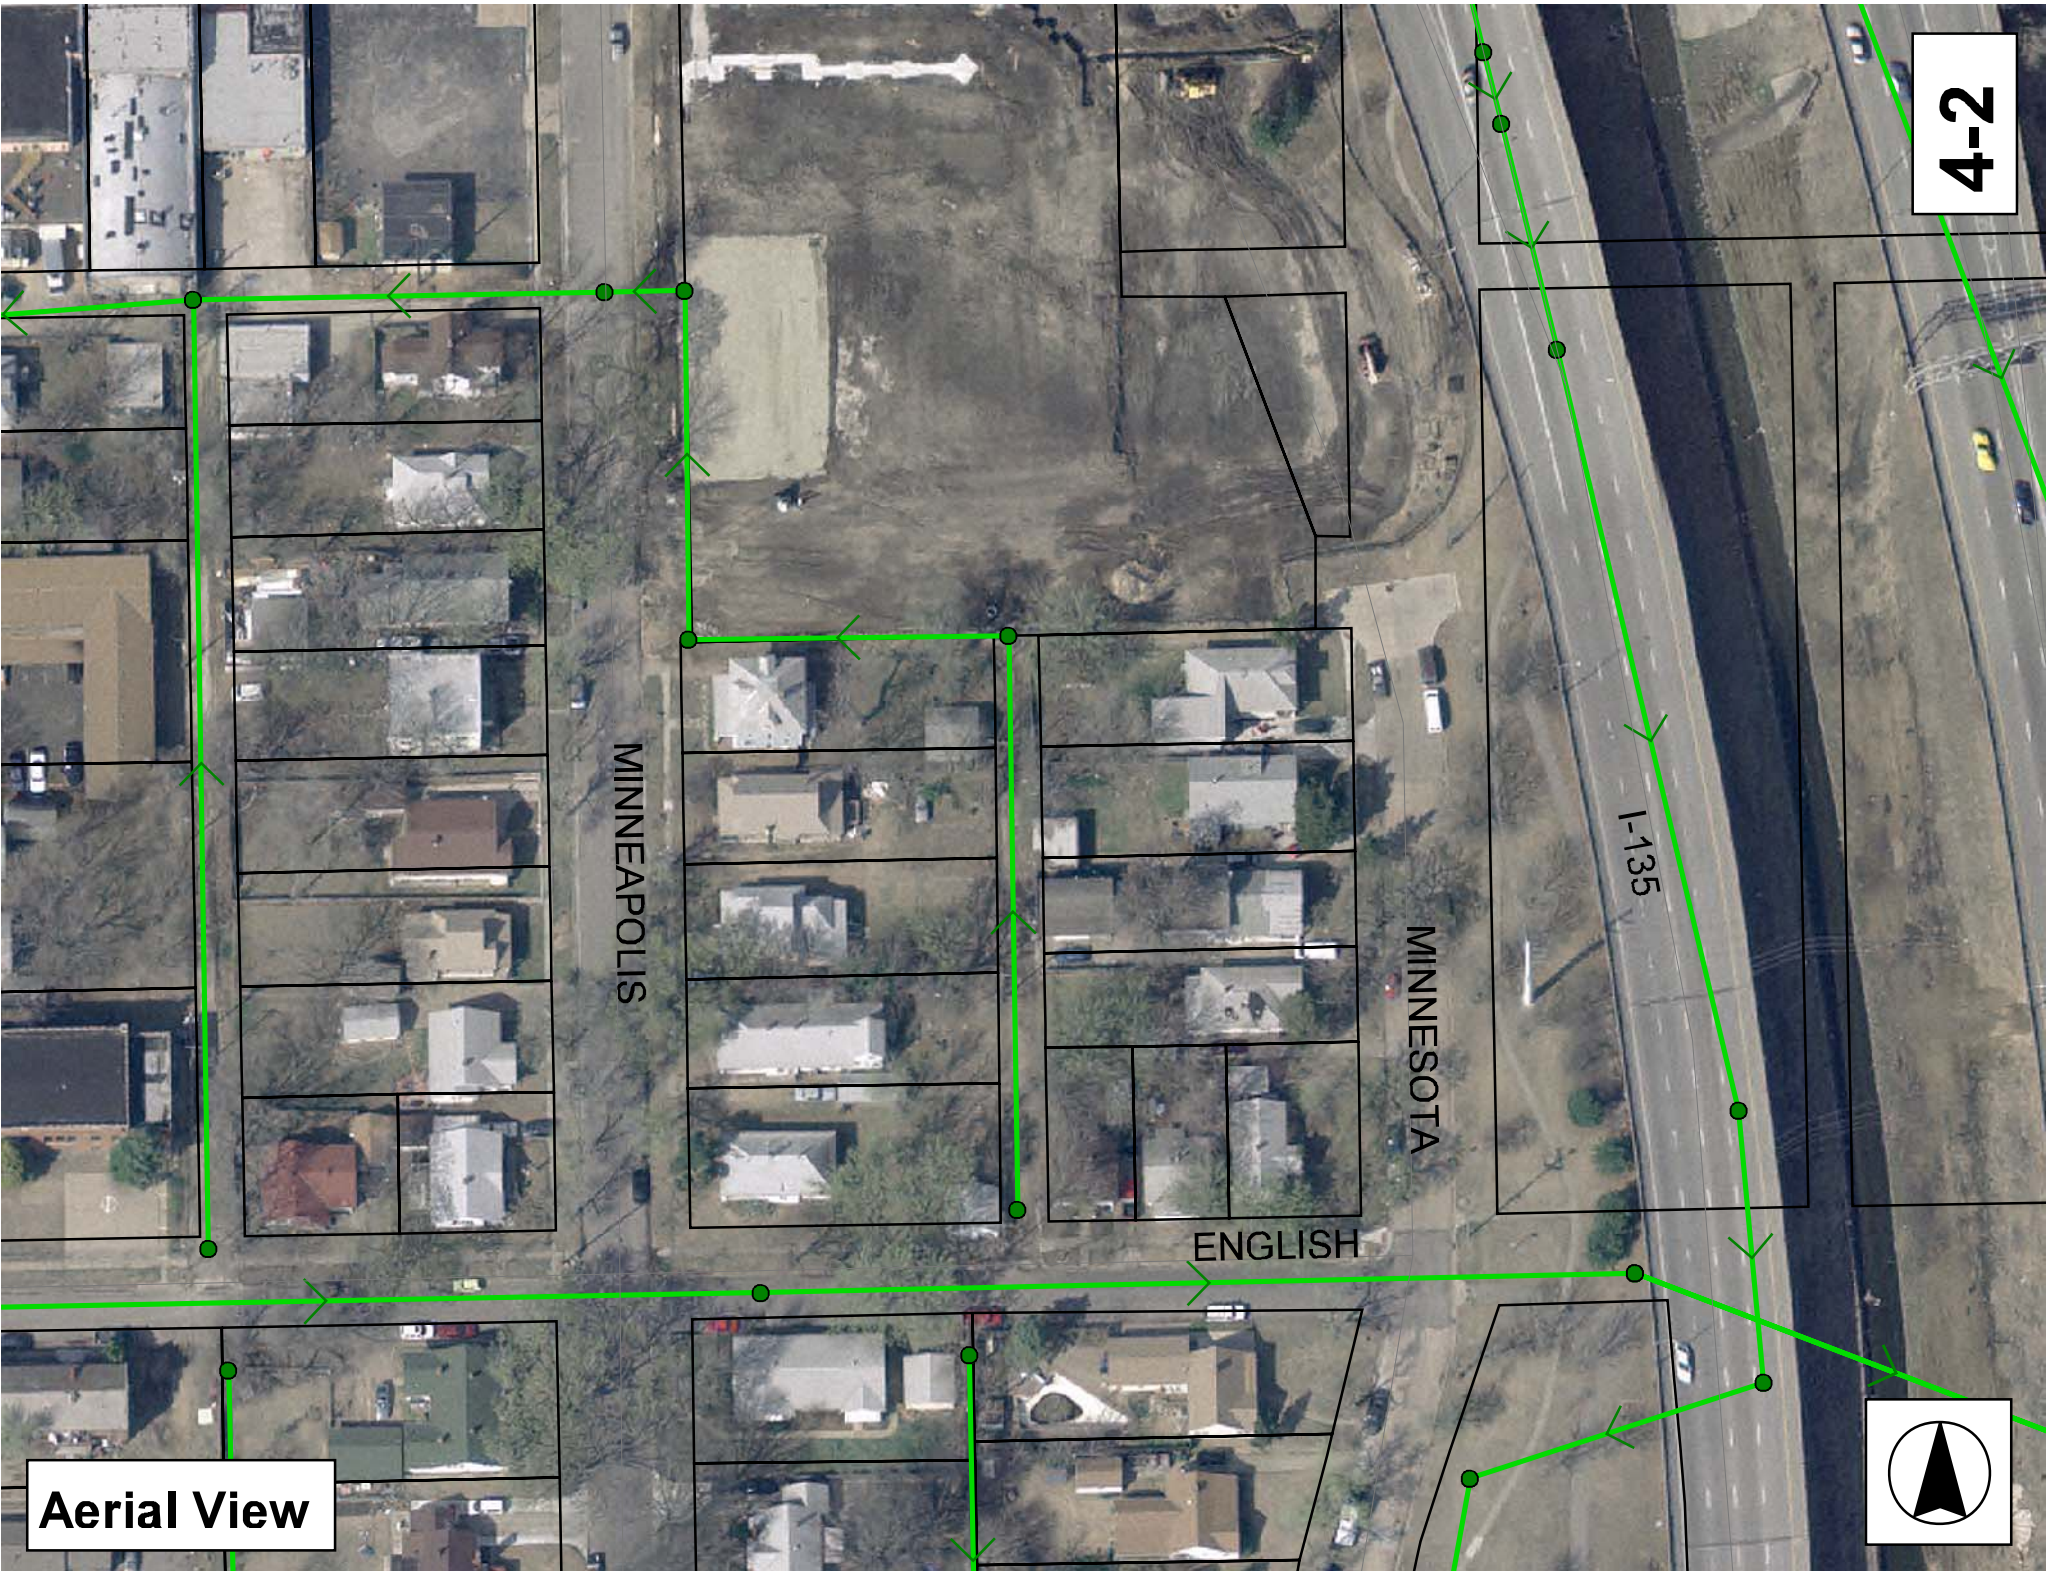
4-2

MH # 5647-635
Approx depth = 6.8 ft

Remove and replace 255 lf of 8" pipe

MH # 5647-069
Reconstruct Manhole
Approx depth = 5.5 ft
