Install 1169 lf of 12" Cured-in-Place Liner from MH 5744-882 to MH 5644-023

SITE 5B

Television Inspection Master Report

Project No. : J-136 Dia/Ht: 12 Material: VCP Length: 605.0 Slope: 0.220

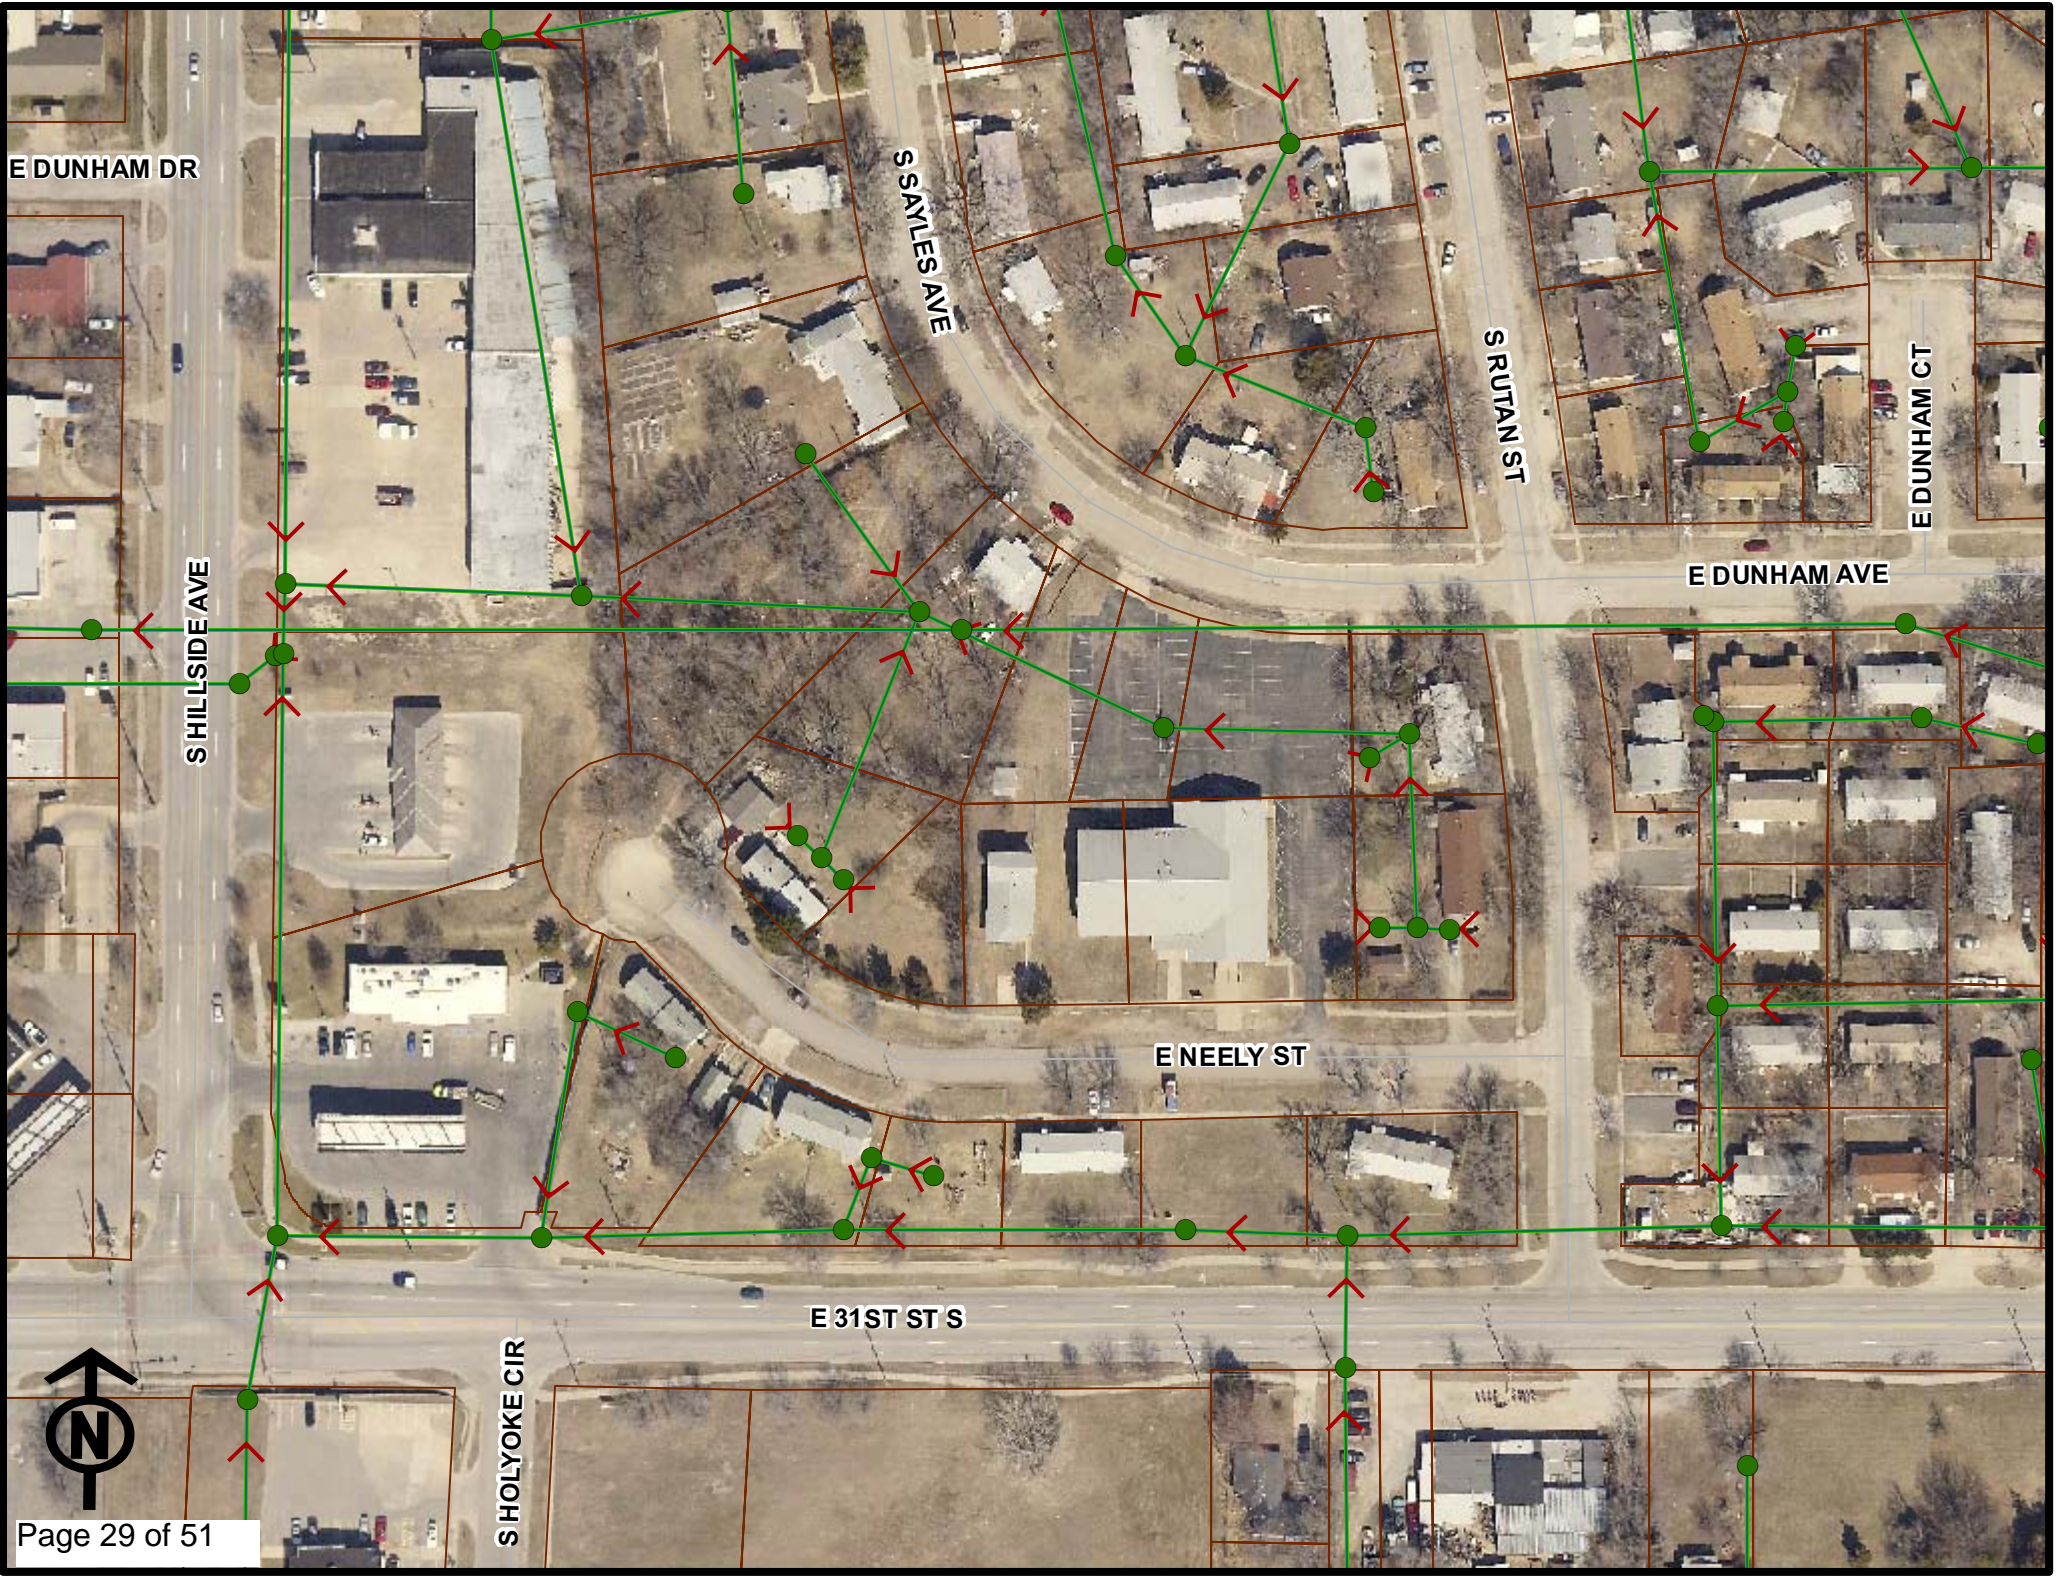
MH # 5744-881
Approx depth = 15.2 ft
3131 S. Sayles

MH # 5744-882
Approx depth = 14.3 ft
3425 E. Dunham

MH # 5644-023
Approx depth = 7.0 ft

Point Repair: Remove and replace approx 10 lf of 12" pipe, from 433' to 443' downstream of MH 5744-881 (see tv log)

Point Repair: Remove and replace approx 6 lf of 12" pipe, from 264' to 270' downstream of MH 5744-881 (see tv log)
