SITE 4

Sheet 10 of 32

SITE 5

Sheet 14 of 32

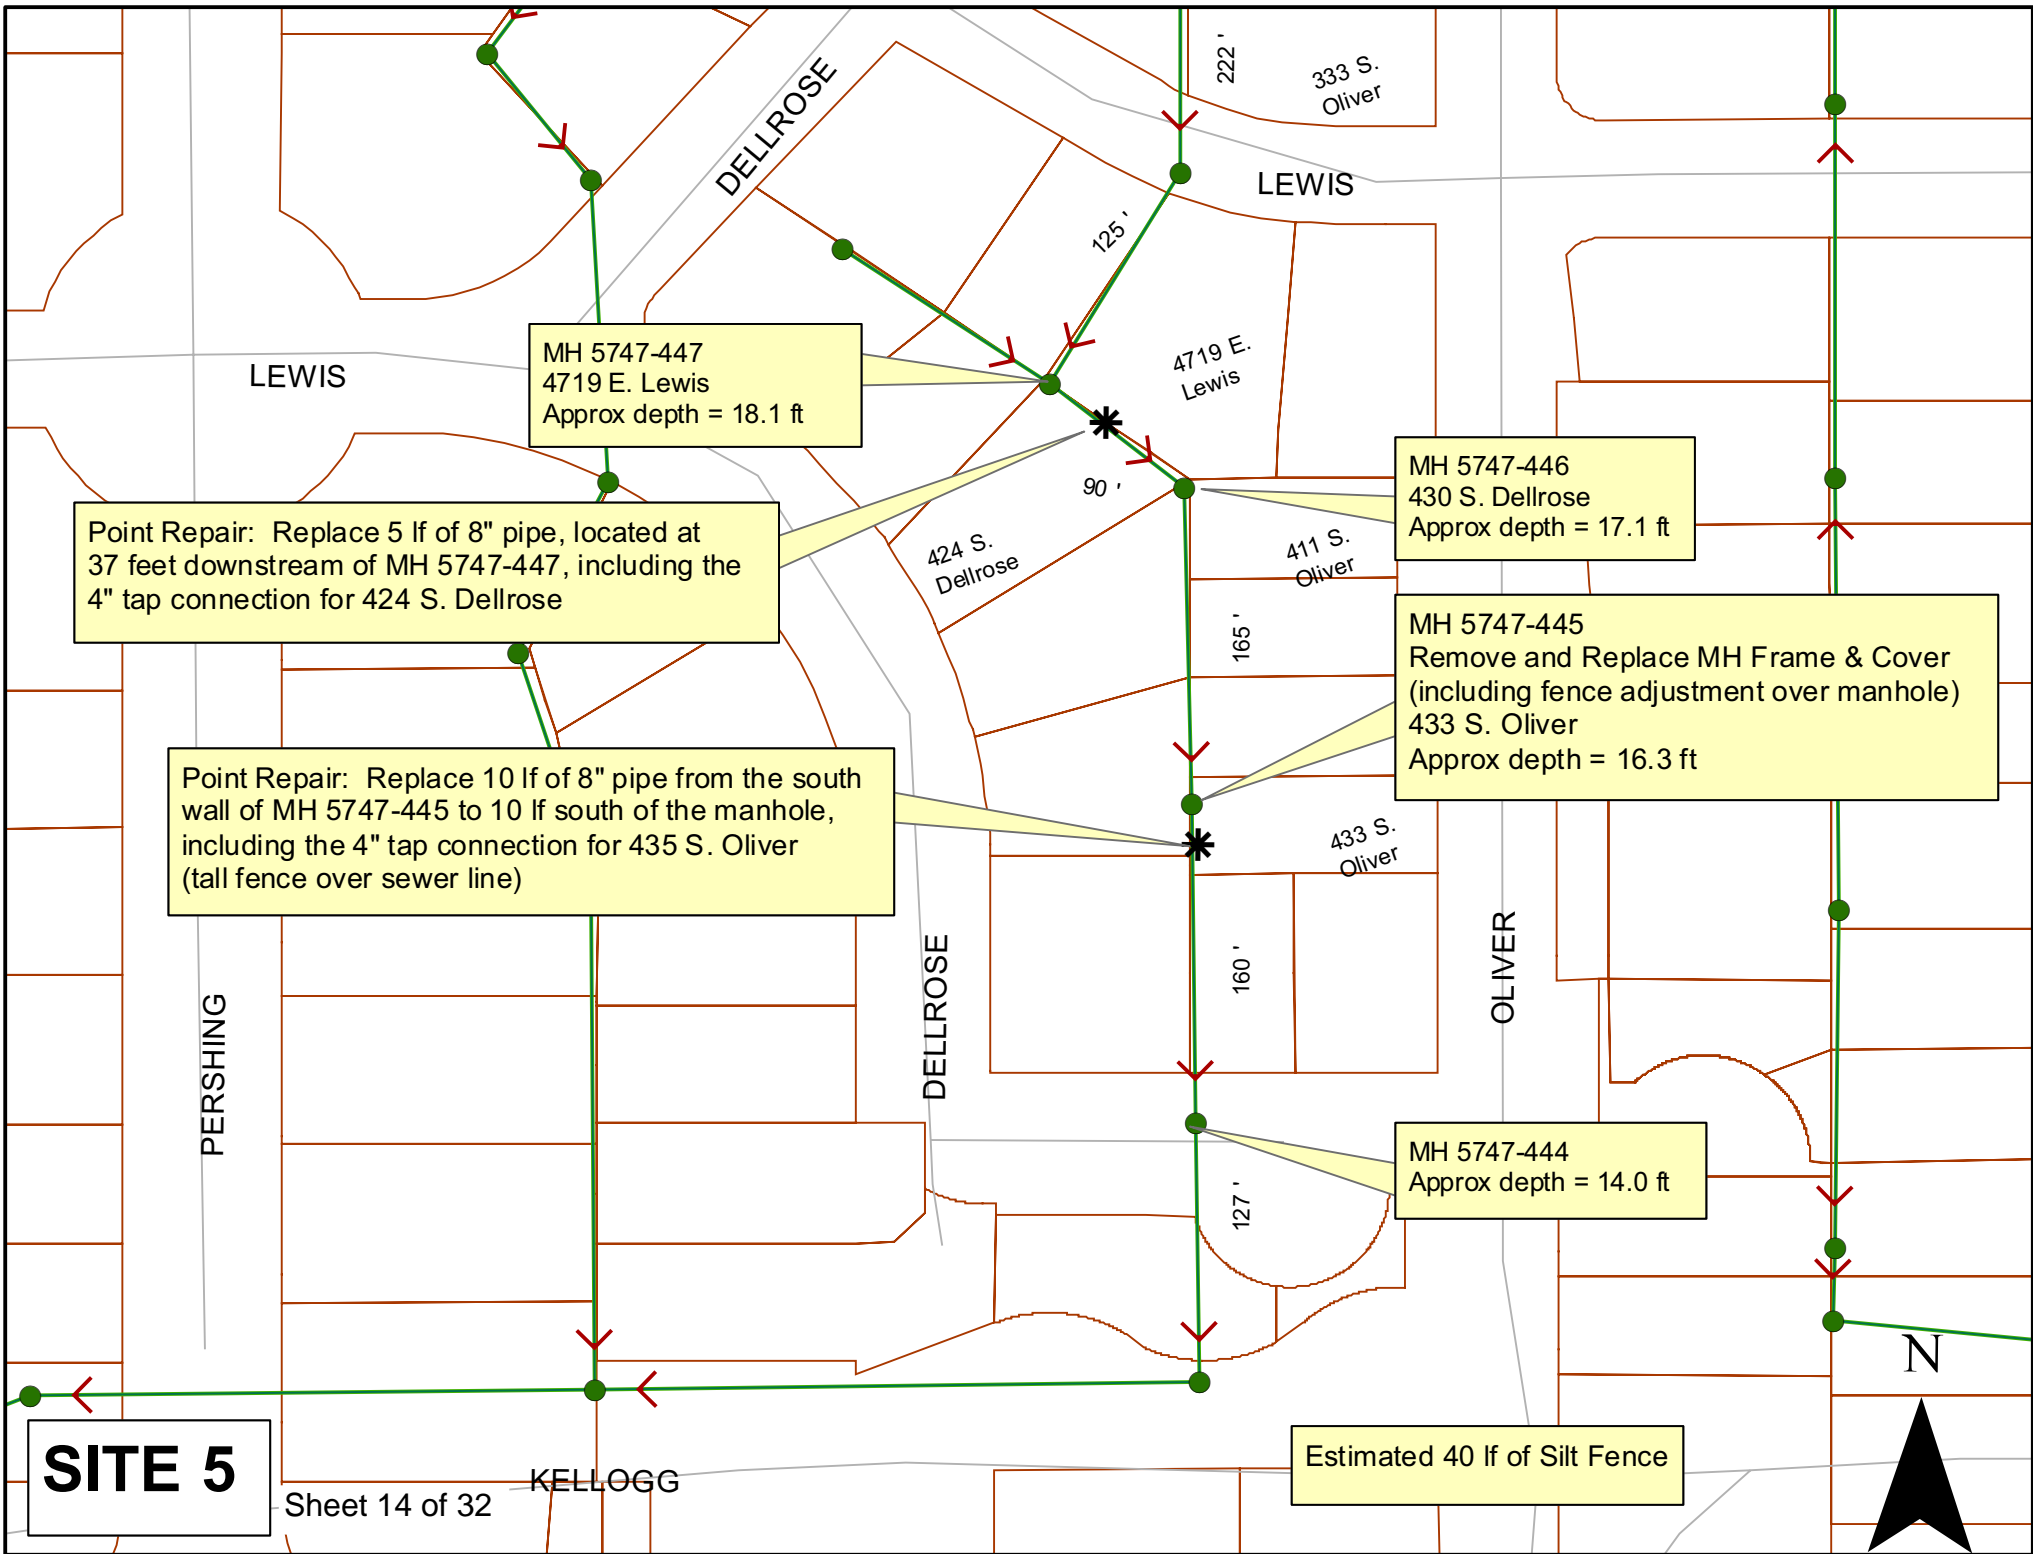
US Structure: 5747-447 414 DELLROSE ST Date Insp: 12/14/2007 Basin: E04C
 DS Structure: 5747-446 430 DELLROSE Dir Televised: Upstream To Downstream

Obs. #	VTR Counter	Distance	Location	Description	Rating	Obsrvd (gpm)	Ratings		Remain (gpm)	
							Struct	Clean		
1		0.0	US Manhole	5747-447 (access from 4719 E. Lewis)	1					
2		6.0		Sealed Off Wye South	1	0.000	0	0	0.000	
3		8.1		Sealed Off Wye North	1	0.000	0	0	0.000	
4		10.2	Joint	Offset	3	0.010	20	0	0.010	
5		26.3		Sealed Off Wye South	1	0.000	0	0	0.000	
6		28.3	Lower Right	Crack-Radial	3	0.004	5	0	0.004	
7		29.3		Sealed Off Wye North	1	0.000	0	0	0.000	
8		33.3	Upper Right	Broken Pipe	2	0.008	44	0	0.008	
9		36.0	Upper Right	Broken Pipe	3	0.010	60	0	0.010	
10		37.1	South	Extended Tap	5	0.002	400	0	0.002	
				424 S DELLROSE / dropped into the main	4" Break In Connection	Comment: PIPE MISSING / needs point repair				
11		49.3		Sealed Off Wye South	1	0.000	0	0	0.000	
12		51.5		Sealed Off Wye North	2	0.002	0	0	0.002	
13		58.5	Crown	Broken Pipe	2	0.008	44	0	0.008	
14		61.3	Crown	Broken Pipe	2	0.008	44	0	0.008

15		63.9	Crown	Broken Pipe	2	0.008	44	0	0.008	
16		69.5		Sealed Off Wye South	1	0.000	0	0	0.000	
17		71.2	Upper Right	Debris / tile	5	0.000	0	75	0.000	
18		72.8		Sealed Off Wye North	1	0.000	0	0	0.000	
19		88.0	North	Break-In Conn	1	0.001	0	0	0.001	
				4719 E LEWIS ST	4" VCP MH Stub					
20		88.0	North	Break-In Conn	1	0.001	0	0	0.001	
				401 S OLIVER ST	4" VCP MH Stub					
21		88.0	South	Break-In Conn	1	0.001	0	0	0.001	
				430 S DELLROSE	4" VCP MH Stub					
22		88.0	DS Manhole	5747-446	1	0.000	0	0	0.000

MH 5747-447
 4719 E. Lewis
 Approx depth = 18.1 ft

Point Repair: Replace 5 lf of 8" pipe, located at 37 feet downstream of MH 5747-447, including the 4" tap connection for 424 S. Dellrose

Point Repair: Replace 10 lf of 8" pipe from the south wall of MH 5747-445 to 10 lf south of the manhole, including the 4" tap connection for 435 S. Oliver (tall fence over sewer line)

MH 5747-446
 430 S. Dellrose
 Approx depth = 17.1 ft

MH 5747-445
 Remove and Replace MH Frame & Cover (including fence adjustment over manhole)
 433 S. Oliver
 Approx depth = 16.3 ft

MH 5747-444
 Approx depth = 14.0 ft
