SITE 1

Video Inspection Master Report

US Structure: 5445-351 2100 S BROADWAY AVE ST Date Insp: 9/21/2010 Basin: C05D
 DS Structure: 5445-350 2122 S MARKET AVE ST Dir Televised: Upstream To Downstream

Shape: Round Length Status: Project No. : D-150
 Dia/Ht: 8 Material: VCP Index:
 Length: 215.0 Slope: 0.102 Surface:

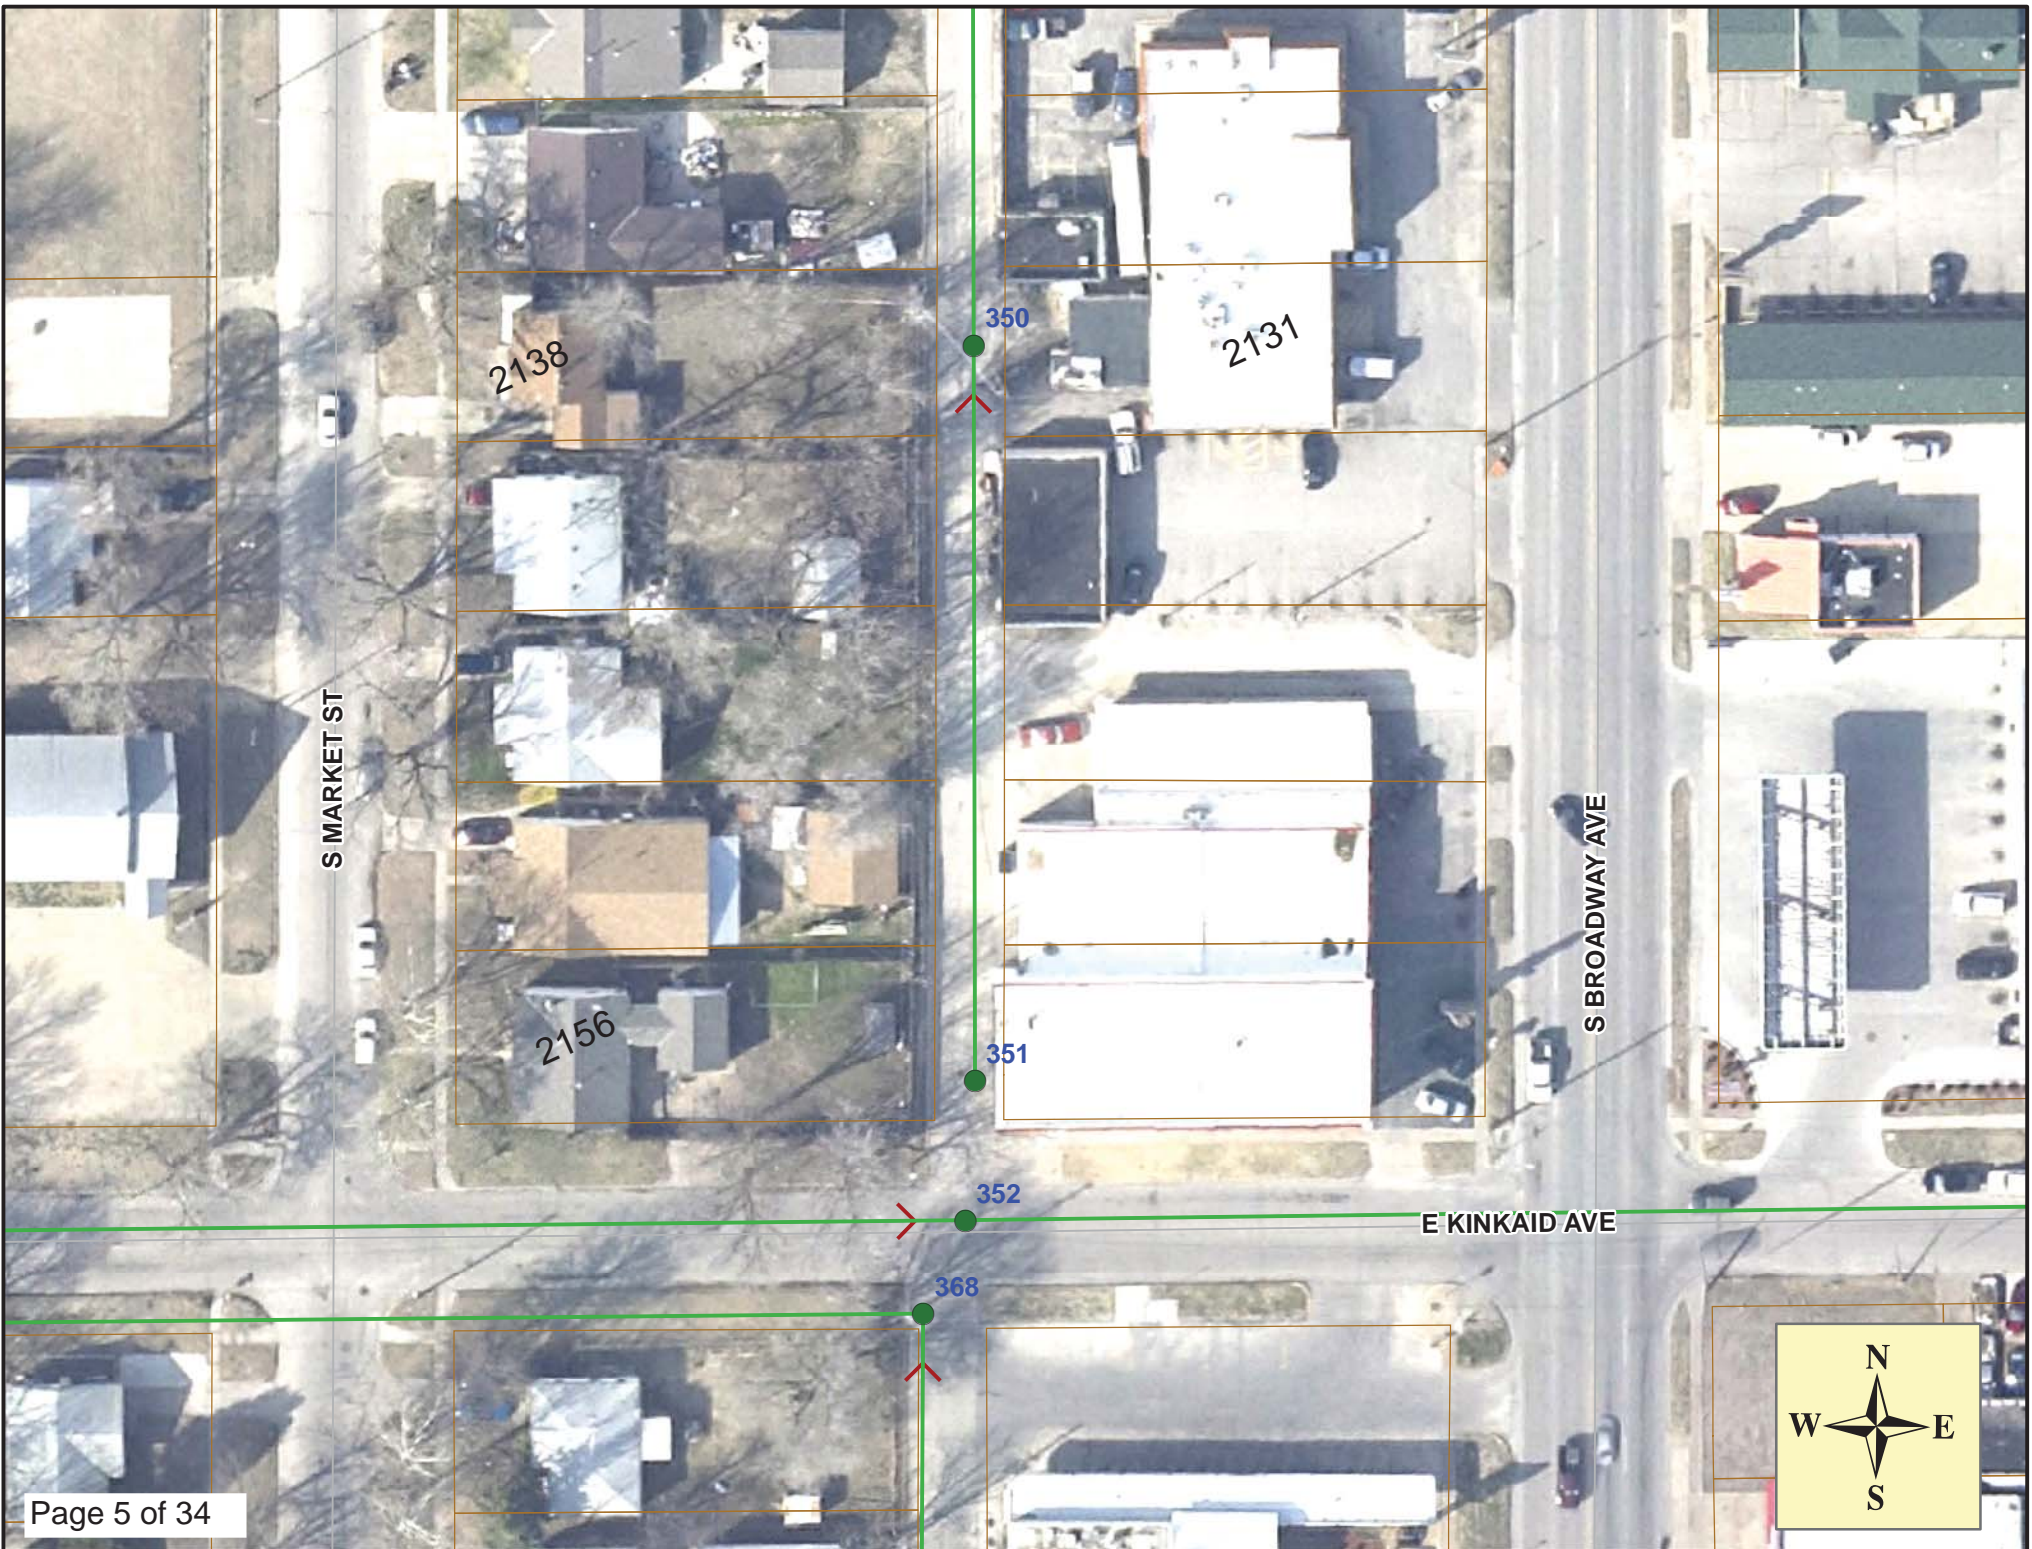
Estimated 8 Service Reconnections (4")
Estimated 1 Service Reconnection (6")

MH 5445-350
Remove and Replace MH Frame & Cover
Approx MH depth = 3.3 ft

Remove 215 lf of 8" Pipe
Install 215 lf of 8" Pipe
Remove & Replace approx
218 lf of Concrete Pavement
Install 215 lf of Fill Sand (flushed & vibrated)

MH 5445-351
Remove and Replace MH Frame & Cover
Approx MH depth = 2.8 ft
