Remove 311 lf of 6" pipe / Install 311 lf of 8" pipe  
from MH 5744-736 to MH 5744-684  
See site pictures / Contractor should review the site

# Television Inspection Master Report

3407 E SUNNYBROOK ST

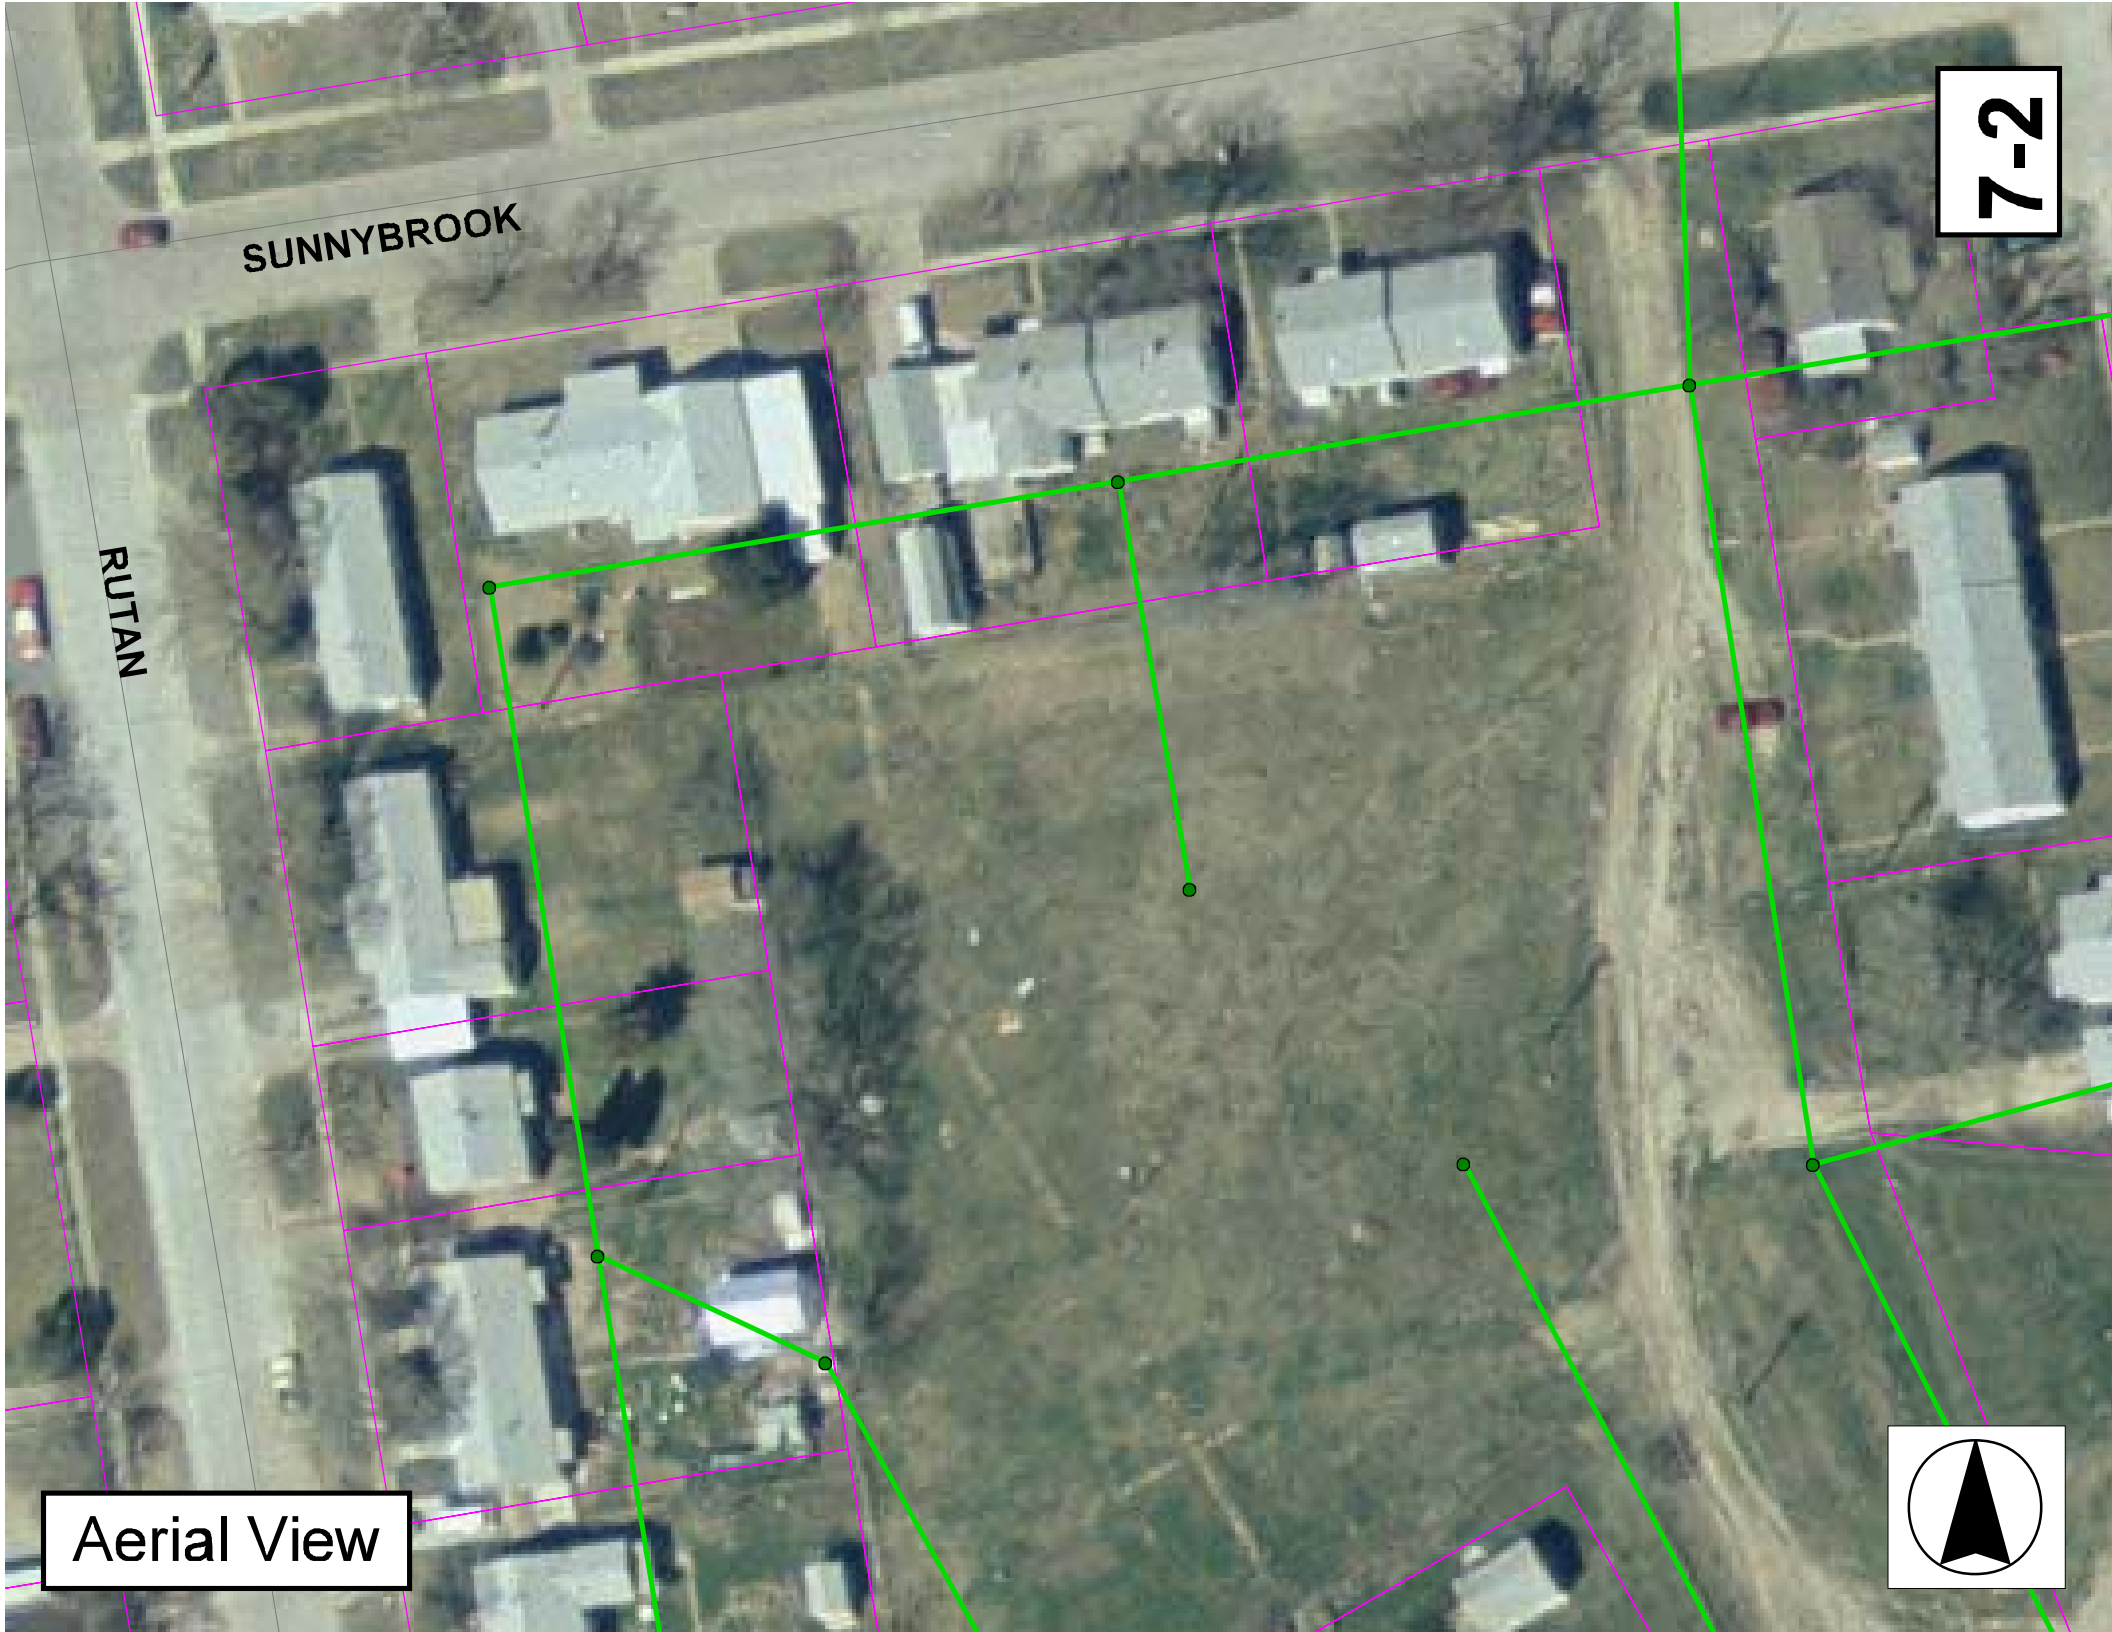
Aerial View

MH # 5744-684  
Approx depth = 12.0 ft

MH # 5744-736  
Adjust Manhole to Grade (< 6")  
Rework Manhole Bench & Invert  
Approx depth = 10.7 ft

# 5744-735CO (cleanout) / Not found  
Disconnect and sealoff pipe from the southeast.  
Remove cleanout. No bid item for this.
