SITE 1

# Television Inspection Master Report

**US Structure:** 5448-080      1330 N WELLINGTON PL PL      **Date Insp:** 2/5/2007      **Basin:** C03D  
**DS Structure:** 5448-077      116 W 12TH ST      **Dir Televised:** Upstream To Downstream

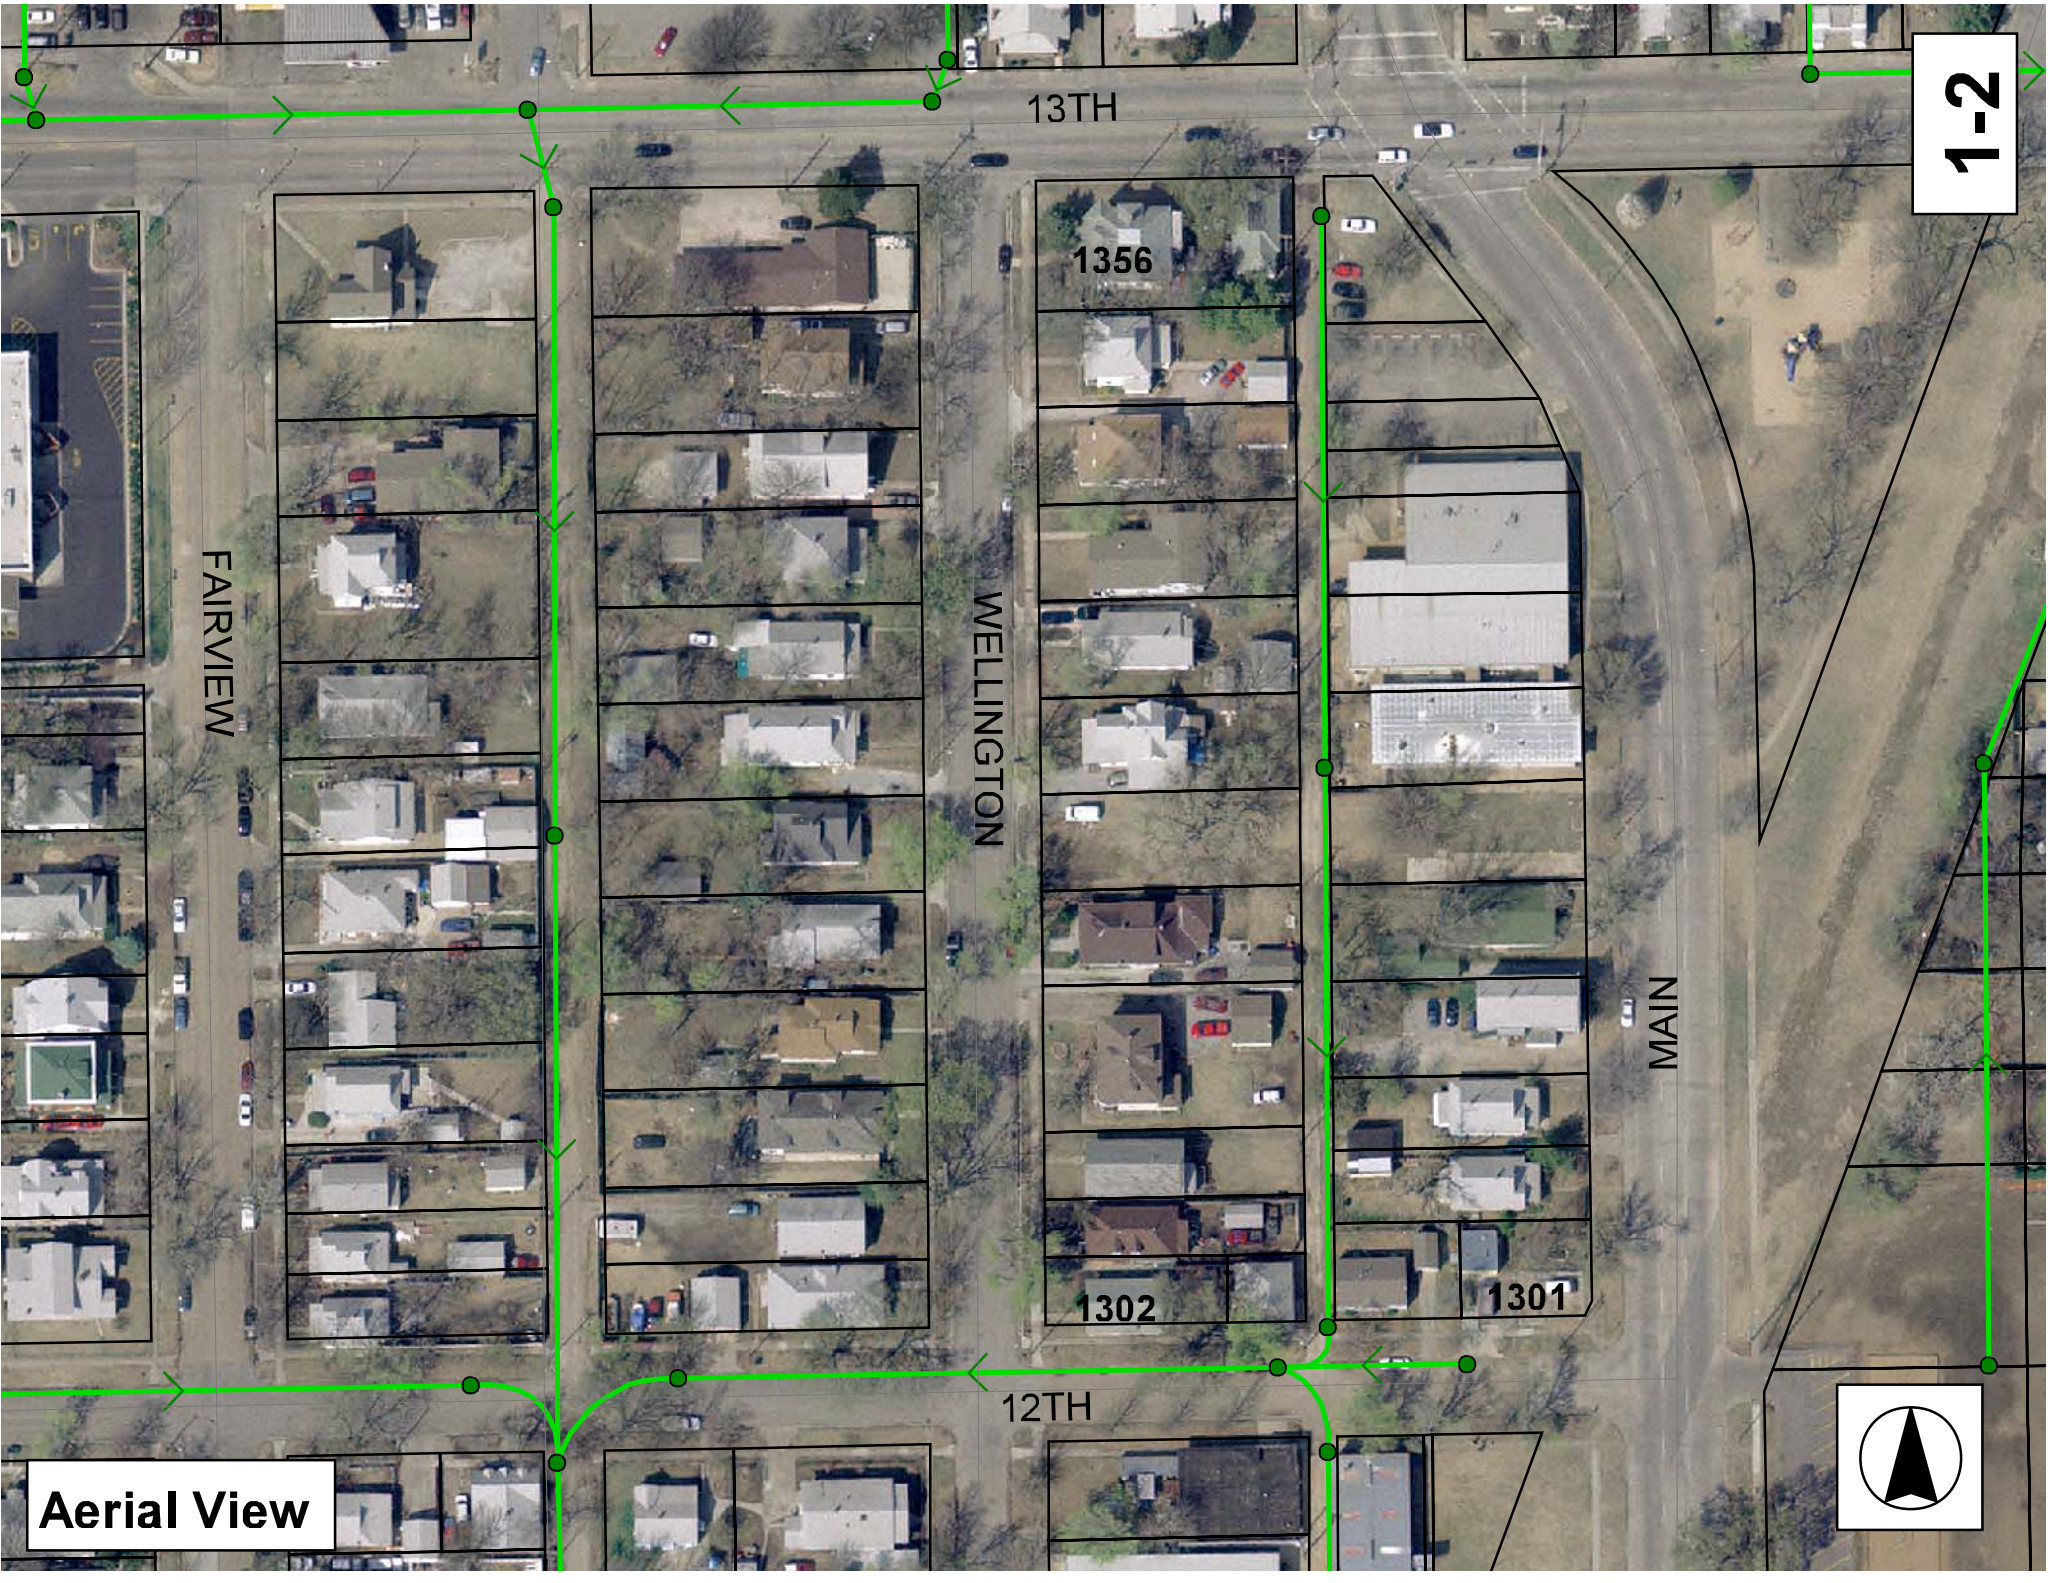
MH # 5448-083  
Reconstruct Manhole  
Approx depth = 2.7 ft

MH # 5448-080  
Reconstruct Manhole  
Approx depth = 5.6 ft

MH # 5448-077  
Reconstruct Manhole  
Approx depth = 5.0 ft

# 5448-084E  
Capped End of Pipe  
(nothing visible at surface)  
(See notes on tv log)

MH # 5448-073  
Reconstruct Manhole  
Approx depth = 5.3 ft

MH # 5448-076  
Reconstruct Manhole  
Approx depth = 4.7 ft

Remove & Replace  
290 lf of 8" Pipe
