SITE 3

Television Inspection Master Report

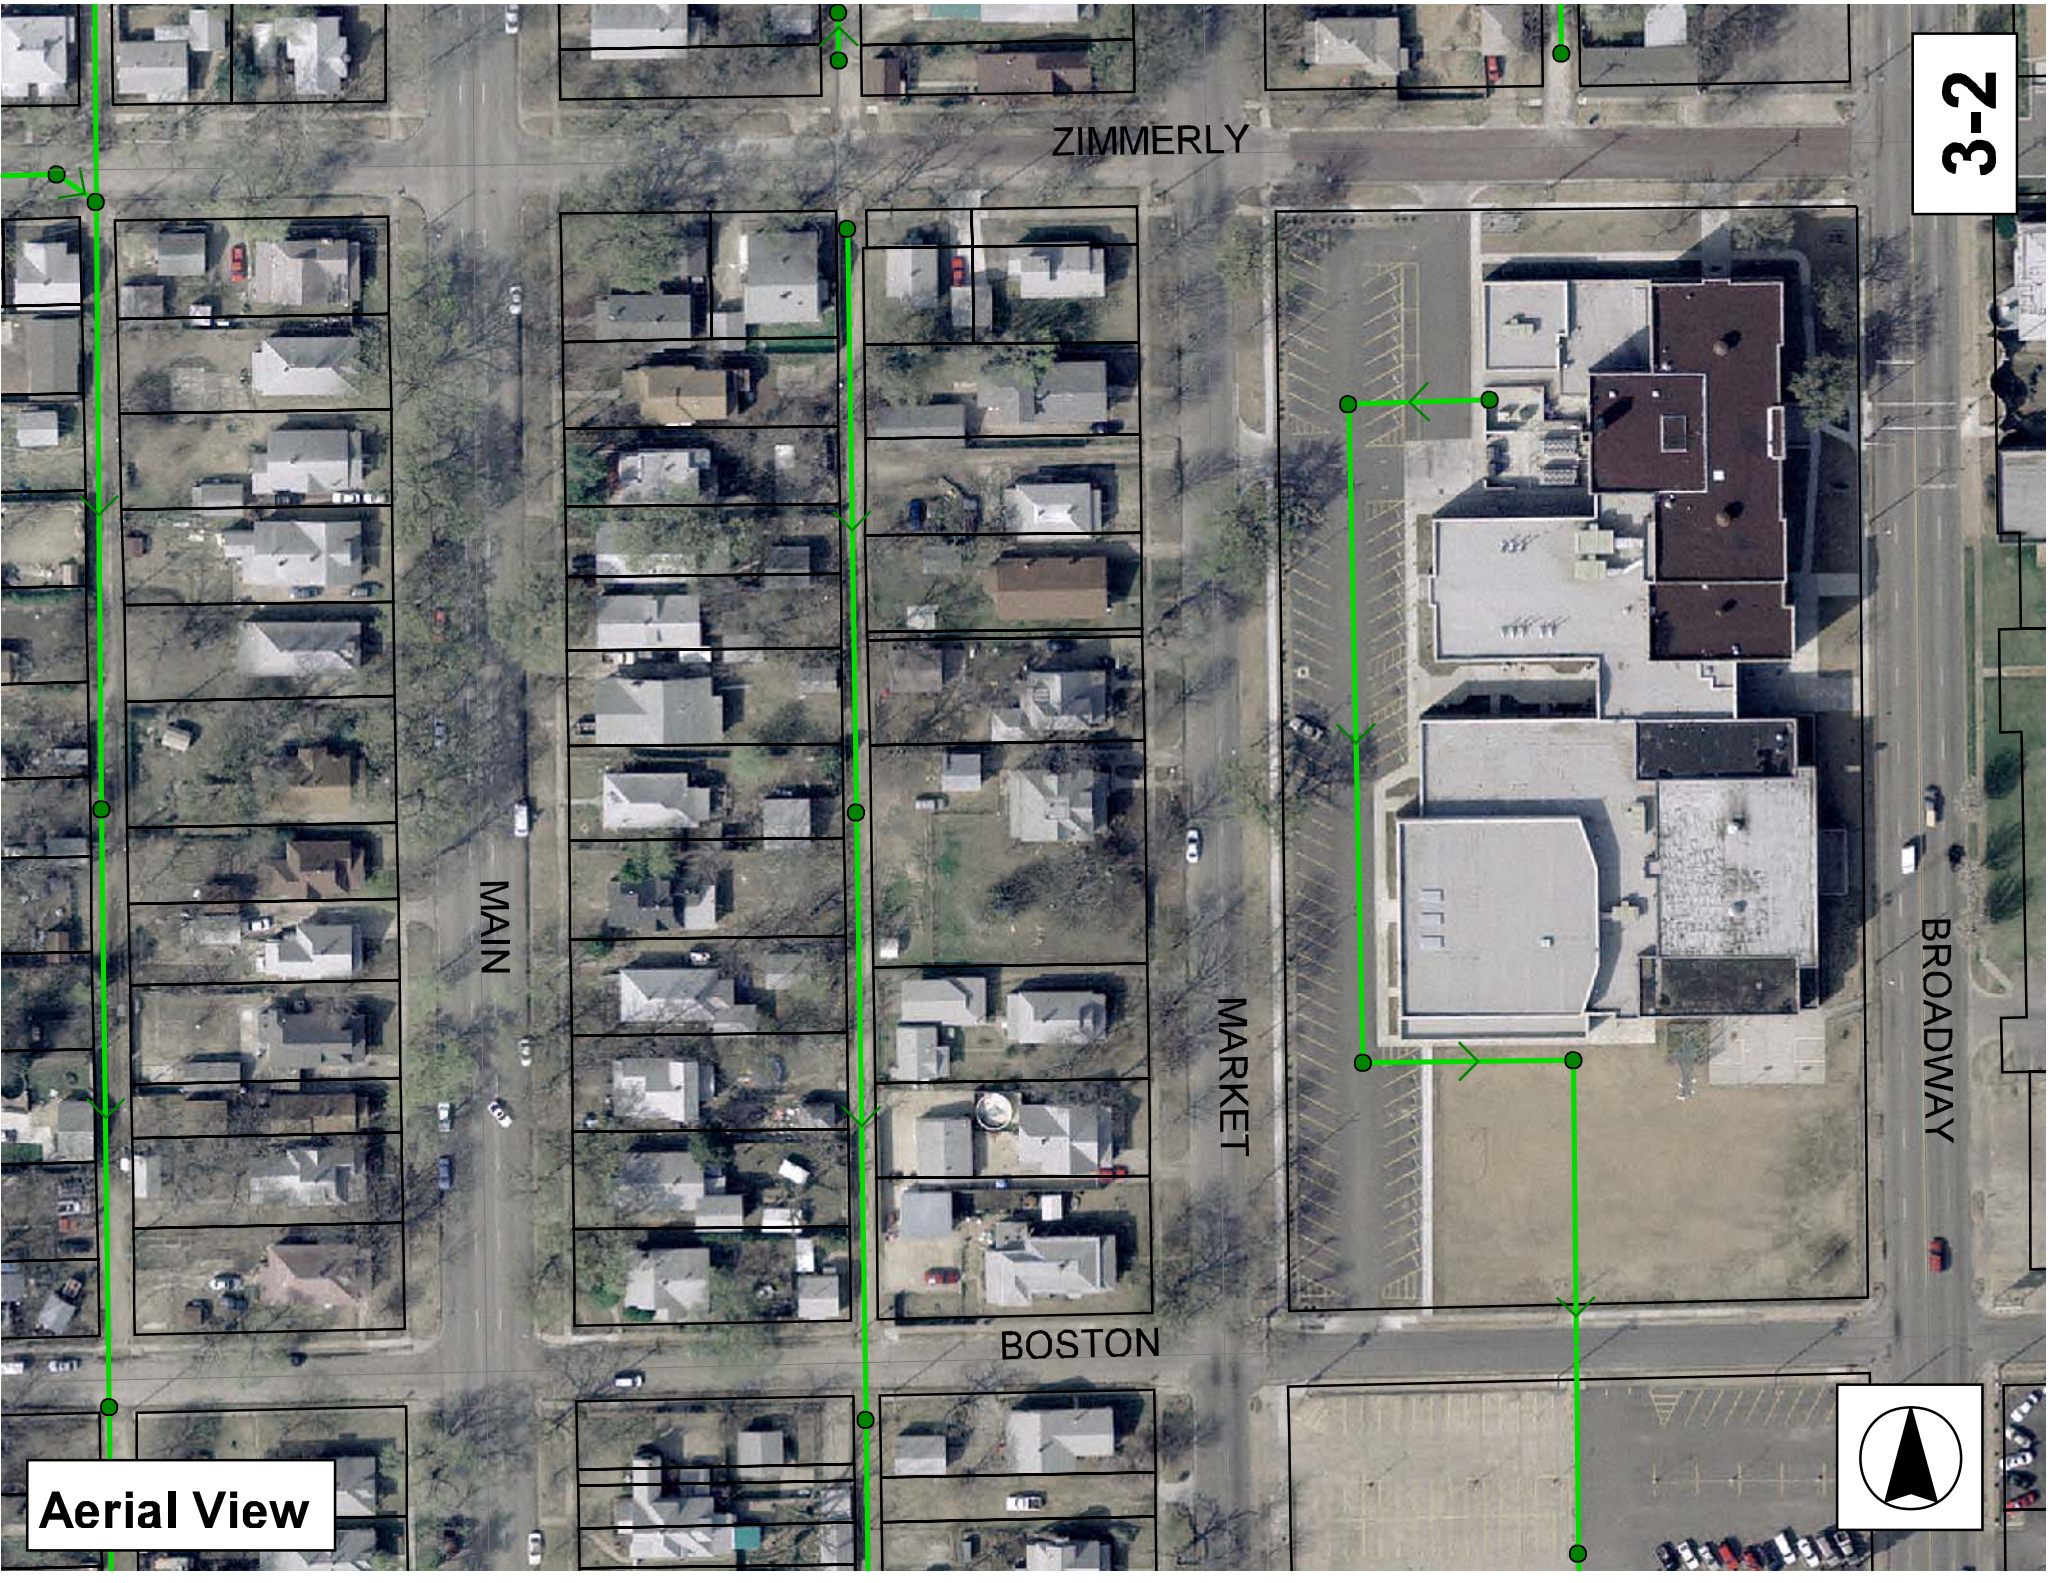
Aerial View

MH # 5446-495
Replace Manhole Frame & Cover
Approx depth = 3.0 ft

MH # 5446-492
Reconstruct Manhole
Depth not measured
(buried approx. 4")

MH # 5446-489
Approx depth = 6.2 ft

Point Repair:
Remove approx. 8 lf of 8" cast iron pipe and
install C-900 pipe. From approx 19' north of MH
5446-489 to 27' north of MH 5446-489.
Pavement removal and replacement shall be incidental.
