2011 SANITARY SEWER RECONSTRUCTION PHASE 4

OCA # 620580 / 468-84778
(East of Meridian, South of 13th Street North)

Television Inspection Master Report

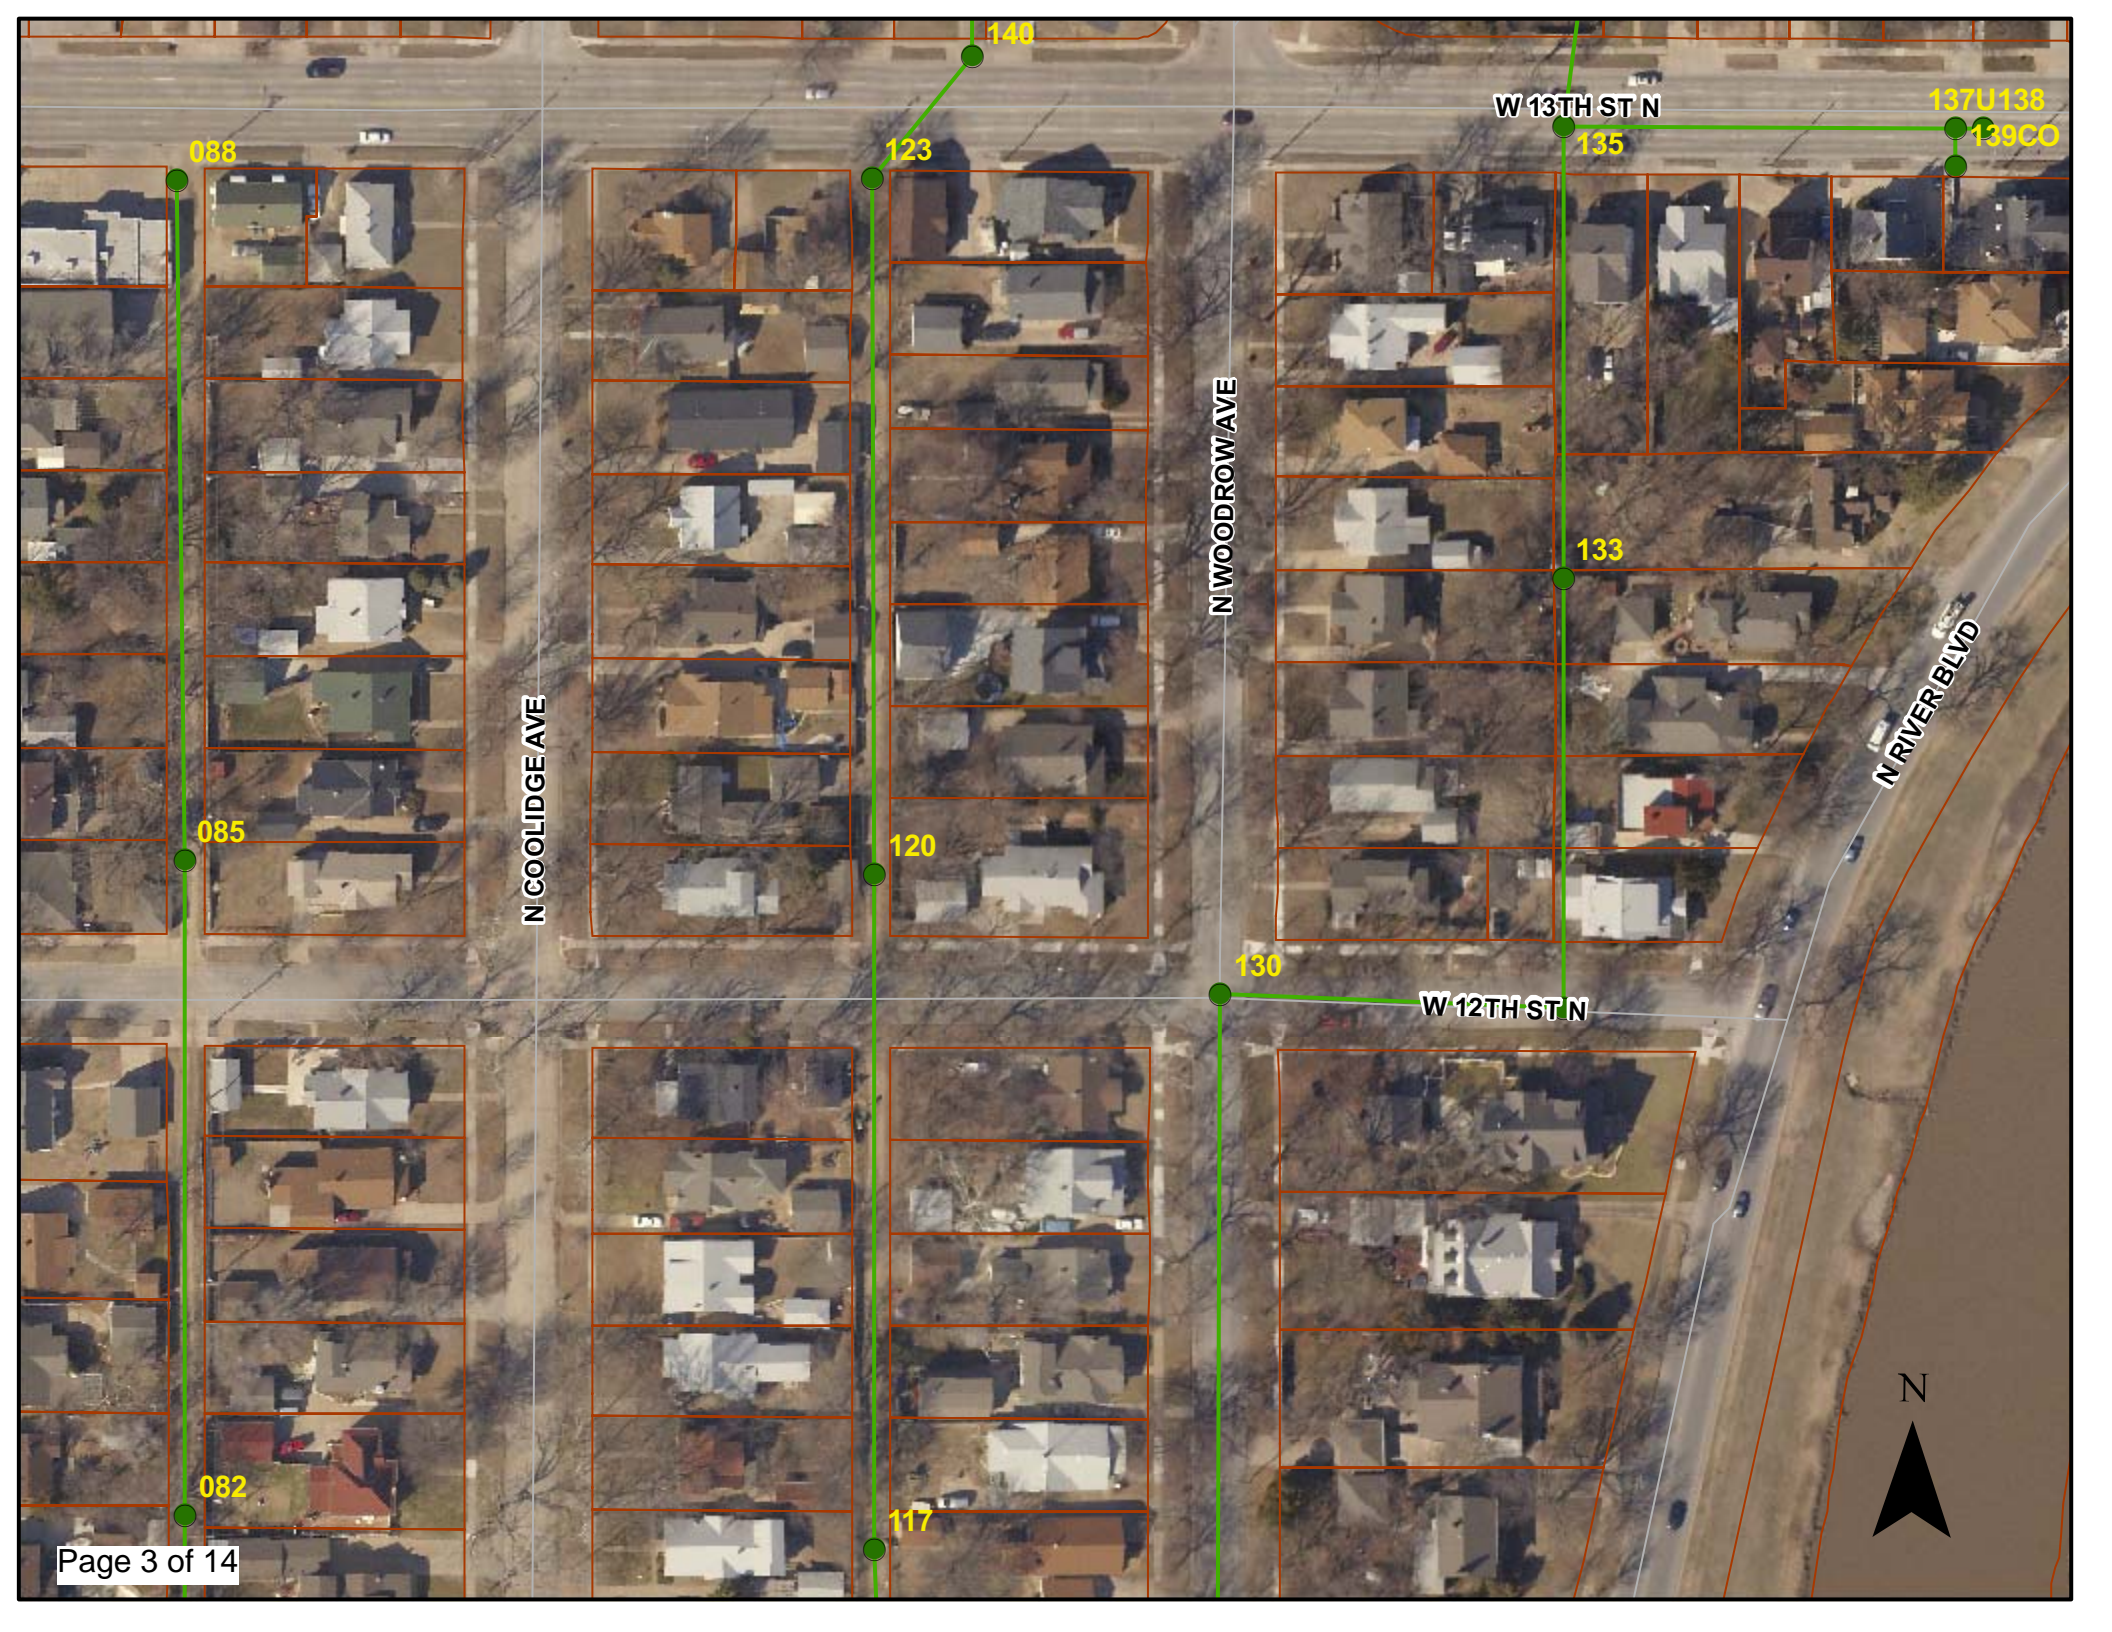
MH # 5348-123
Approx depth = 7.1 ft

MH # 5348-120
Reconstruct Manhole
Approx depth = 7.9 ft

MH # 5348-117
Reconstruct Manhole
Approx depth = 8.6 ft

Point Repair: Remove and replace
40 lf of pipe, from MH 5348-117 to
40 lf north, including two Service
Connections (see tv log)

Remove 363 lf of 8" Pipe
Install 363 lf of 8" Pipe
