**SITE 7**

Sheet 20 of 32

# Video Inspection Master Report

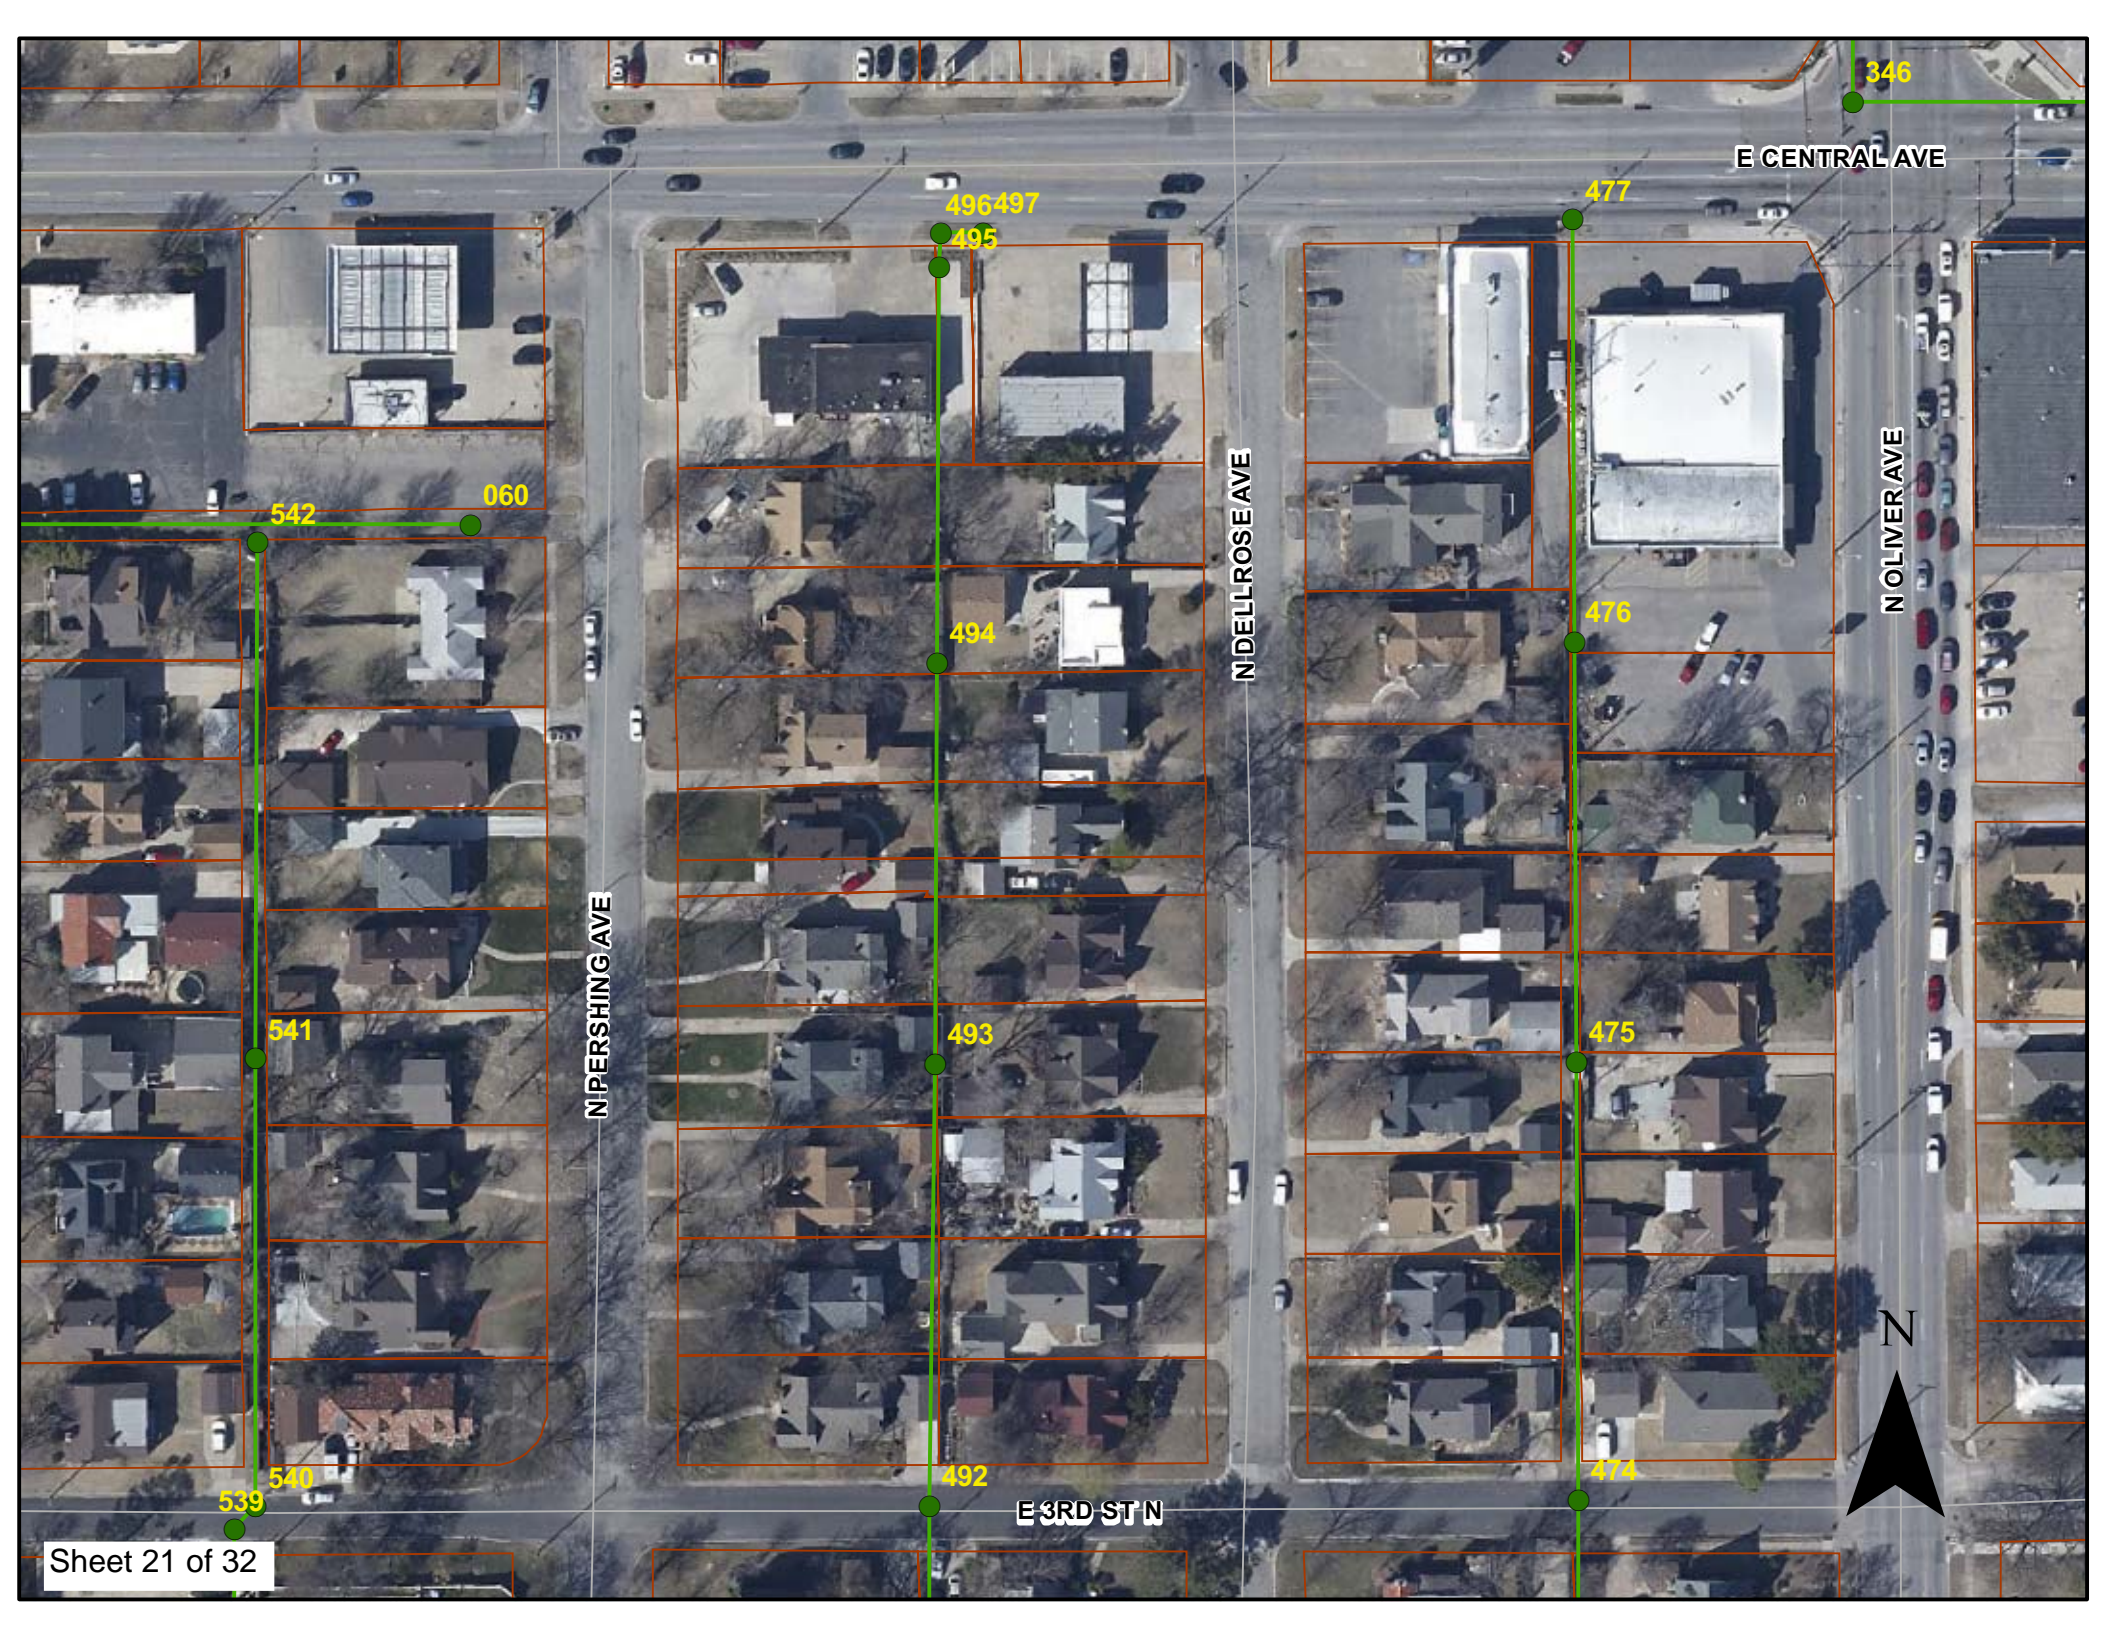
MH 5747-494  
Remove and Replace MH Frame & Cover  
442 N. Pershing

MH 5747-493  
Remove and Replace MH Frame & Cover  
414 N. Pershing

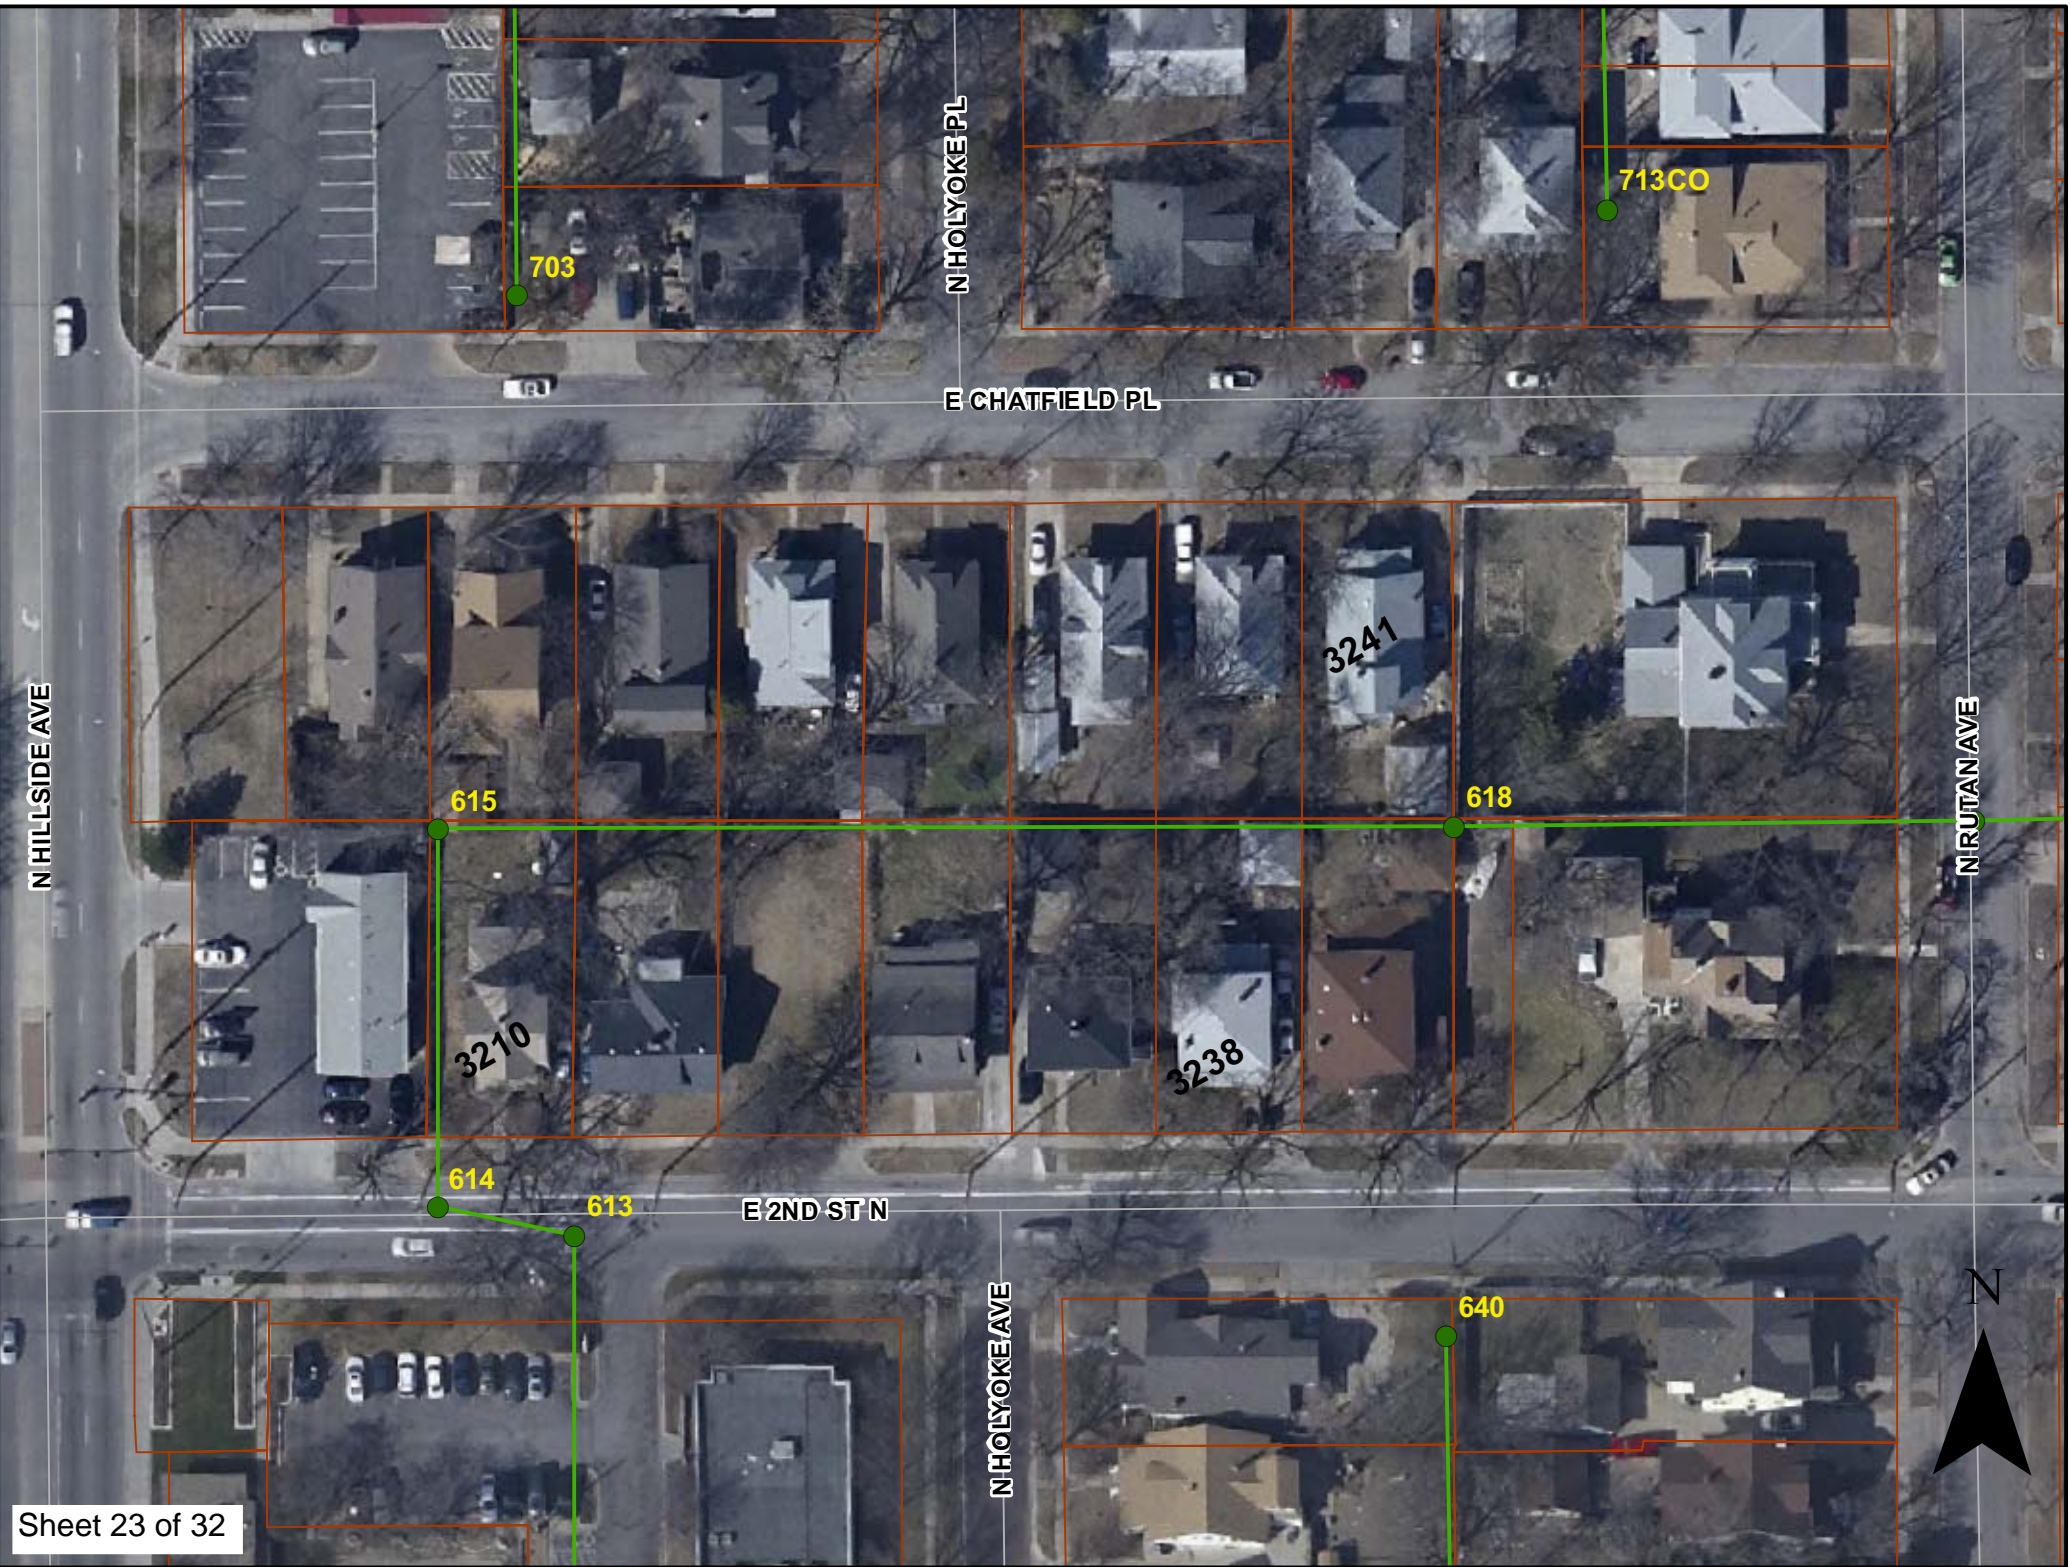
**SITE 8**

MH 5747-615  
Remove and Replace MH Frame & Cover  
3210 E. 2nd Street N.  
Approx MH depth = 6.7 ft

MH 5747-618  
3241 E. Chatfield  
Estimated MH depth = 8.5 ft

Obs. #	VTR Counter	Distance	Location	Description	Rating	Obsrvd (gpm)	Ratings			Remain (gpm)
							Est. (gpm)	Struct	Clean	
1		0.0		5747-618 US Manhole						
2		14.5		Sealed off wye						
3		15.9		Sealed off wye						
4		36.8		Tap for 3242 E. 2 <sup>nd</sup> / roots						
5		39.7		Sealed off wye						
6		41.7		Sealed off wye						
7		42.4		3241 E. Chatfield / roots						
8		44.4		cracked all around, including Invert / broken pipe						
9		46.6		3242 E. 2 <sup>nd</sup> / cavity / this could be sealed off?					<u>needs tested</u>	
There is a large tree here and not a good place to excavate. If this is not an active connection, we can line through this with CIPP.										
10		64.5		Broken pipe						
11		66.0		Broken pipe						
12		66.0		PVC begins						
13		67.9		3229 E. Chatfield / PVC tap						
14		<b>69.4</b>		<b>PVC ends</b>						
15		<b>69.7</b>		<b>Sealed off wye</b>						
16		<b>71.0</b>		<b>Broken pipe</b>

17		<b>77.6</b>		<b>Tap for 3238 E. 2<sup>nd</sup> / pipe missing / dirt showing / packed with roots</b>						
18		<b>78.4</b>		<b>Broken pipe</b>						
<b><u>NEEDS REPLACED FROM PVC AT 69 FEET TO 87 FEET</u></b>										
19		92.6		Sealed off wye						
20		95.4		Sealed off wye						
21		101.7		Roots						
22		109.3		Roots						
23		115.8		Sealed off wye						
24		118.4		Sealed off wye						
25		119.3		Tap for 3225 E. Chatfield / roots

Point Repair: Remove and replace 18 lf of pipe, from existing PVC located at 69 ft west of MH 5747-618, to a point 87 ft west of MH 5747-618. Includes 4" tap replacement for 3238 E. 2nd St. N. (See tv log)

Estimated 20 lf Silt Fence
