SITE 5

SHEET 21 OF 55

Video Inspection Master Report

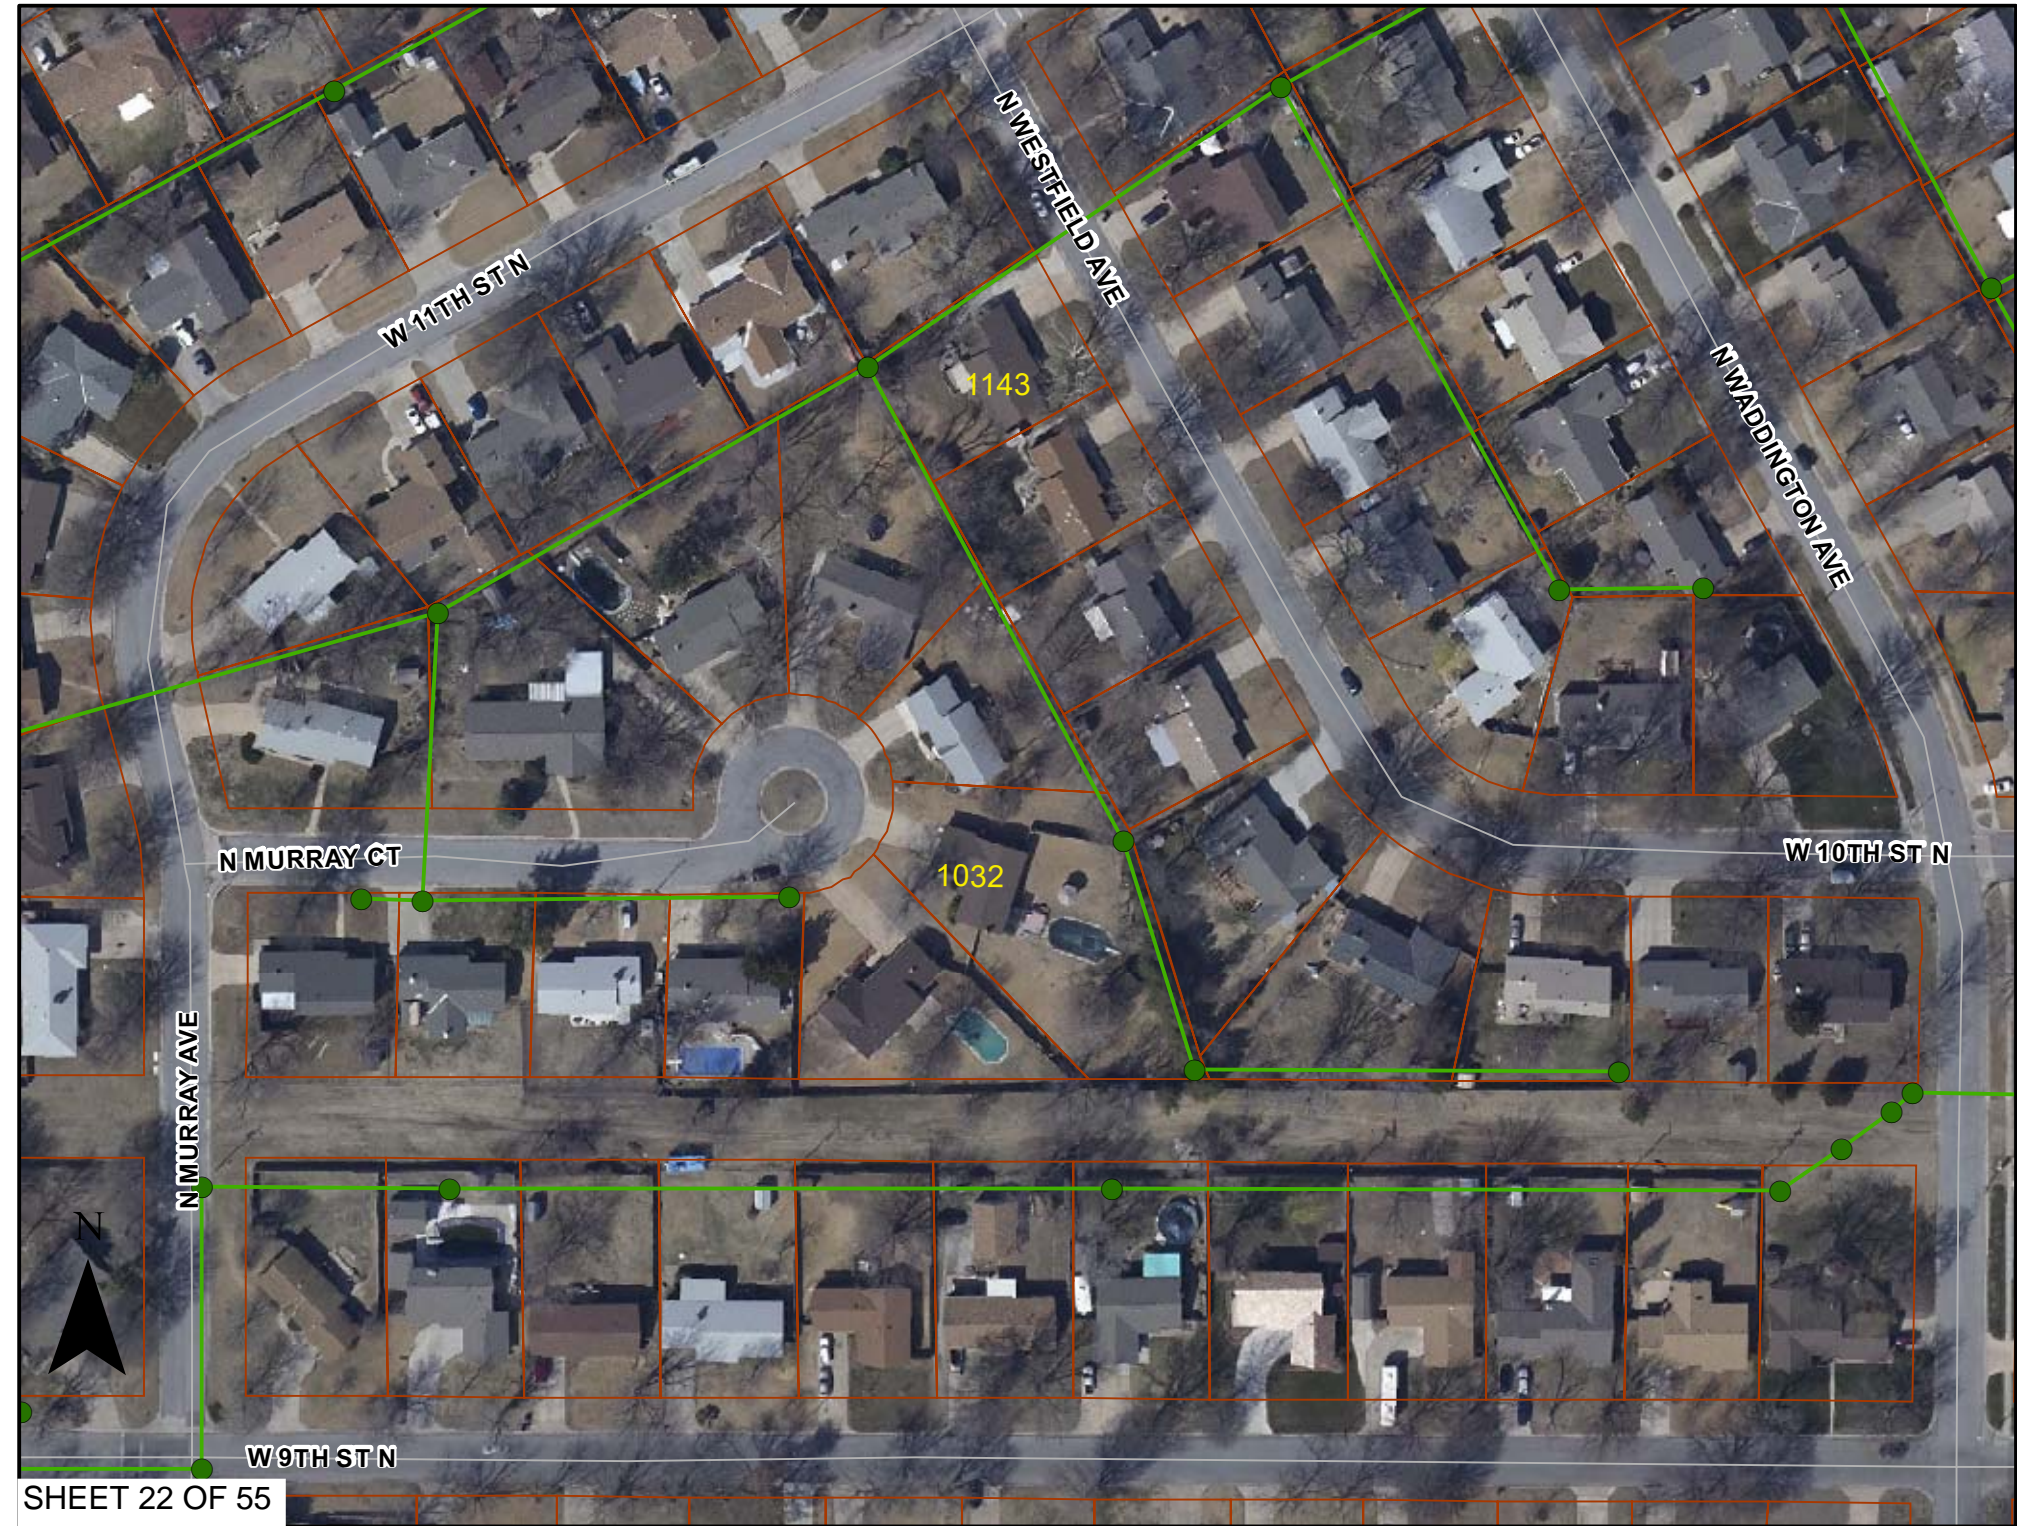
US Manhole 4848-185		DS Manhole 4848-184		Basin	
Shape Round	Dia/HT 8	Width	Length	Pipe Sec Length	Length Status TV Inspections
Material VCP	Liner N/A	Slope	Project Number 2012-005180	Index	Surface Rear Easement
Pipe Comment

Date Inspected 5/1/2012	Crew 694 MP	Weather Sunny	Surface Condition Trees & Fences	Dyed Test No	% Full
Purpose TV Existing Line	Flow Normal Flow	Direction Upstream	Tape ID DVD #0713	Start	Stop
Inspection Comment CONDITION 1 TELEVISED AGAINST FLOW AND ALSO TELEVISED PULLING CAMERA BACKWARDS
