Install 487 lf of 8" Cured-in-Place Liner

SITE 7

Video Inspection Master Report

US Structure: 5747-623 311 N. Clifton Date Insp: 4/13/2012 Basin: EC02A
 DS Structure: 5747-620 307 N RUTAN ST Dir Televised: Downstream To Upstream

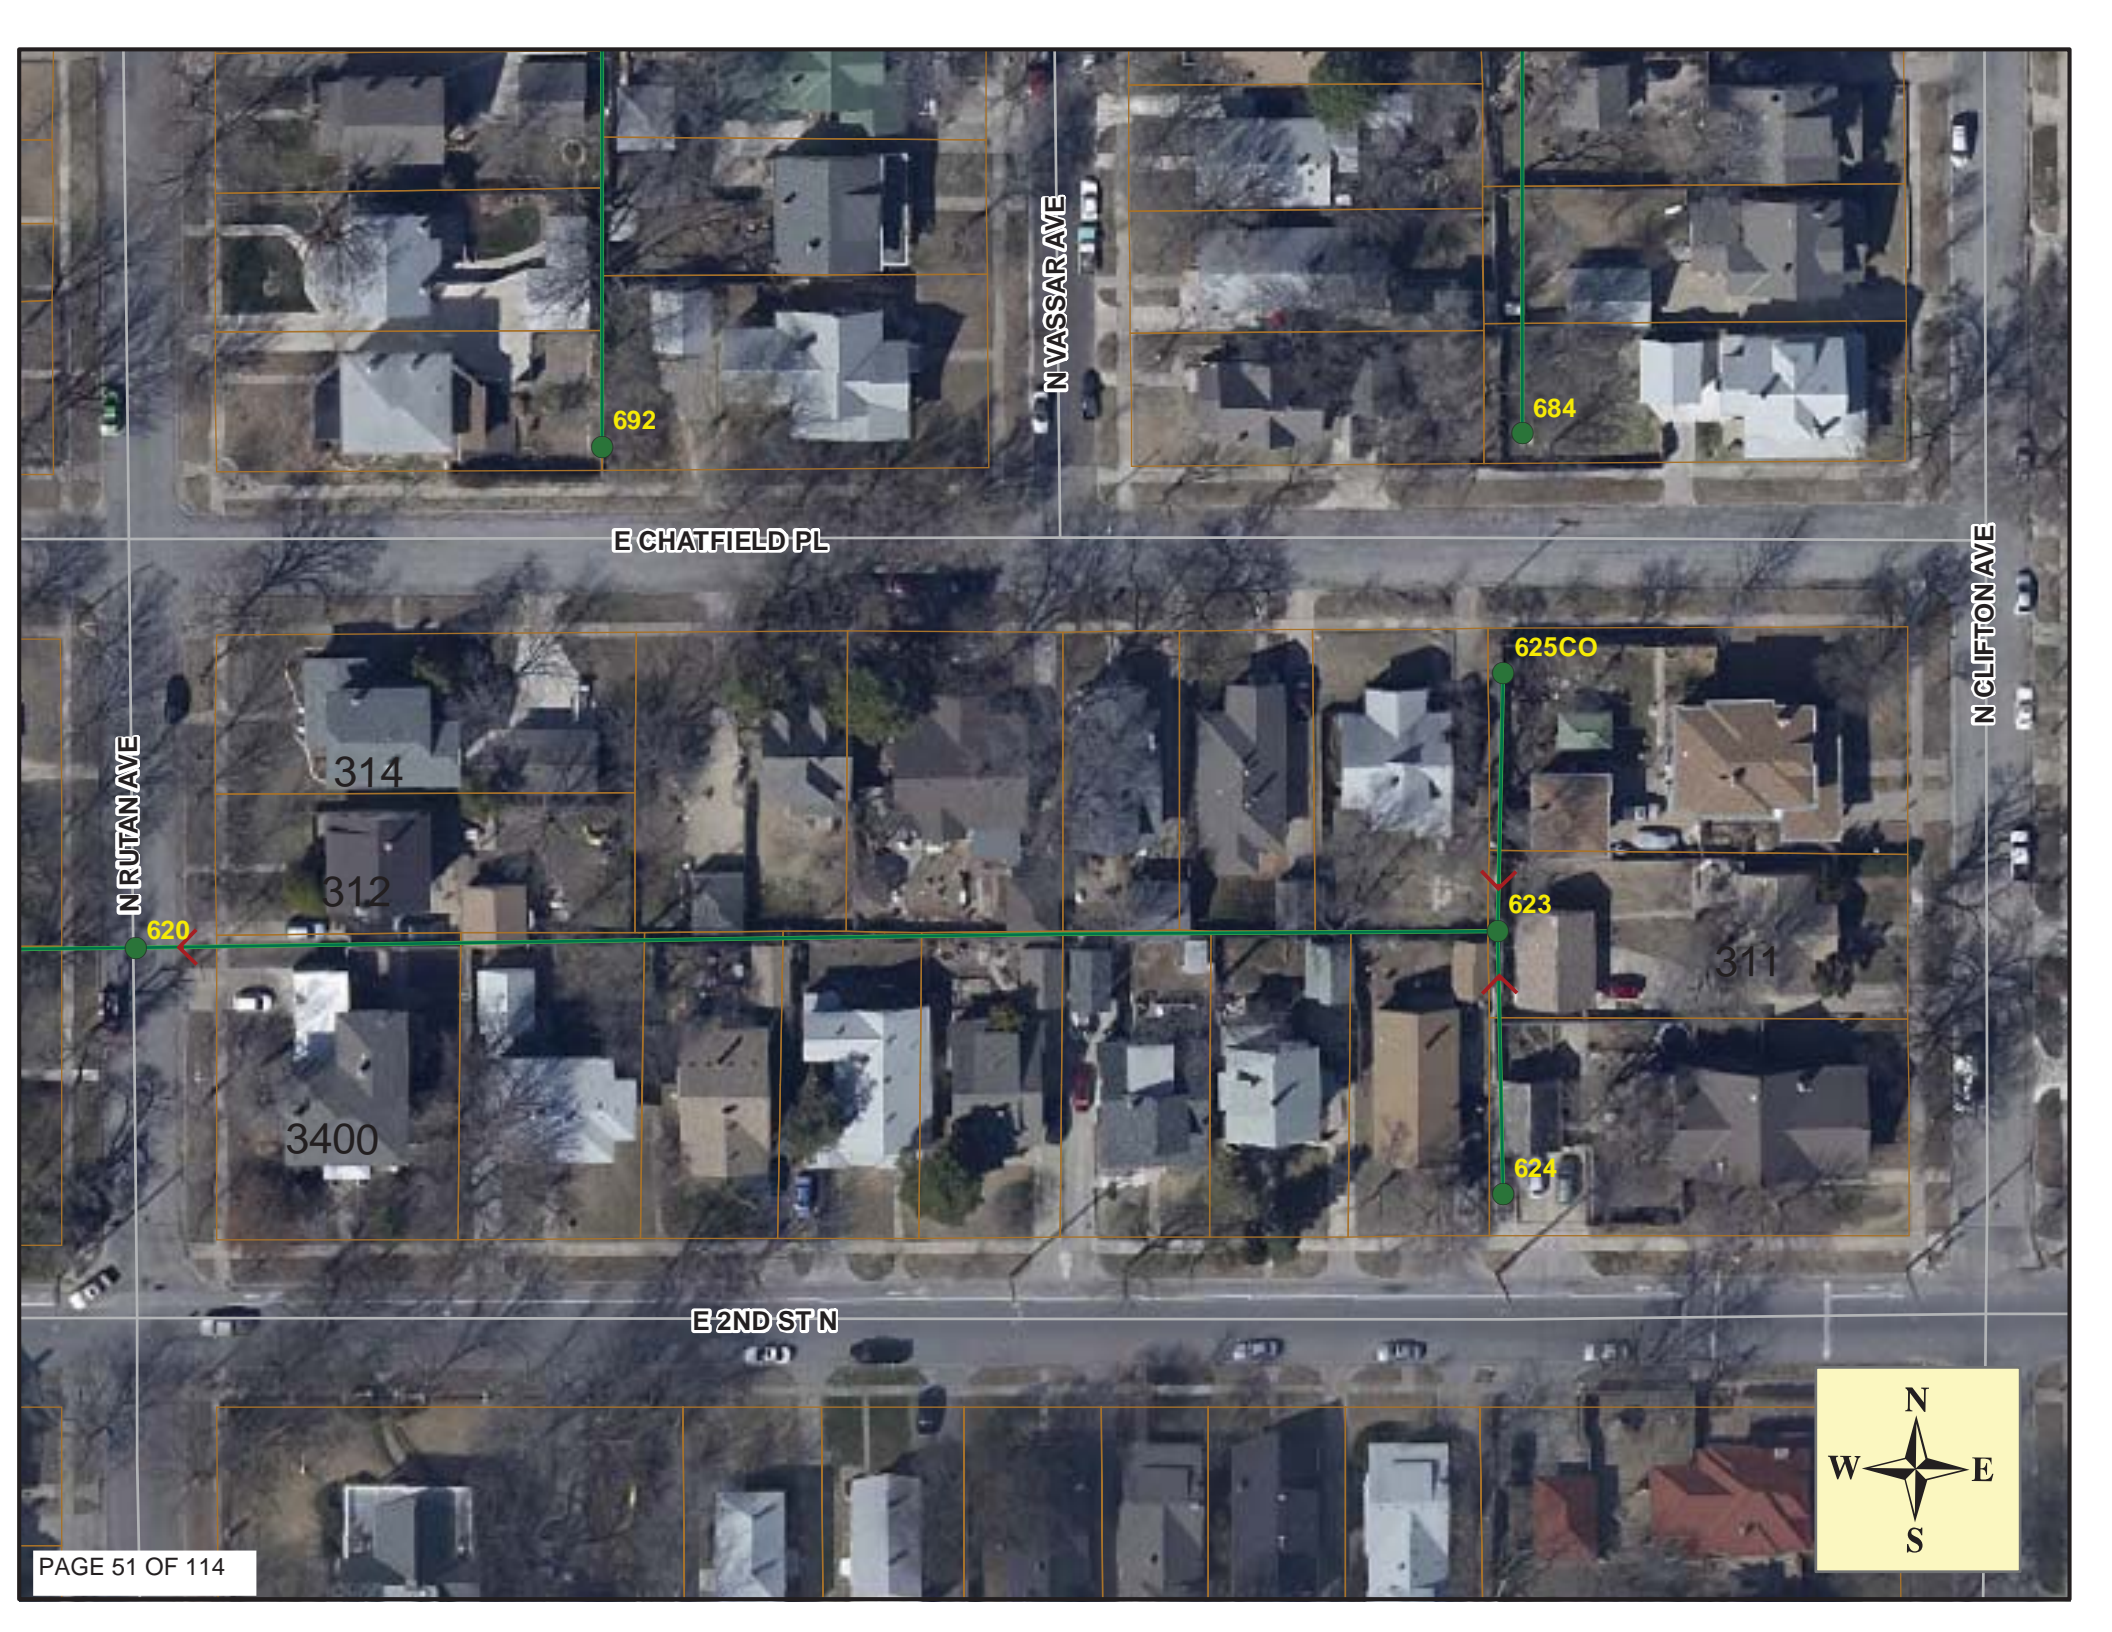
MH 5747-620
Estimated MH depth = 8.5 ft

MH 5747-623
311 N. Clifton
Approx MH depth = 10.6 ft

45 **327.8** This spot used to be MH 5747-622, which was abandoned by Sewer Maintenance with an internal sleeve repair. This manhole is located under the footings of a garage and was not accessible.

Mineral deposits at the joints. Sealed off wyes are leaking and have mineral deposits.
