Install 854 lf of 8" Cured-in-Place Liner  
from MH 5848-027 to MH 5848-445

**SITE 10**

## Video Inspection Master Report

US Structure: 5848-027                      644 N OLIVER ST                      Date Insp: 2/6/2013                      Basin: E04E  
 DS Structure: 5848-026                      647 N GLENDALE ST                      Dir Televised: Upstream To Downstream

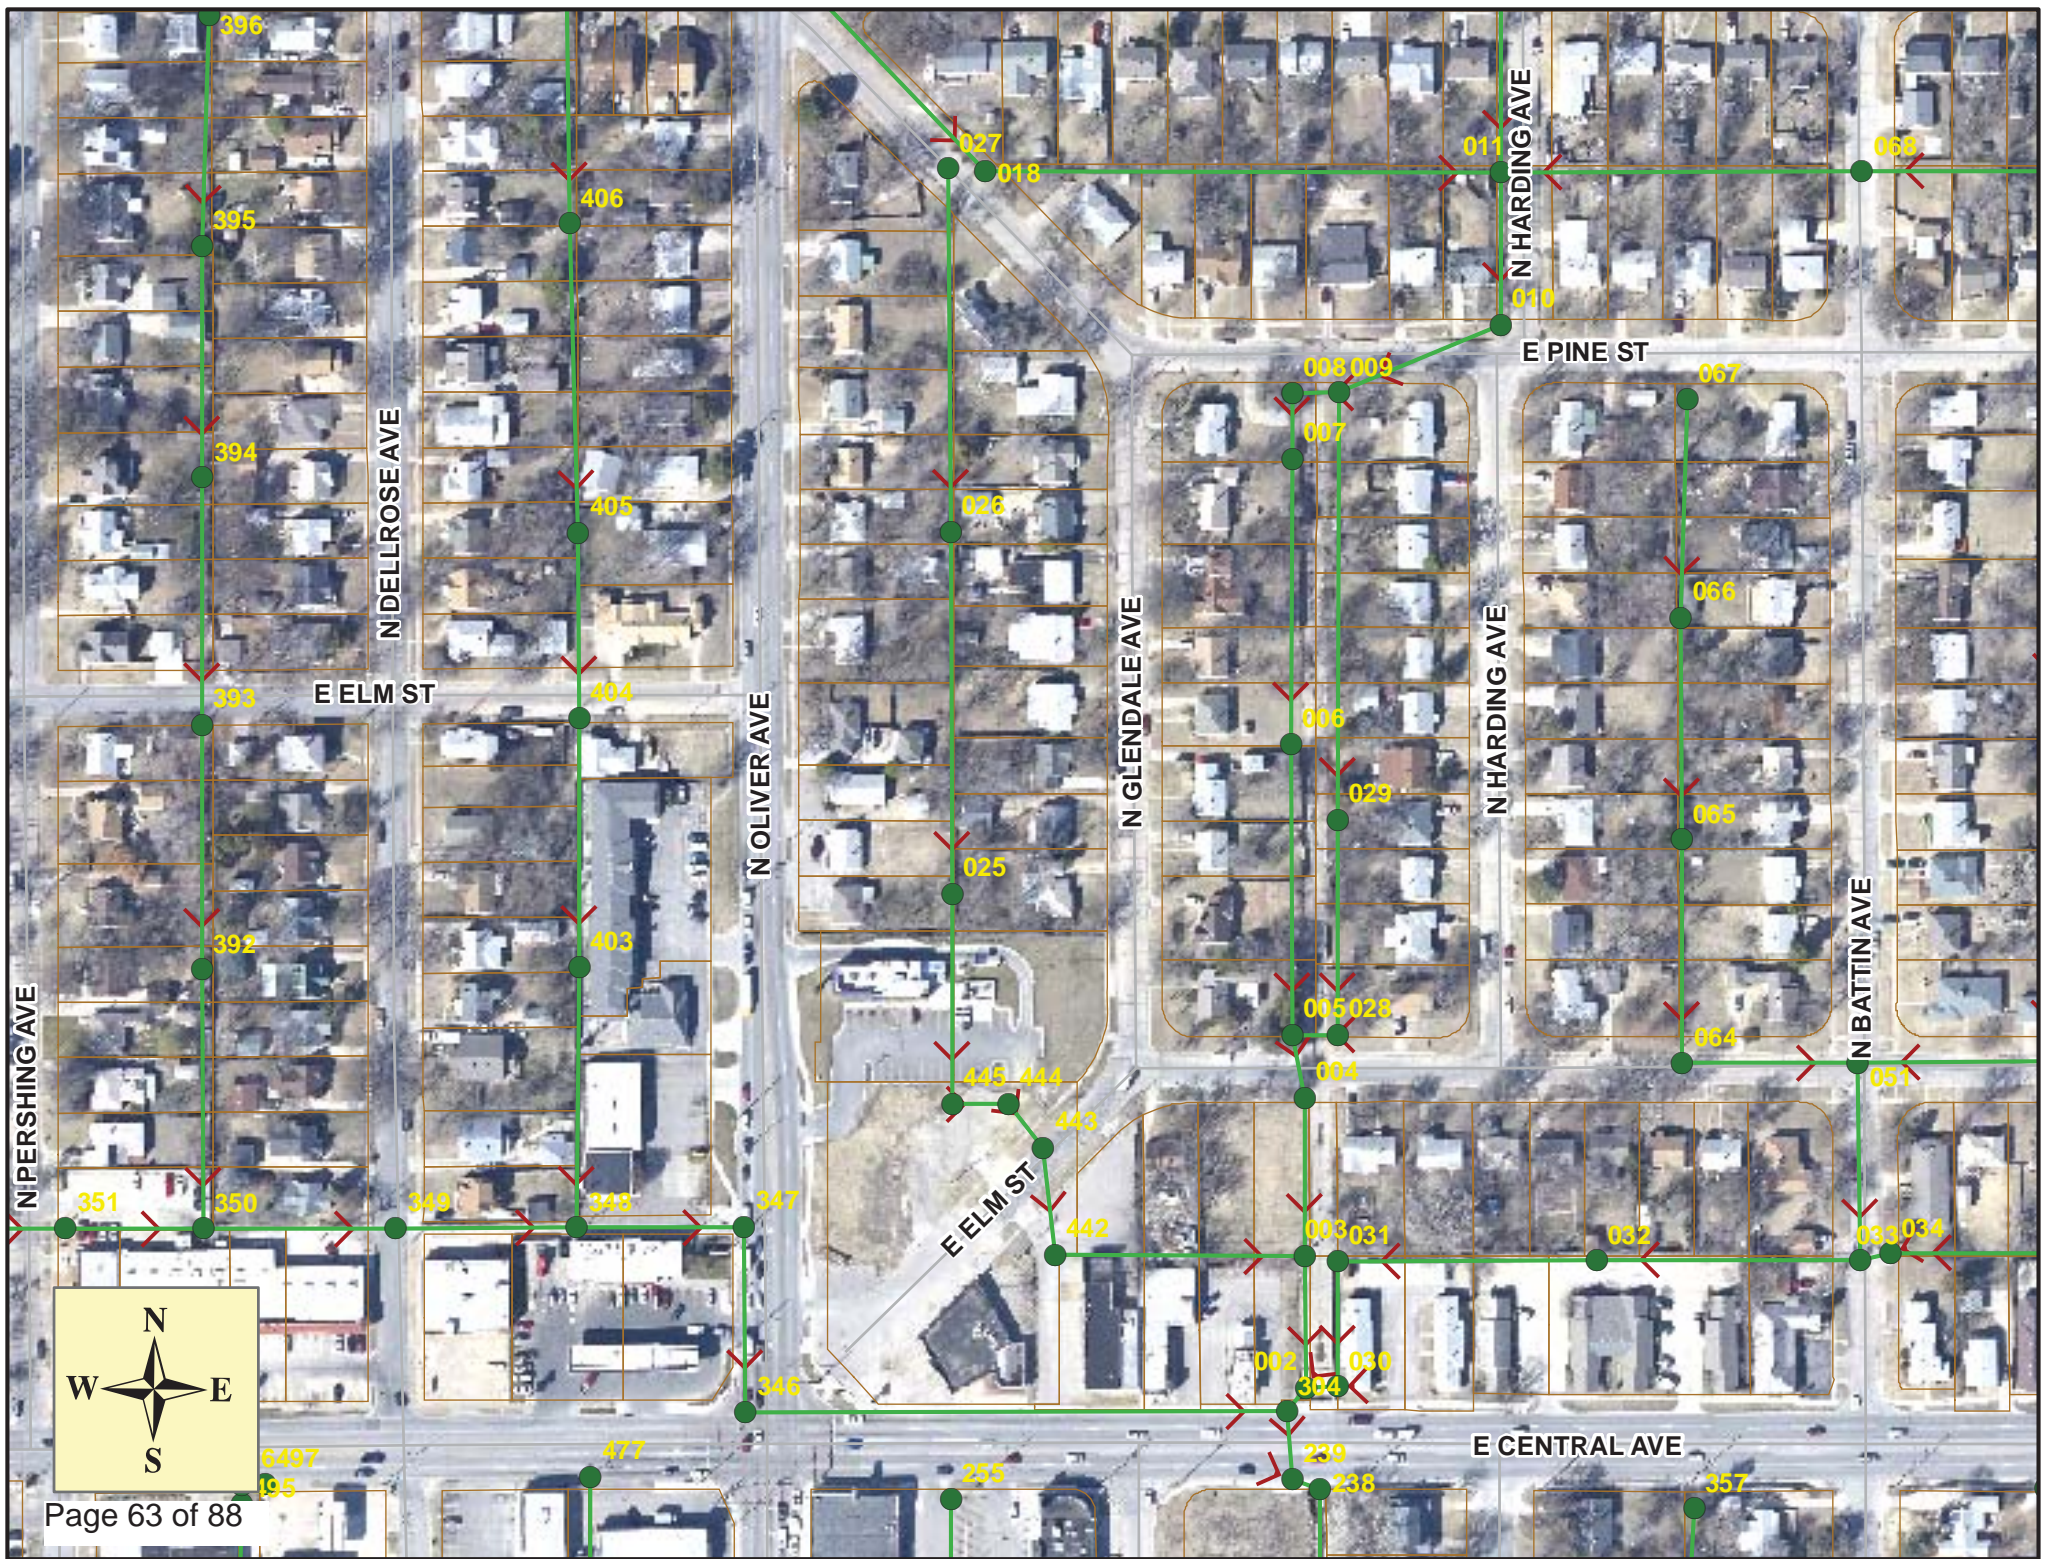
MH 5848-027  
Approx depth = 11.2 ft

MH 5848-026  
Approx depth = 12.6 ft

MH 5848-025  
Approx depth = 11.3 ft

MH 5848-445  
Approx depth = 11.3 ft  
(precast manhole)
