Remove and replace 986 lf of 8" pipe from MH 5445-277 to MH 5445-271

SITE 1

Video Inspection Master Report

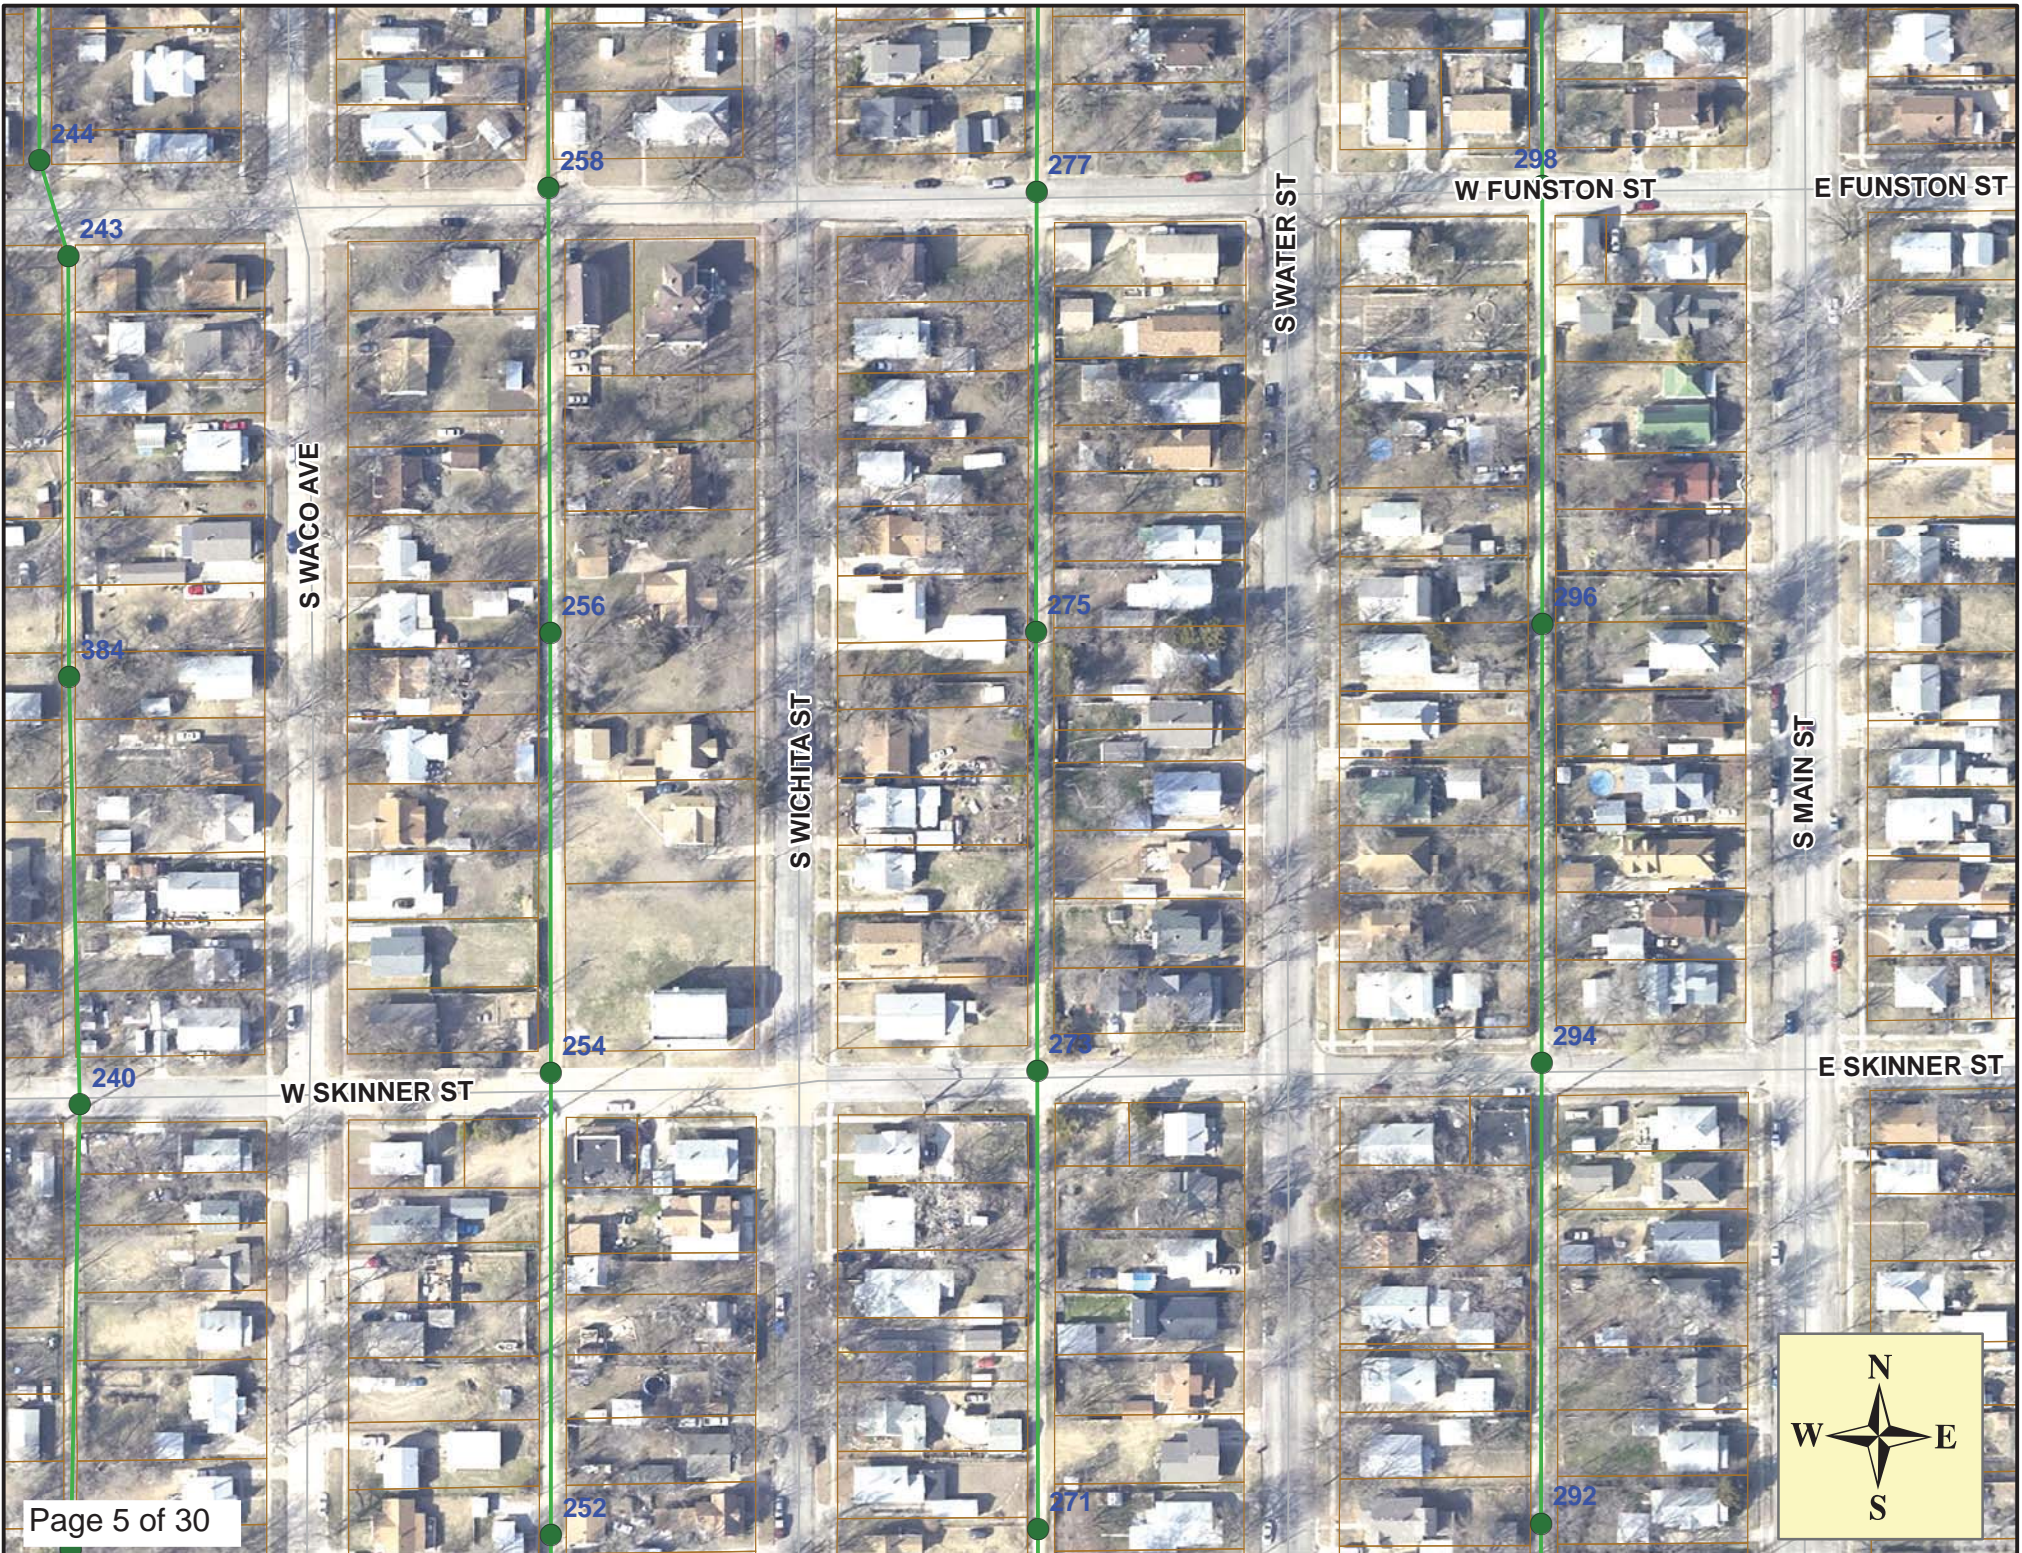
MH 5445-277
Est. depth = 7.0 ft
(precast manhole)

MH 5445-275
Remove Manhole
Construct Standard Manhole
Approx MH depth = 7.7 ft

MH 5445-273
Remove & Replace MH Bench & Invert
Approx MH depth = 6.6 ft

MH 5445-271
Remove Manhole
Construct Standard Manhole
Approx MH depth = 7.7 ft

Remove and replace 20 lf of Pavement
Remove and replace 7 lf of Concrete Approach
Install 27 lf of Flowable Fill
(no water or storm to cross in Funston)

Remove and replace 35 lf of Pavement (incl gutters)
Remove and replace 7 lf of Concrete Approach (S)
Install 42 lf of Flowable Fill
(no water or storm to cross in Skinner)

Estimated 38 Service Reconnections (4")
Estimated 1 Service Reconnection (6")
