**SITE 2**

## Video Inspection Master Report

US Structure: 5445-348                      2055 S BROADWAY AVE                      Date Insp: 9/22/2010                      Basin: C05D  
 Dir Televised: Upstream To Downstream

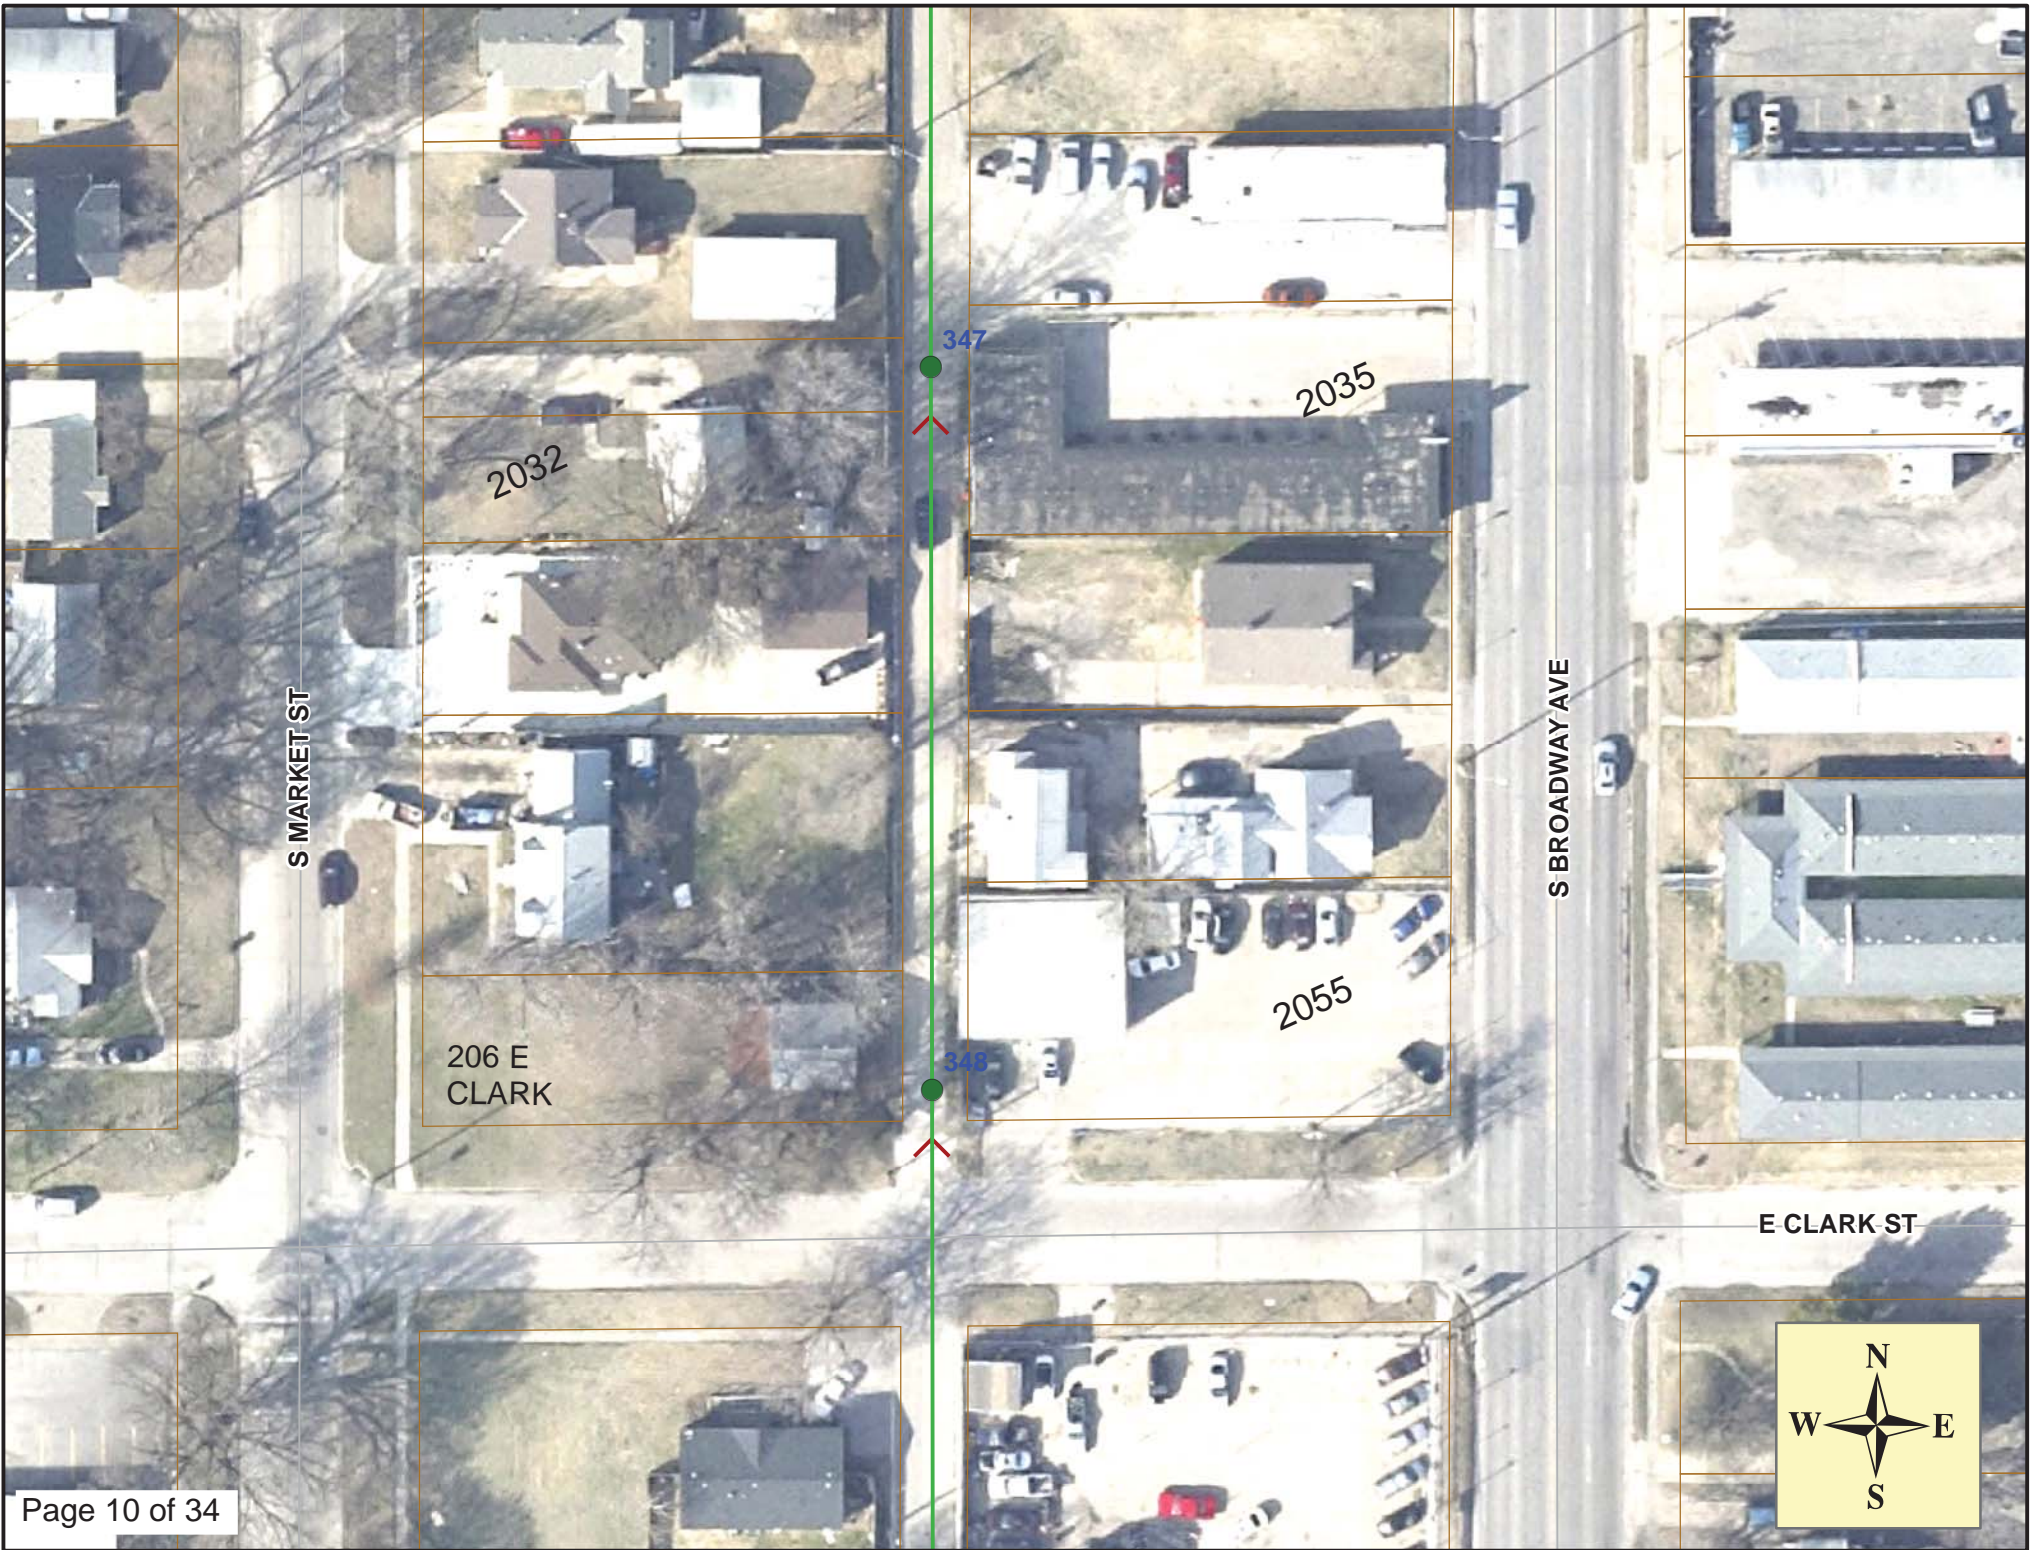
MH 5445-346  
Remove and Replace MH Bench & Invert  
Approx MH depth = 5.9 ft

MH 5445-347  
Remove and Replace MH Bench & Invert  
Approx MH depth = 4.7 ft

Remove 210 lf of 8" Pipe  
Install 210 lf of 8" Pipe  
Restoration of the alley shall be subsidiary to Site Restoration

MH 5445-348  
Remove and Replace MH Bench & Invert  
Remove and Replace MH Frame & Cover  
Approx MH depth = 4.2 ft

**Comments:** 125 FEET CONNECTION NEEDS REPAIR,149 FEET SAG,165 FEET CONNECTION NEEDS REPAIR,166 FEET SAG, 175 FEET CONNECTION NEEDS REPAIR,182 FEET PIPE NEEDS REPAIR TILE MISSING,194 FEET PIPE NEEDS REPAIR TILE MISSING,208 TILE MISSING IN BOTTM OF MANHOLE NEEDS REPAIR.
