2013 Sanitary Sewer Reconstruction Phase 5

OCA 620640 / 468-84895

Video Inspection Master Report

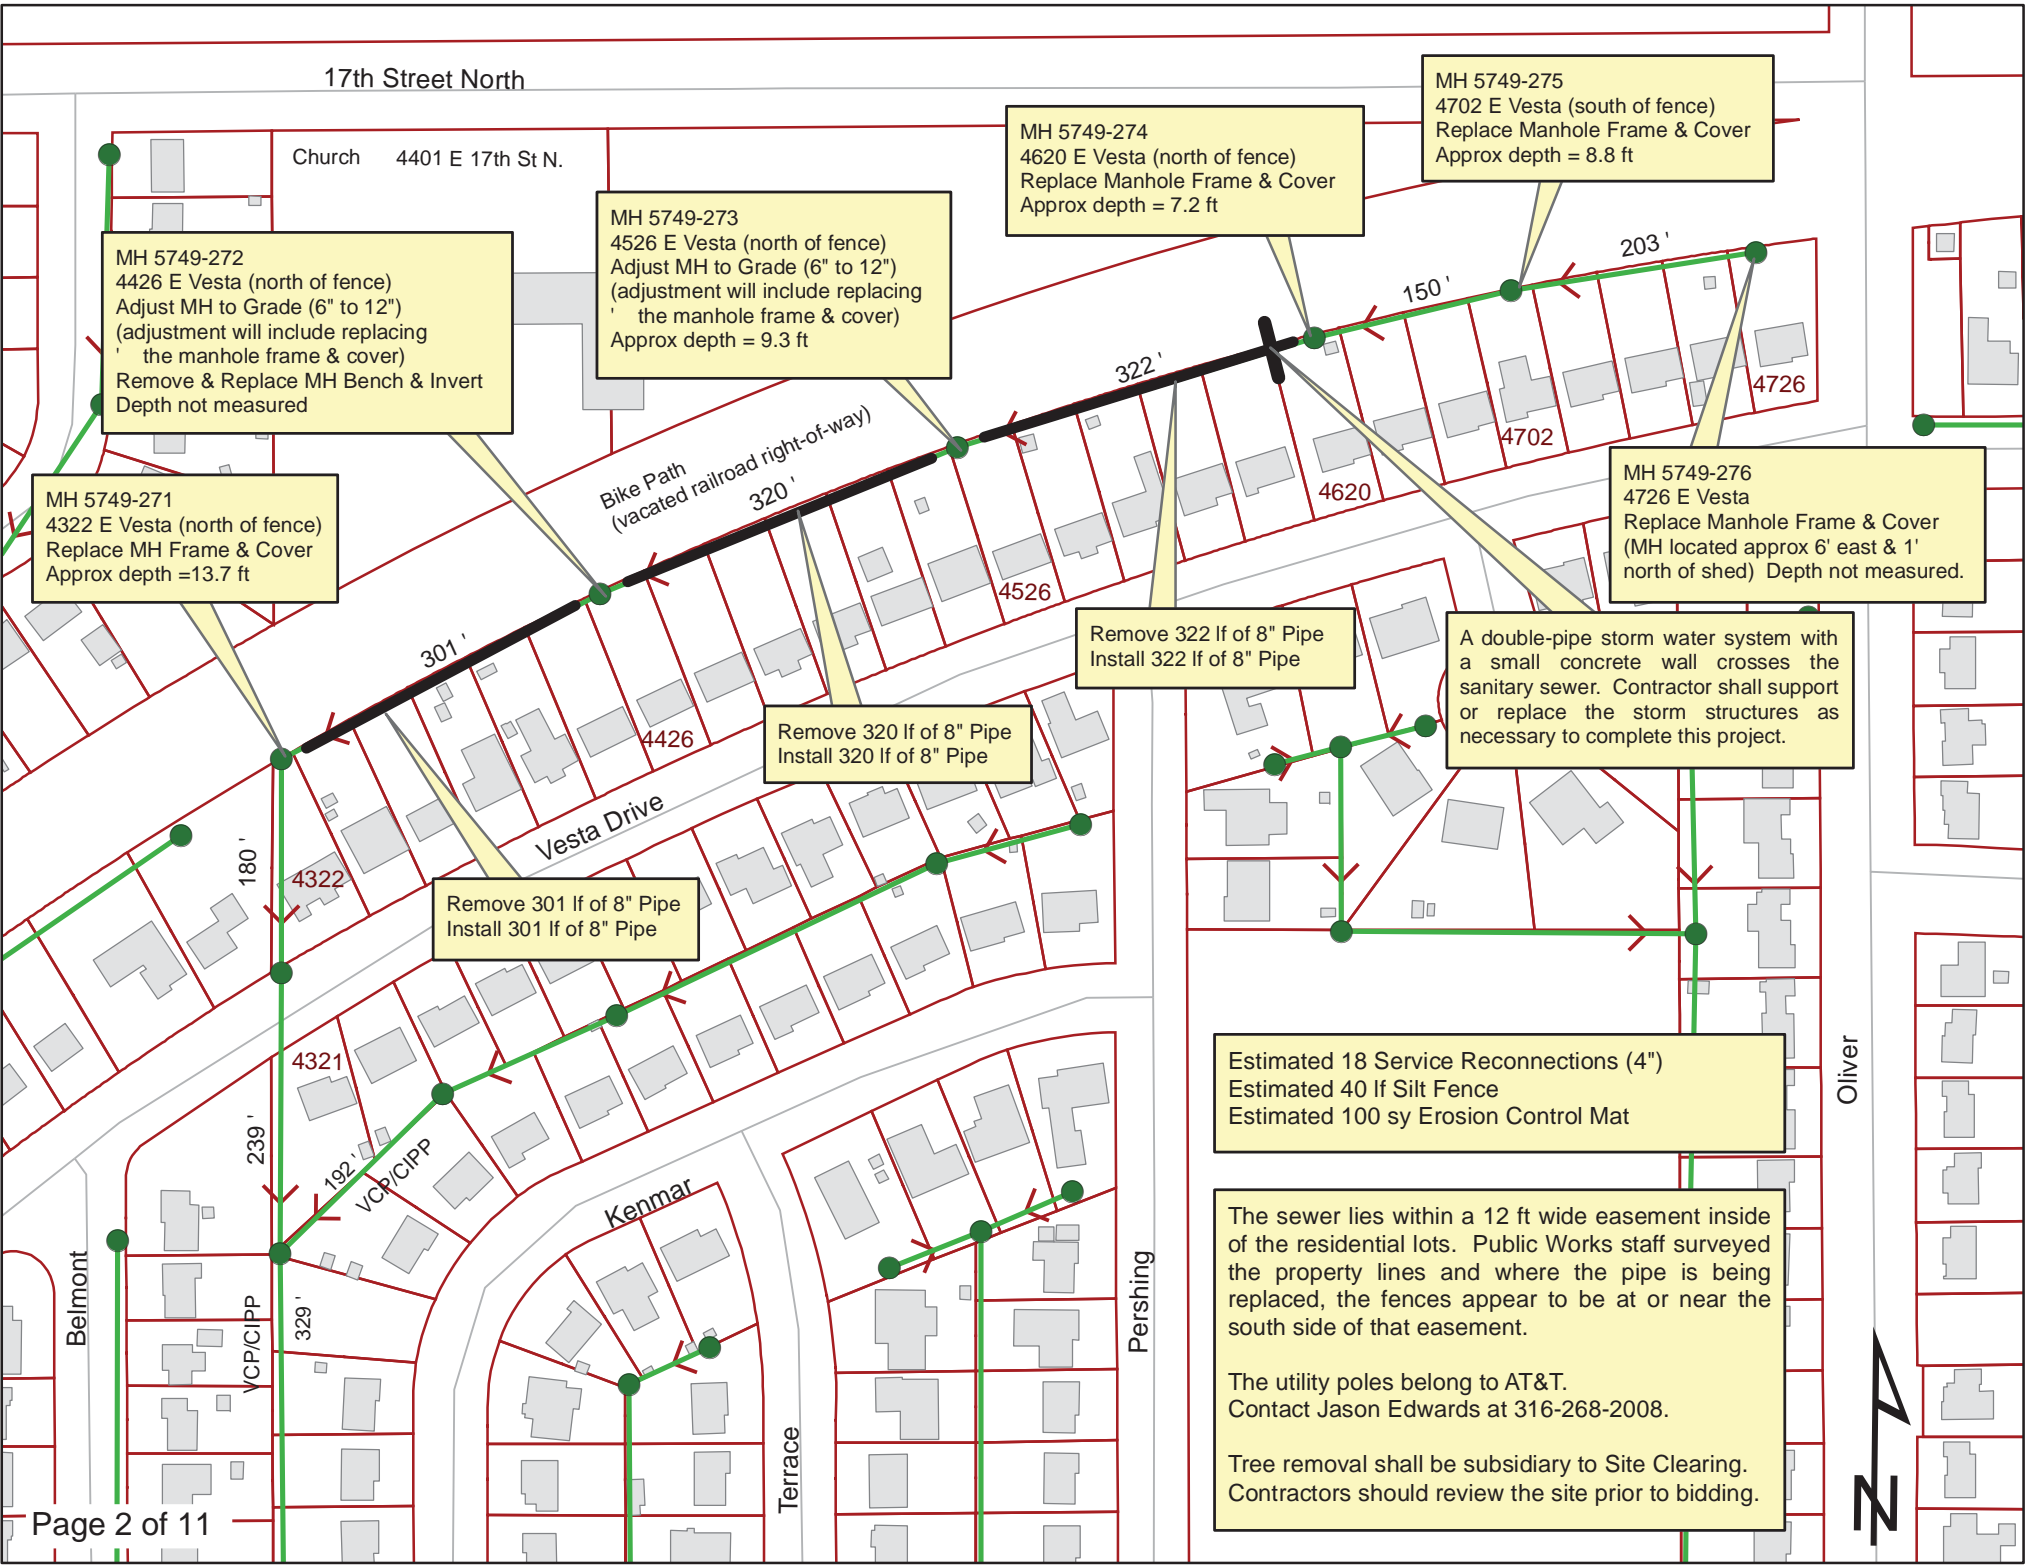
MH 5749-275
4702 E Vesta (south of fence)
Replace Manhole Frame & Cover
Approx depth = 8.8 ft

MH 5749-274
4620 E Vesta (north of fence)
Replace Manhole Frame & Cover
Approx depth = 7.2 ft

MH 5749-273
4526 E Vesta (north of fence)
Adjust MH to Grade (6" to 12")
(adjustment will include replacing
the manhole frame & cover)
Approx depth = 9.3 ft

MH 5749-272
4426 E Vesta (north of fence)
Adjust MH to Grade (6" to 12")
(adjustment will include replacing
the manhole frame & cover)
Remove & Replace MH Bench & Invert
Depth not measured

MH 5749-271
4322 E Vesta (north of fence)
Replace MH Frame & Cover
Approx depth = 13.7 ft

MH 5749-276
4726 E Vesta
Replace Manhole Frame & Cover
(MH located approx 6' east & 1'
north of shed) Depth not measured.

A double-pipe storm water system with
a small concrete wall crosses the
sanitary sewer. Contractor shall support
or replace the storm structures as
necessary to complete this project.

The sewer lies within a 12 ft wide easement inside
of the residential lots. Public Works staff surveyed
the property lines and where the pipe is being
replaced, the fences appear to be at or near the
south side of that easement.

Remove 322 lf of 8" Pipe
Install 322 lf of 8" Pipe

Remove 320 lf of 8" Pipe
Install 320 lf of 8" Pipe

Remove 301 lf of 8" Pipe
Install 301 lf of 8" Pipe

Estimated 18 Service Reconnections (4")
Estimated 40 lf Silt Fence
Estimated 100 sy Erosion Control Mat
