SITE 1

Video Inspection Master Report

US Structure: 5549-522

DS Structure: 5549-517

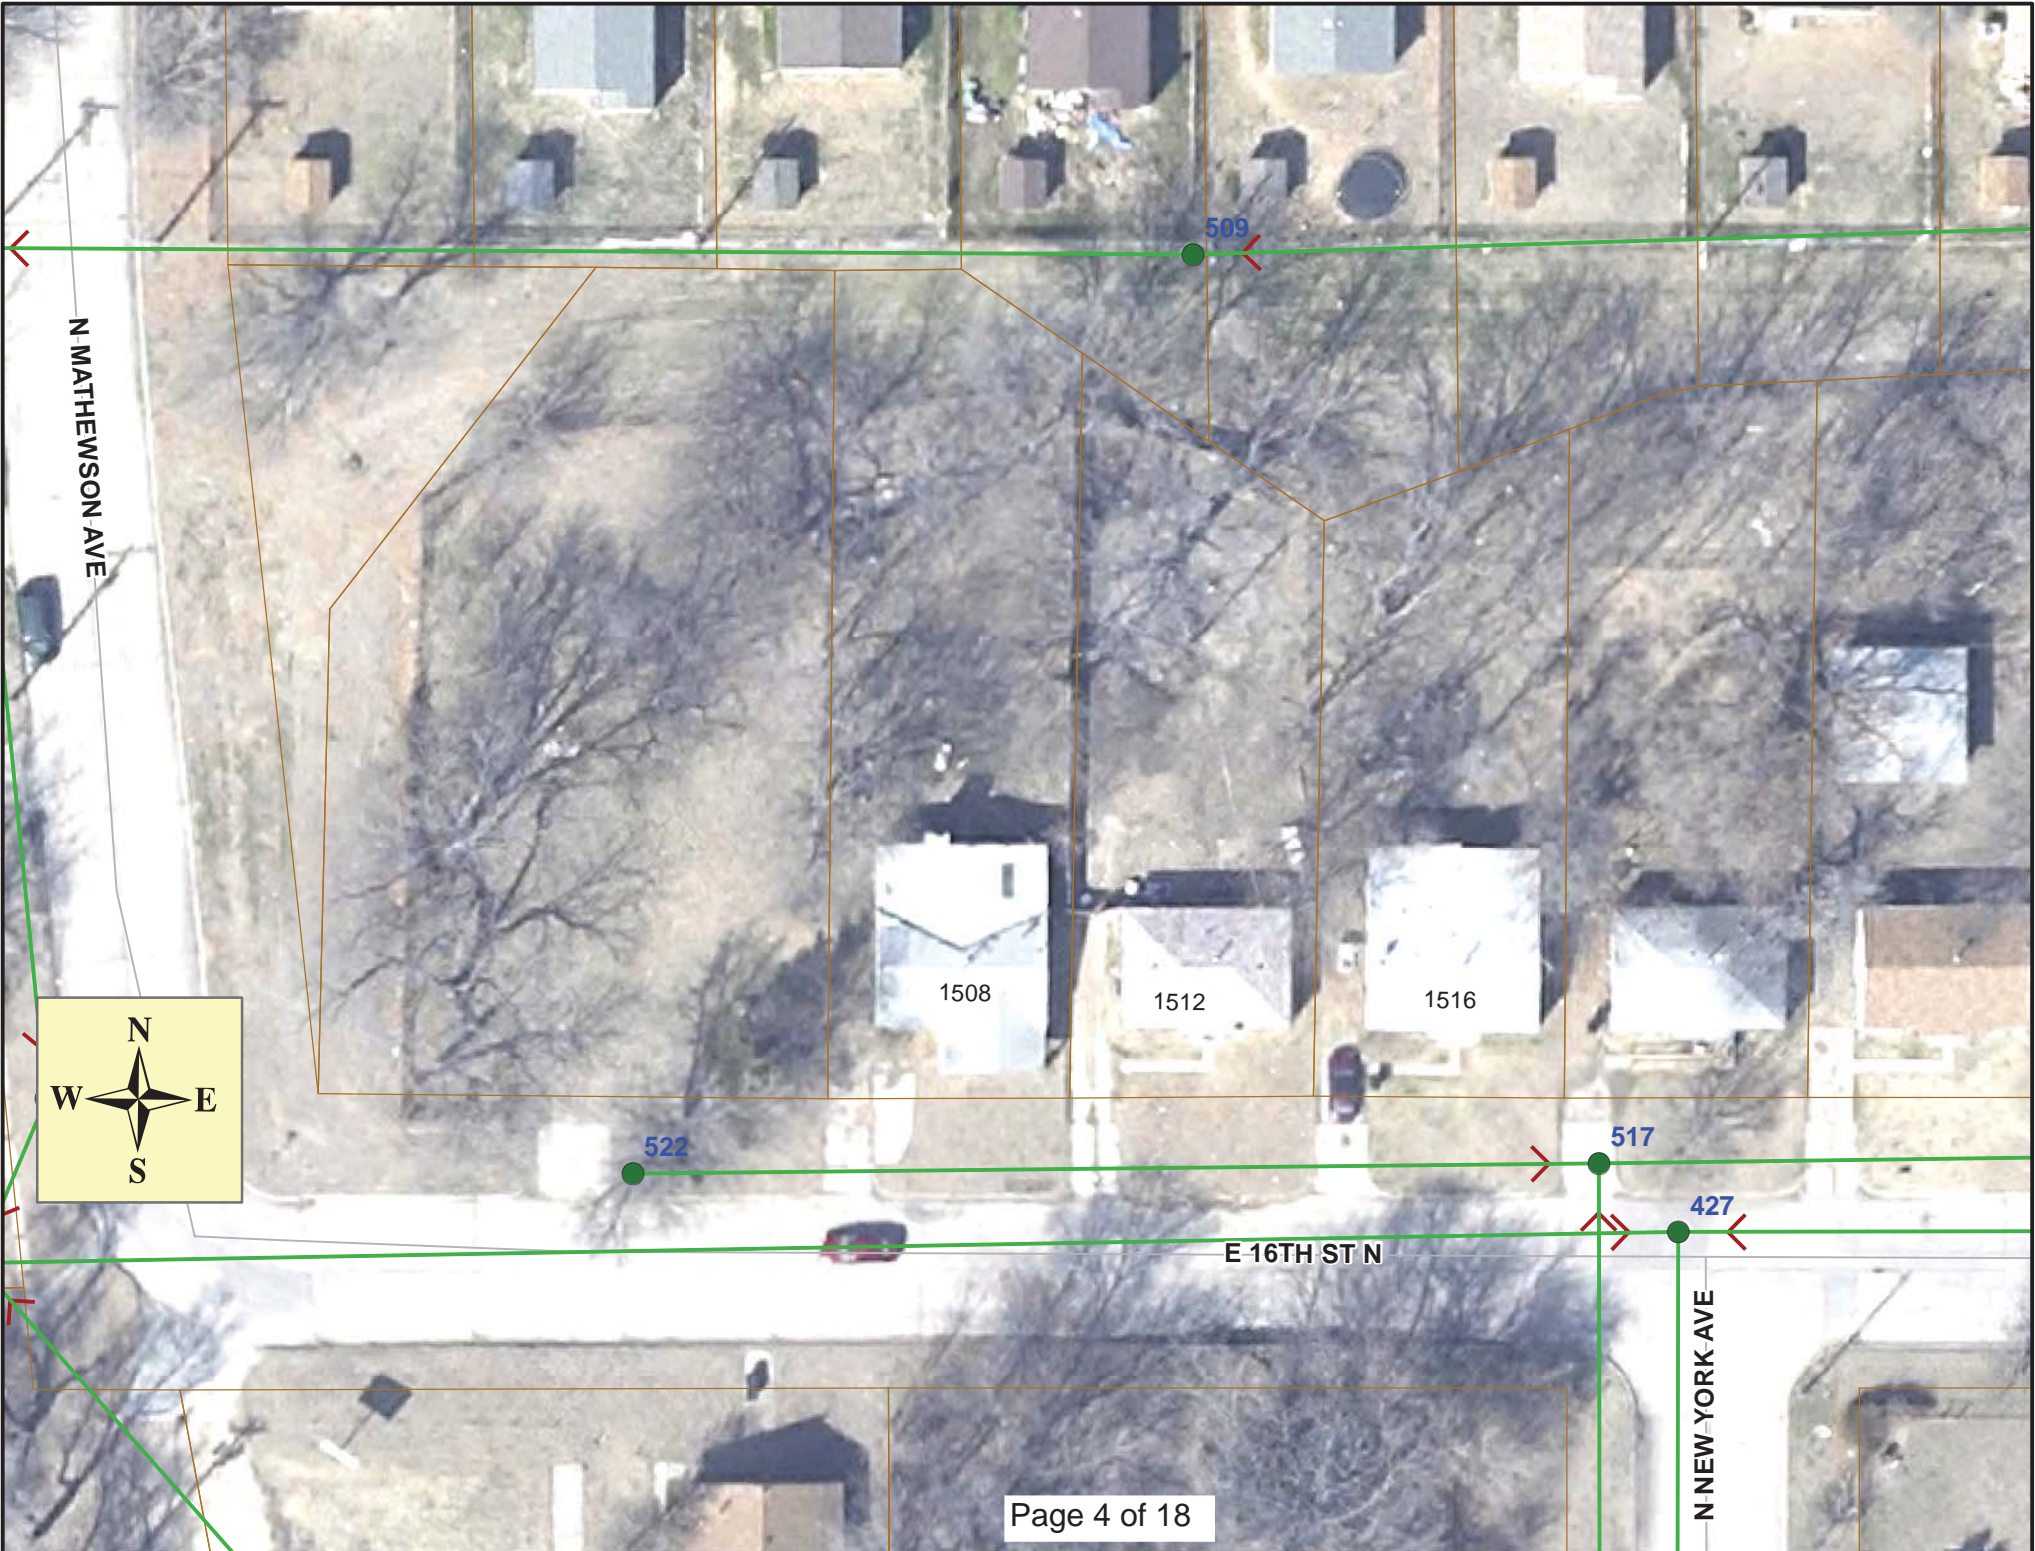
Sta 1+65
MH 5549-522 (re-use number)
Construct Shallow Manhole

Sta 1+96
MH 5549-522 (existing)
Remove Manhole
(in grass, east of drive)
Est. depth = less than 4 ft

Sta 0+00
MH 5549-517
Approx depth = 4.2 ft

Remove 165 lf of 8" Pipe
Install 165 lf of 8" Pipe

Abandon approx 31 lf of 8" pipe west of Sta 1+65. Cost subsidiary to the project.

Three water meters are at or near the sewer line location. Contractor shall support and/or reset the meters or temporarily relocate the meters as necessary for construction. Cost subsidiary to the project. The water main is 2.5" cast iron and is located approx 4 ft to 5 ft south of the sewer main.

The three maple trees shall be removed by the Contractor (approved by Park Dept). Cost subsidiary to Site Clearing.
