**SITE 1**

Sheet 3 of 23

# Video Inspection Master Report

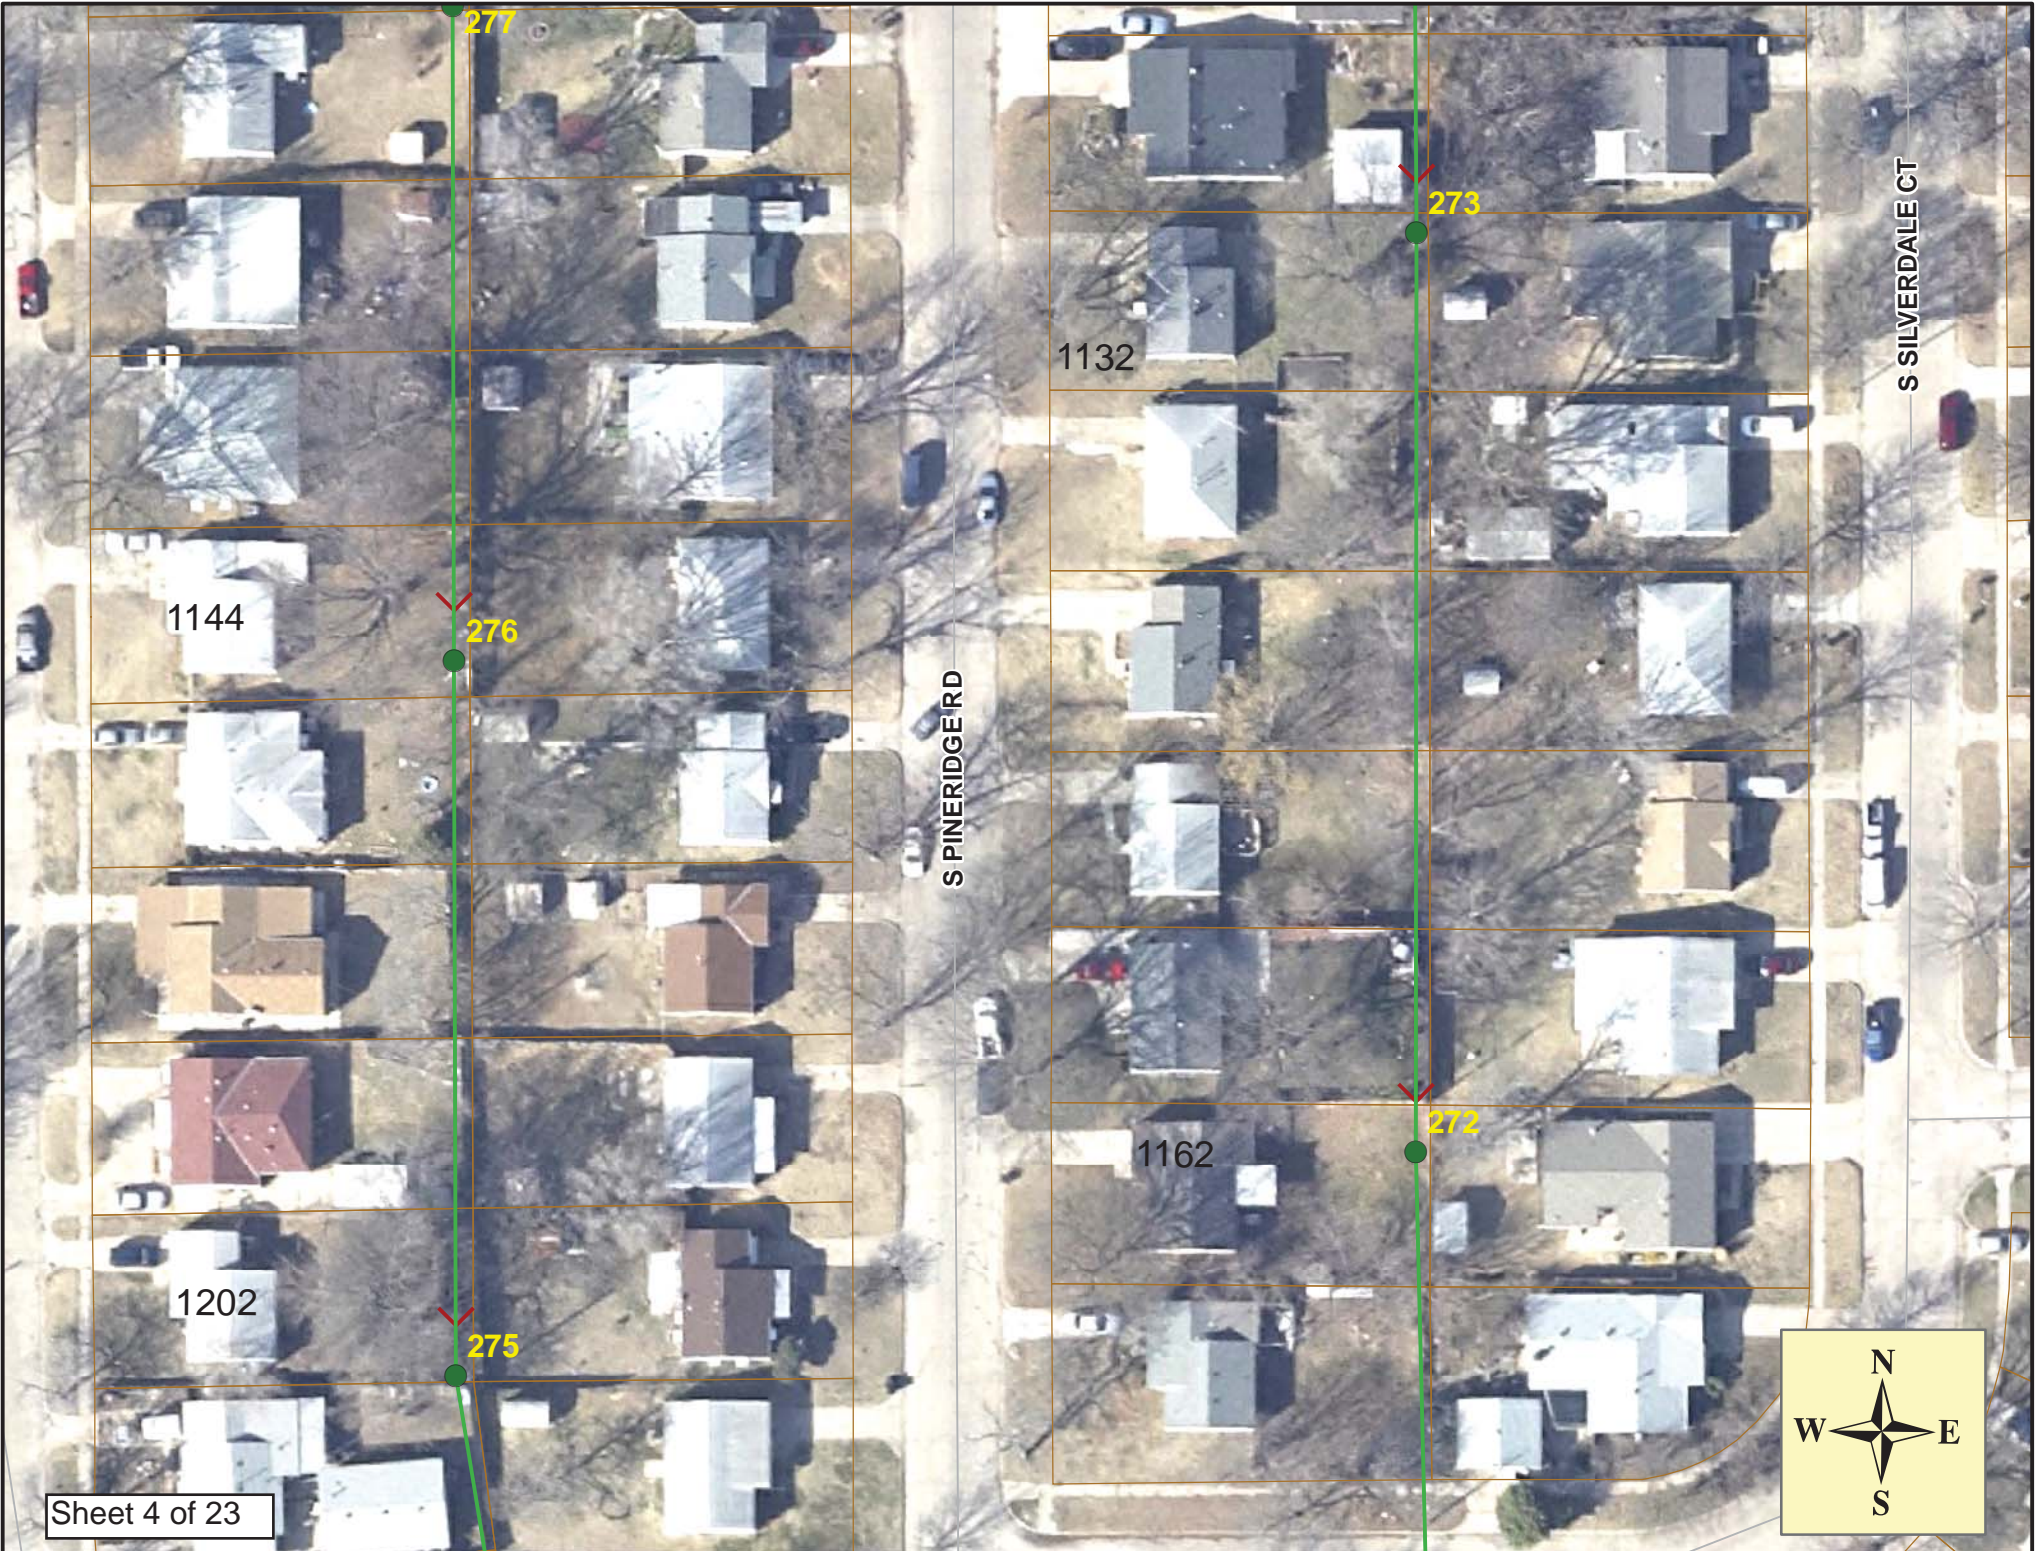
MH 5846-276  
 Replace MH Frame & Cover  
 1144 Christine  
 Approx MH depth = 9.1 ft

MH 5846-275  
 Replace MH Frame & Cover  
 1202 Christine

Construct Outside Drop  
 (north side of brick MH)  
 Approx pipe depth = 8.0 ft  
 Approx MH depth = 14.0 ft.

MH 5846-273  
 1132 Pineridge  
 Approx depth = 12.7 ft

MH 5846-272  
 Replace MH Frame & Cover  
 1162 Pineridge  
 Approx depth = 10.4 ft

**POINT REPAIR:**  
 Remove and replace 33 lf of 8" pipe, from  
 MH 5846-275 to 33 lf north of said manhole.  
 This repair item will include the service  
 reconNECTIONS for 1202 Christine and 1169  
 Pineridge. Est. pipe depth = 8.0 ft

Remove 277 lf of 8" Pipe  
 Install 277 lf of 8" Pipe  
 Estimated 10 Service  
 ReconNECTIONS (4")

Seeding will be allowed on this Site.
