**SITE 3**

Sheet 15 of 23

## Video Inspection Master Report

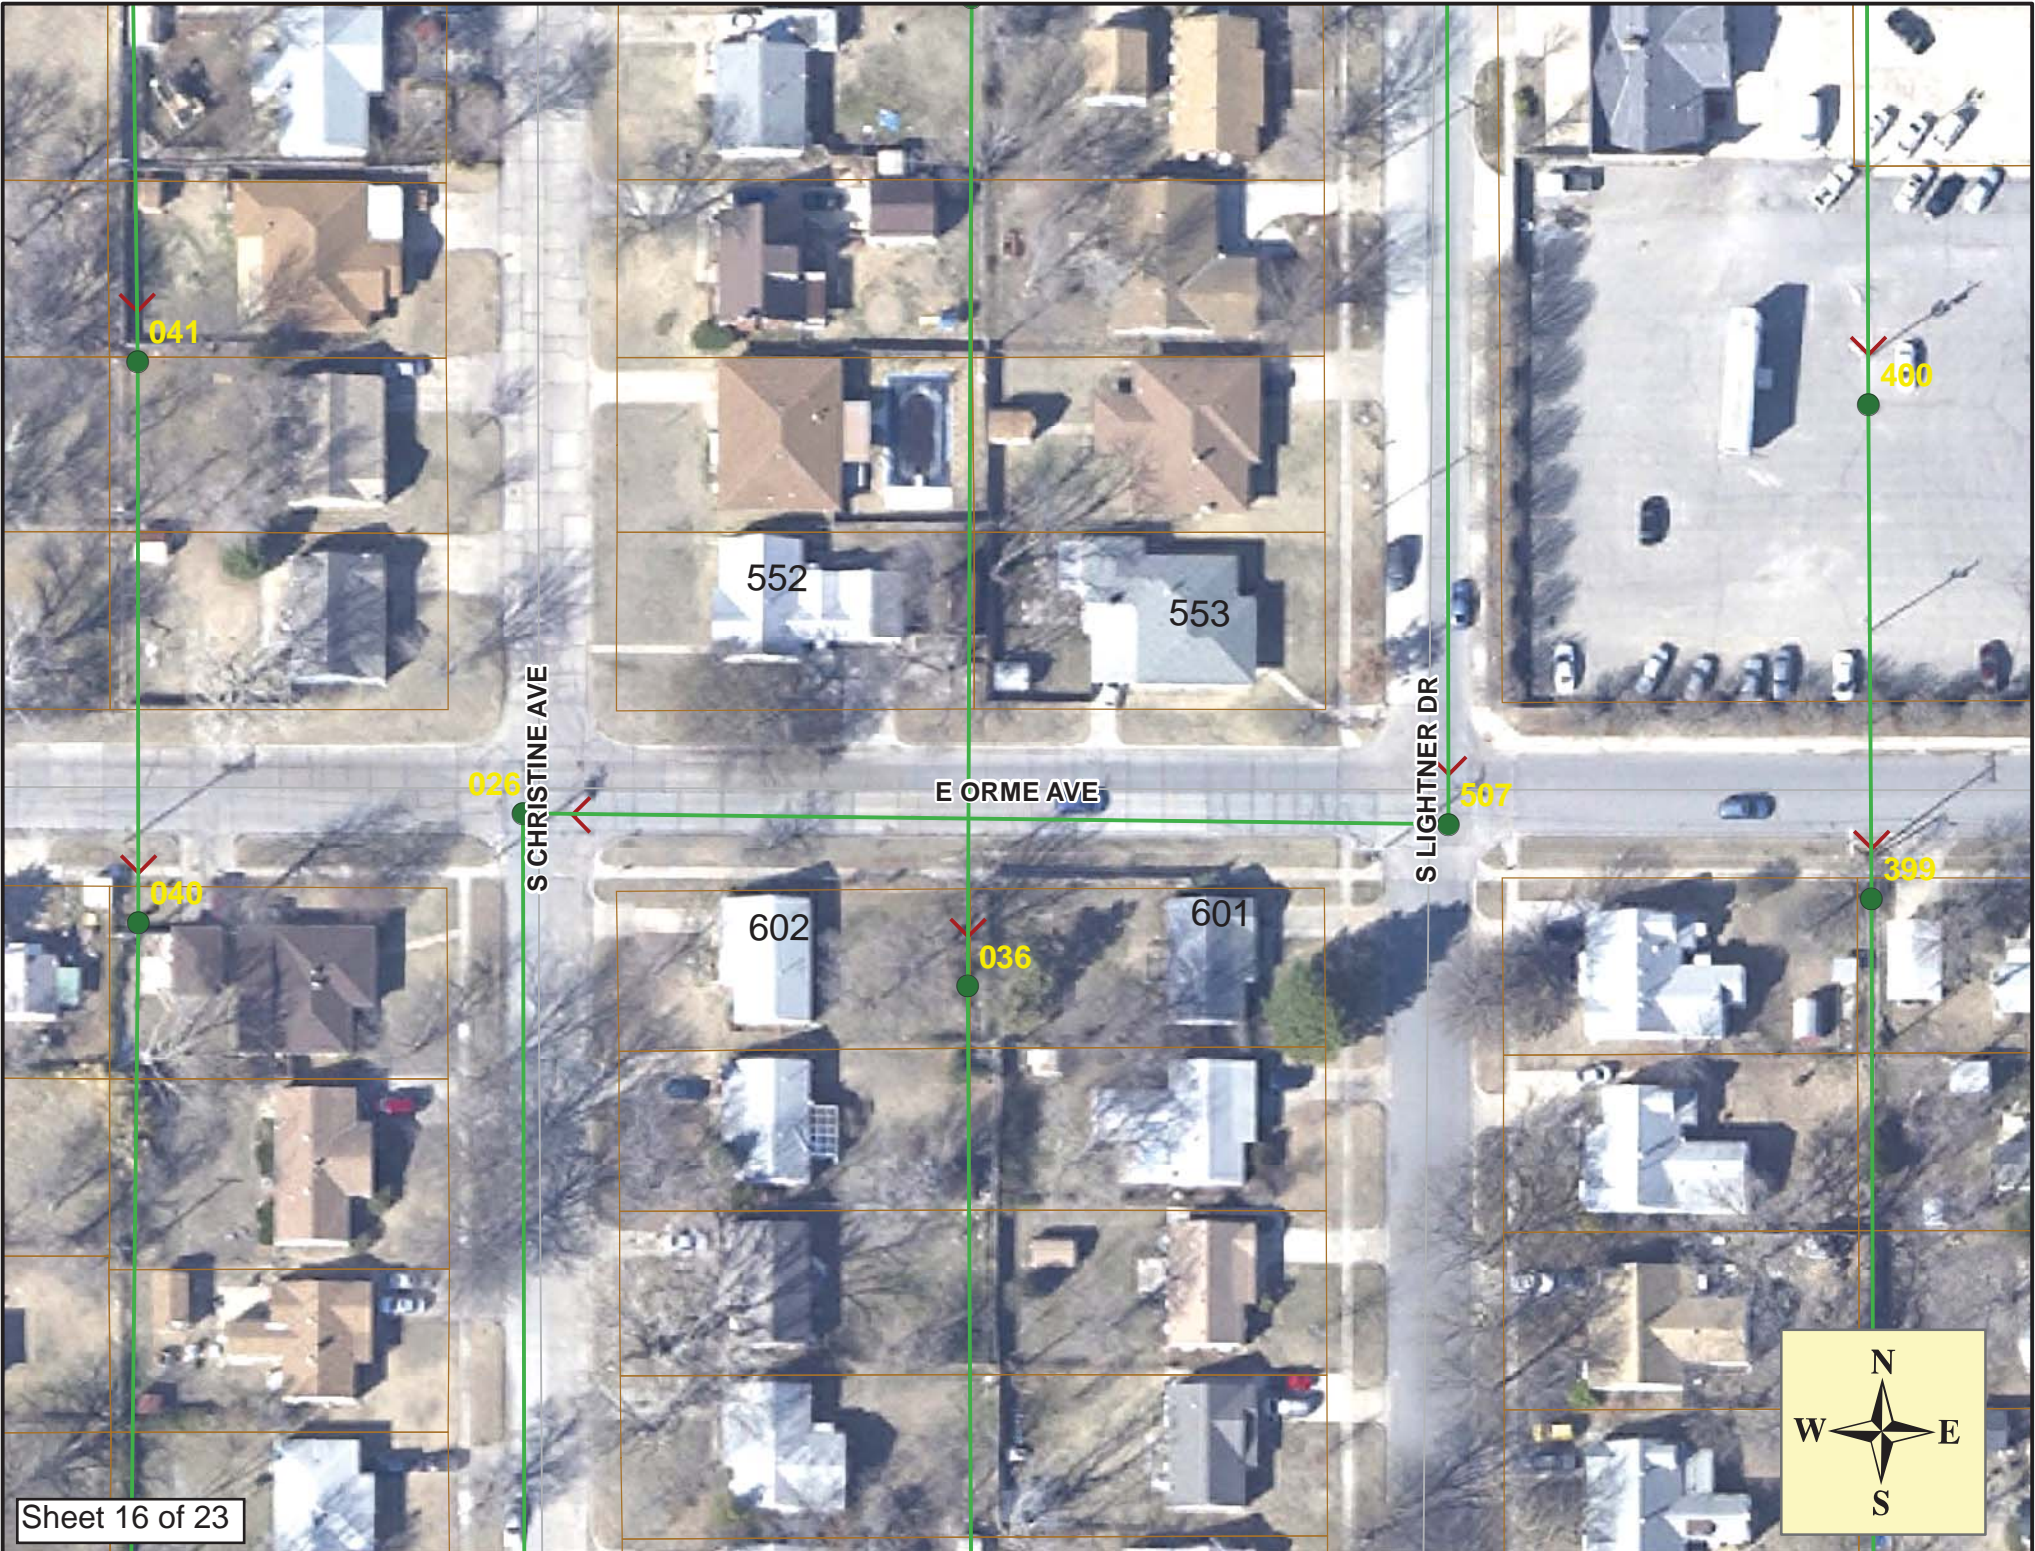
MH 5846-037  
Approx depth =10.2 ft

MH 5846-036  
602 S. Christine  
Remove & Replace MH Bench & Invert  
Replace MH Frame & Cover  
Approx depth =11.1 ft

(there is no water or storm water  
located in Orme Street)  
(27" sanitary is well below the repair)

19		271.3		Mat. Chngs to PVC	1	Pipe immediately dips downward to full sag				
20		272.4		Sag / then entire PVC repair is a sag	5	0.000	25	0	0.000	
21		282.3	Offset joint	Mat. Chngs to VCP	1	0.000	0	0	0.000	
24		284.1	Offset joint	Sag ends	1	0.000	1	0	0.000	
25		292.7		Sag begins	2	0.000	2	0	0.000	
26		294.1		Sag / lens submerged	5	0.000	25	0	0.000	
27		298.7		Sag / lens emerged	1	0.000	1	0	0.000	
28		298.7		Sag ends	1	0.000	1	0	0.000	
29		328.0	5846-036	DS Manhole	3

The flowline of the 27" sanitary sewer is approx. 10 feet below the flowline of the 8" sewer. There is a utility pole and guy wire in the south parking of Orme Street. -LML

Remove and replace 16 lf of Concrete Pavement (incl curb/gutter)  
Install 16 lf of Flowable Fill  
Remove and replace 4 lf of Concrete Sidewalk

Point Repair:  
Remove and replace 57 lf of 8" pipe from the north wall of  
MH 5846-036 to 57 lf north. (north end of the repair should  
be the north end of the existing PVC repair - see tv log)

Estimated 30 sy Erosion Control Mat  
Estimated 20 lf Back of Curb Protection  
Seeding will be allowed on this Site.
