Install 609 lf of 8" Cured-in-Place Liner from MH 5846-278 to MH 5846-275

SITE 13

Install 265 lf of 8" Cured-in-Place Liner

SITE 14

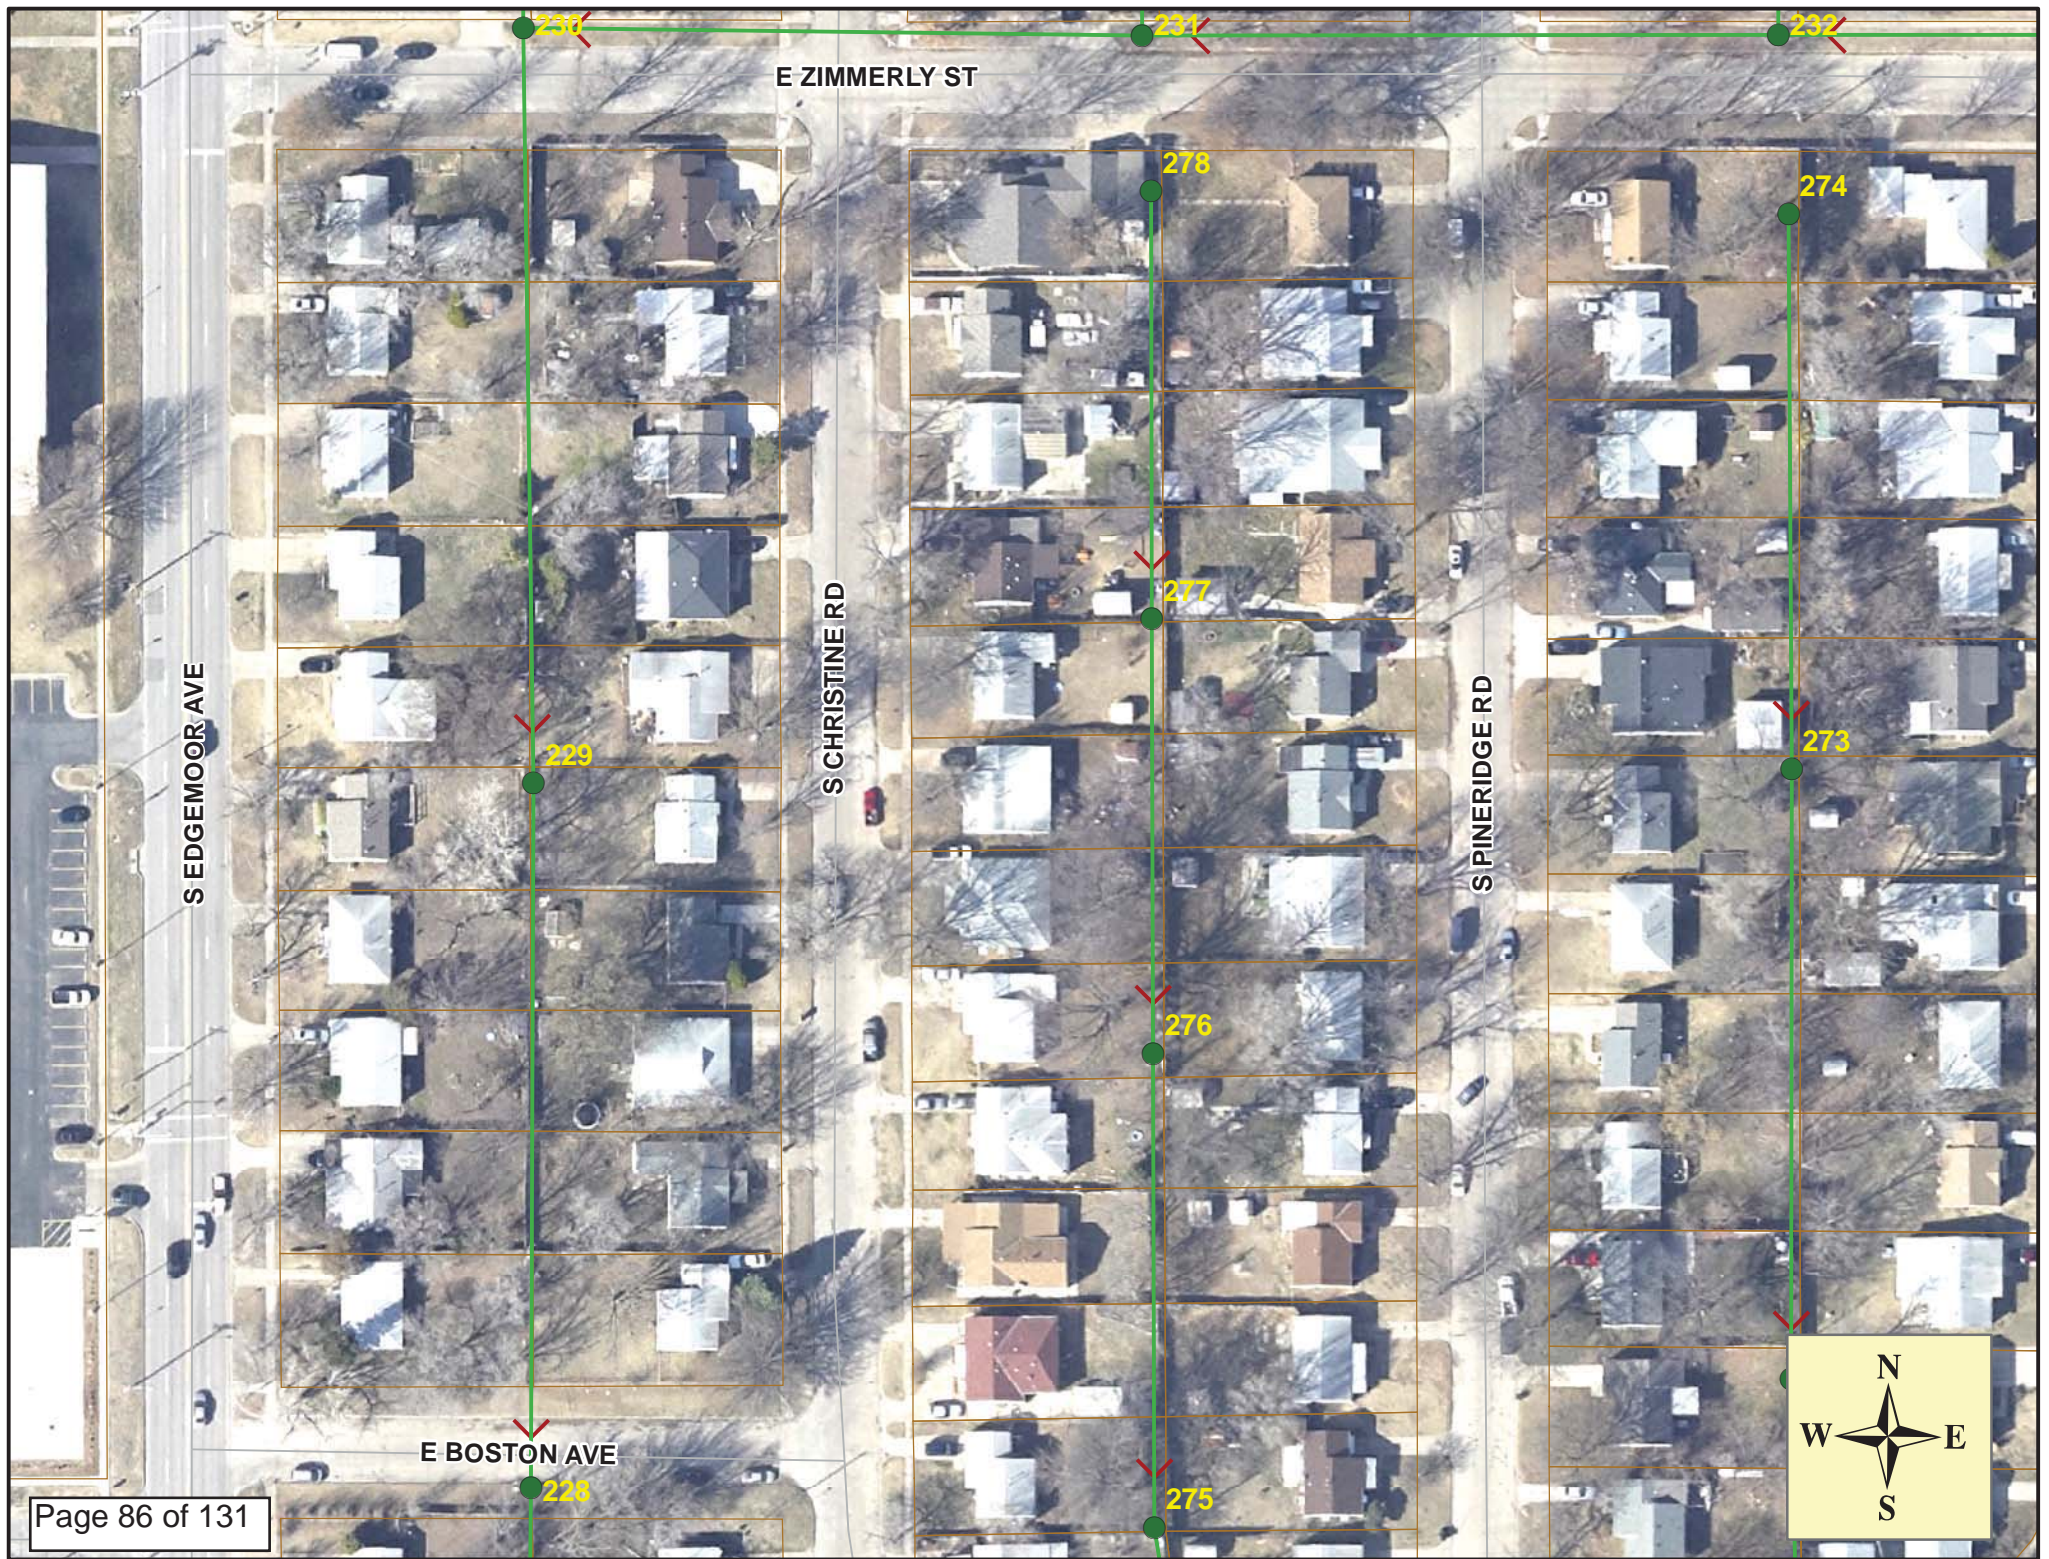
MH 5846-278
Record depth = 9.0 ft

MH 5846-277
1120 Christine
Record depth = 10.0 ft

MH 5846-276
1144 Christine
Approx depth = 9.2 ft

MH 5846-275
1202 Christine
Approx pipe depth = 8.0 ft
Approx MH depth = 14.0 ft

Shape: Round Length Status: Project No. : F-176
 Dia/Ht: 8 Material: VCP Index:
 Length: 198.0 Slope: 0.101 DVD #0437
 Overall Cond: Very Poor Comments: BROKEN PIPE THROUGH OUT LINE NEEDS REHAB

27		193.5	Offset Joint	Line over the offset	4	0.030	60	0	0.030	
28		198.0	DS Manhole	5846-276	Comment:	BROKEN PIPE THROUGH OUT LINE NEEDS REHAB

Comment: BROKEN PIPE THROUGH OUT LINE NEEDS REHAB.

A point repair will be performed "by others" prior to liner installation and will also include the construction of an outside drop. Contractor shall check with the Public Works Engineer or Inspector for status of that work prior to scheduling this line for CIPP installation. (refer to 2013 Sanitary Sewer Recon Phase 7)

The downstream 33 lf of pipe will be replaced "by others" prior to liner installation.
 (including taps at 183' and 186') -LML

CONTRACTOR SHALL NOT INSTALL CIPP PRIOR TO THE DOWNSTREAM 33 LF REPAIR. - LML

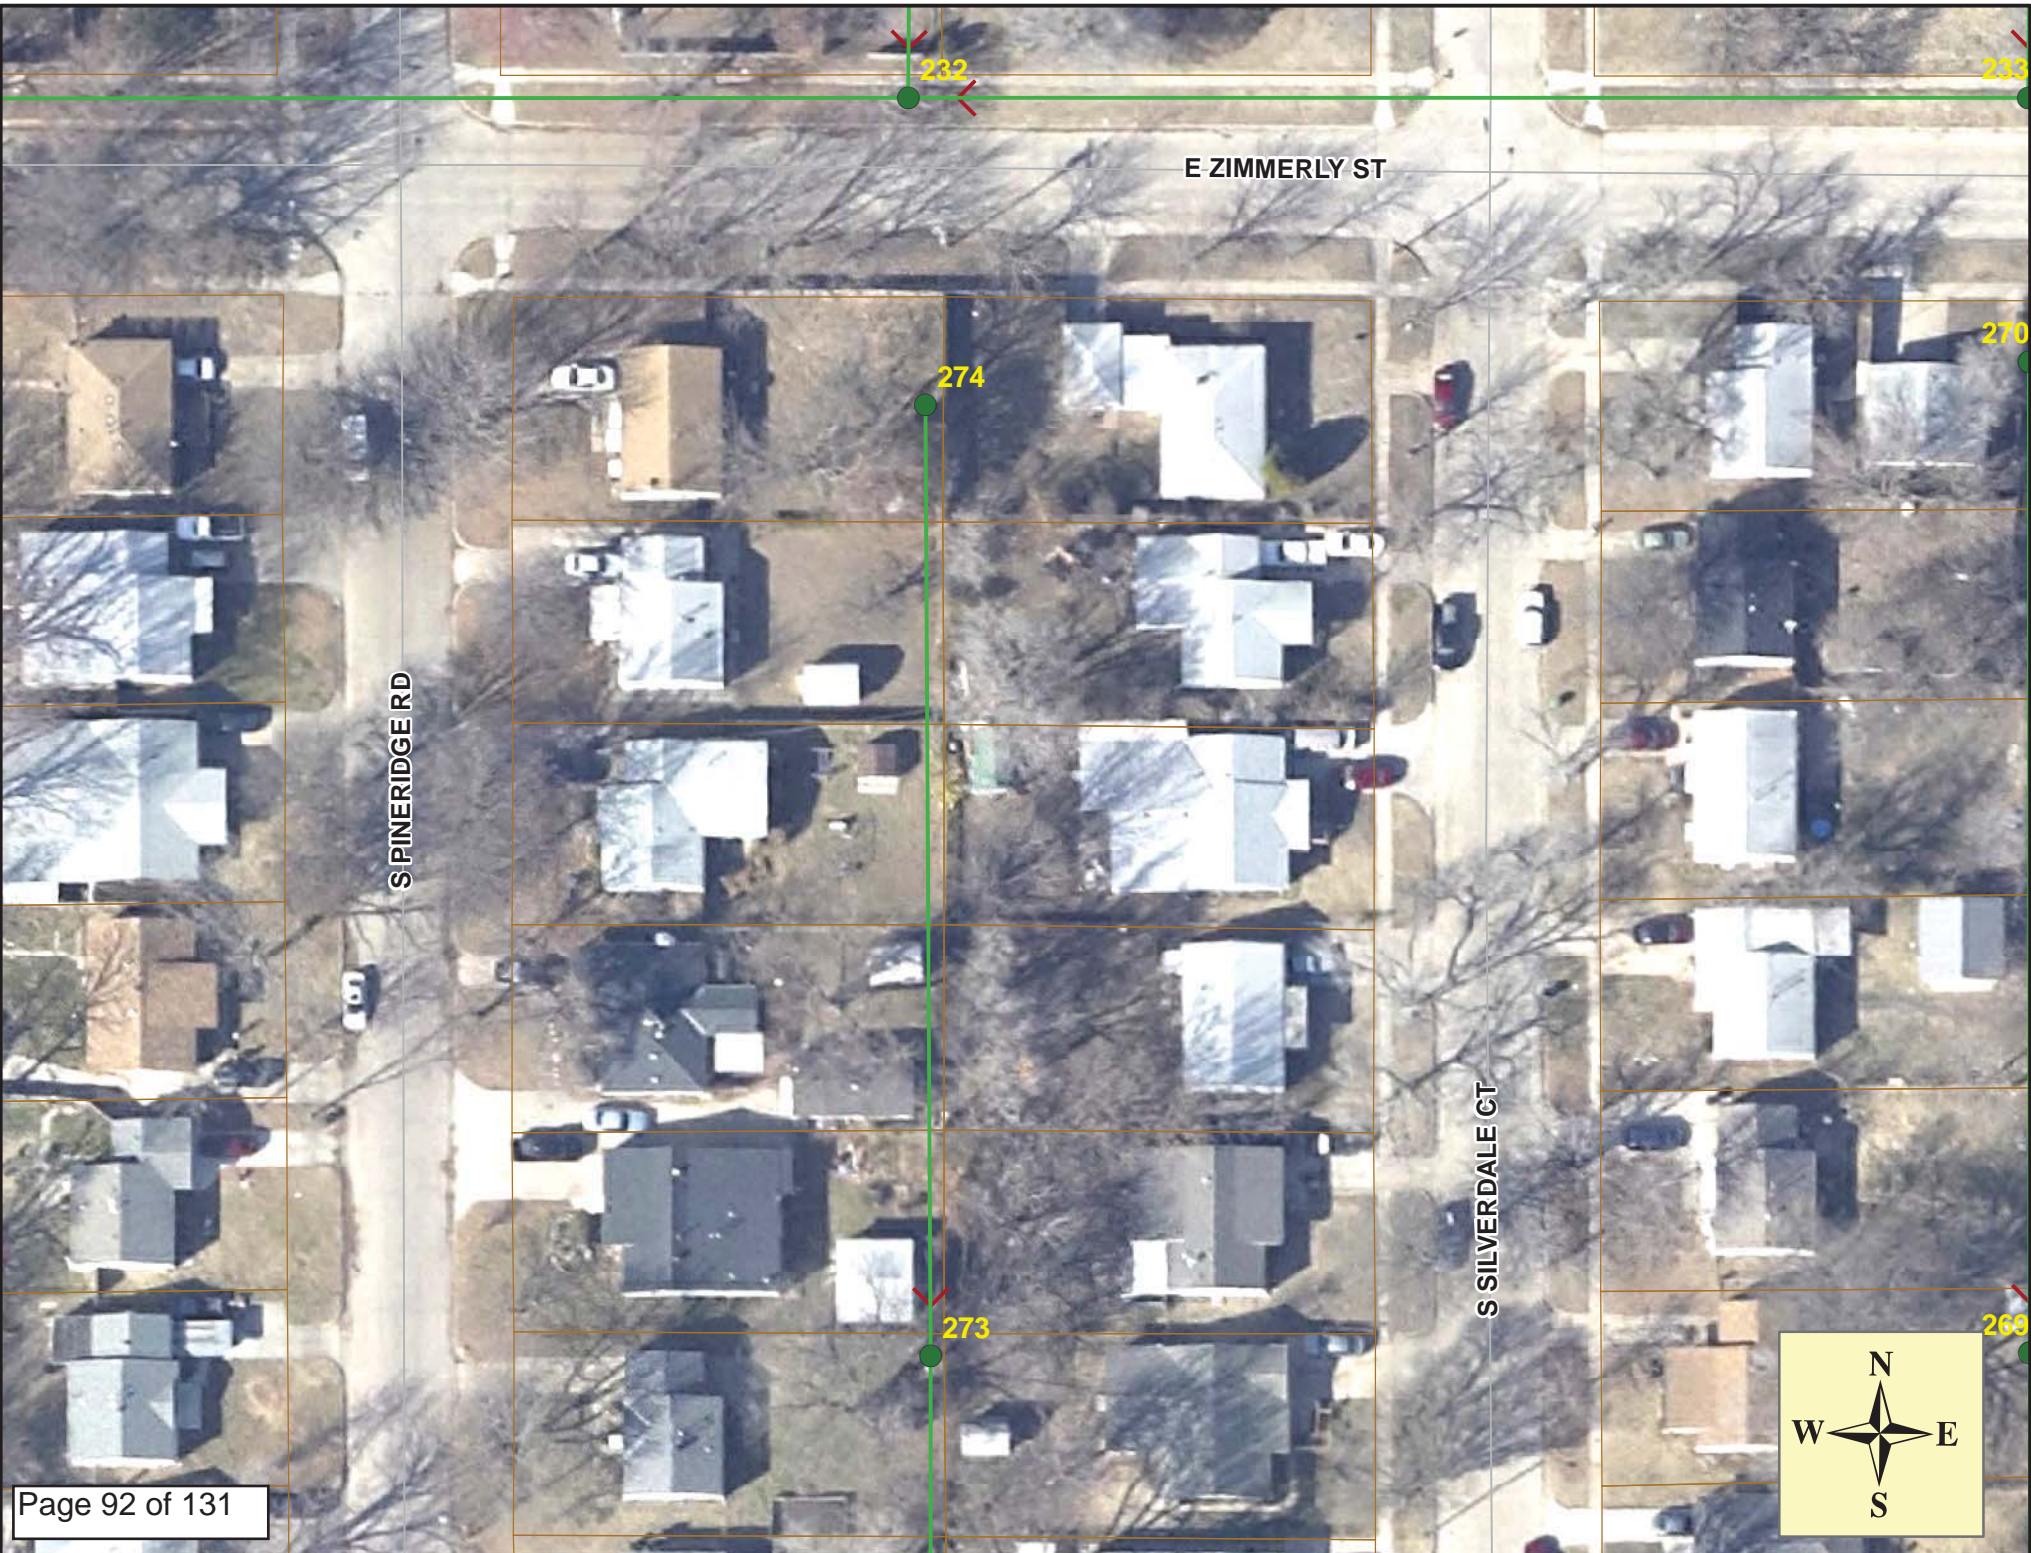
MH 5846-273
1132 Pineridge
Approx depth = 12.7 ft

Obs. #	VTR Counter	Distance	Location	Description	Rating	Obsrvd (gpm)	Ratings			Remain (gpm)
							Est. (gpm)	Struct	Clean	
1		0.0	US Manhole	5846-274	1	0.000	0	0	0.000	
2		3.0	OFFSET		2	0.004	2	4	0.004	
3		6.2	Joint		1	0.002	1	1	0.002	
4		9.2	Offset Joint	Heavy Roots	3	0.008	5	8	0.008	
5		10.5	West	Wye Service	2	0.000	0	0	0.000	
			1102 S PINERIDGE	4" Clay Wye Connection	Comment: ROOTS					
6		11.1	Crown	Broken Pipe	3	0.010	60	0	0.010	
7		12.4	Joint	Roots	2	0.004	2	4	0.004	
8		13.3	East	Wye Service	1	0.000	0	0	0.000	
			1103 S SILVERDALE	4" Clay Wye Connection						
9		15.4	Joint	Heavy Roots	4	0.010	10	25	0.010	
10		21.3	Joint	Heavy Roots	3	0.008	5	8	0.008	
11		27.5	Joint	Heavy Roots	4	0.002	1	1	0.002	
12		30.8	Joint	Roots	1	0.002	1	1	0.002	
13		33.9	Joint	Roots	1	0.002	1	1	0.002	
14		36.9	Joint	Roots	1	0.002	1	1	0.002	
15		56.1	West	Wye Service	1	0.000	0	0	0.000	
			1108 S PINERIDGE	4" Clay Wye Connection

7-23-13: Sewer Maintenance will do a point repair on the north side of MH 5846-273. Pipe should be OK for liner installation after that. -LML

8-8-13: Sewer Maintenance has completed the repair. The next segment south of MH 5846-273 is scheduled for open cut replacement. - LML
