Install 1572 lf of 15" Cured-in-Place Liner
from MH 6047-042 to MH 6047-039

SITE 5

Television Inspection Master Report

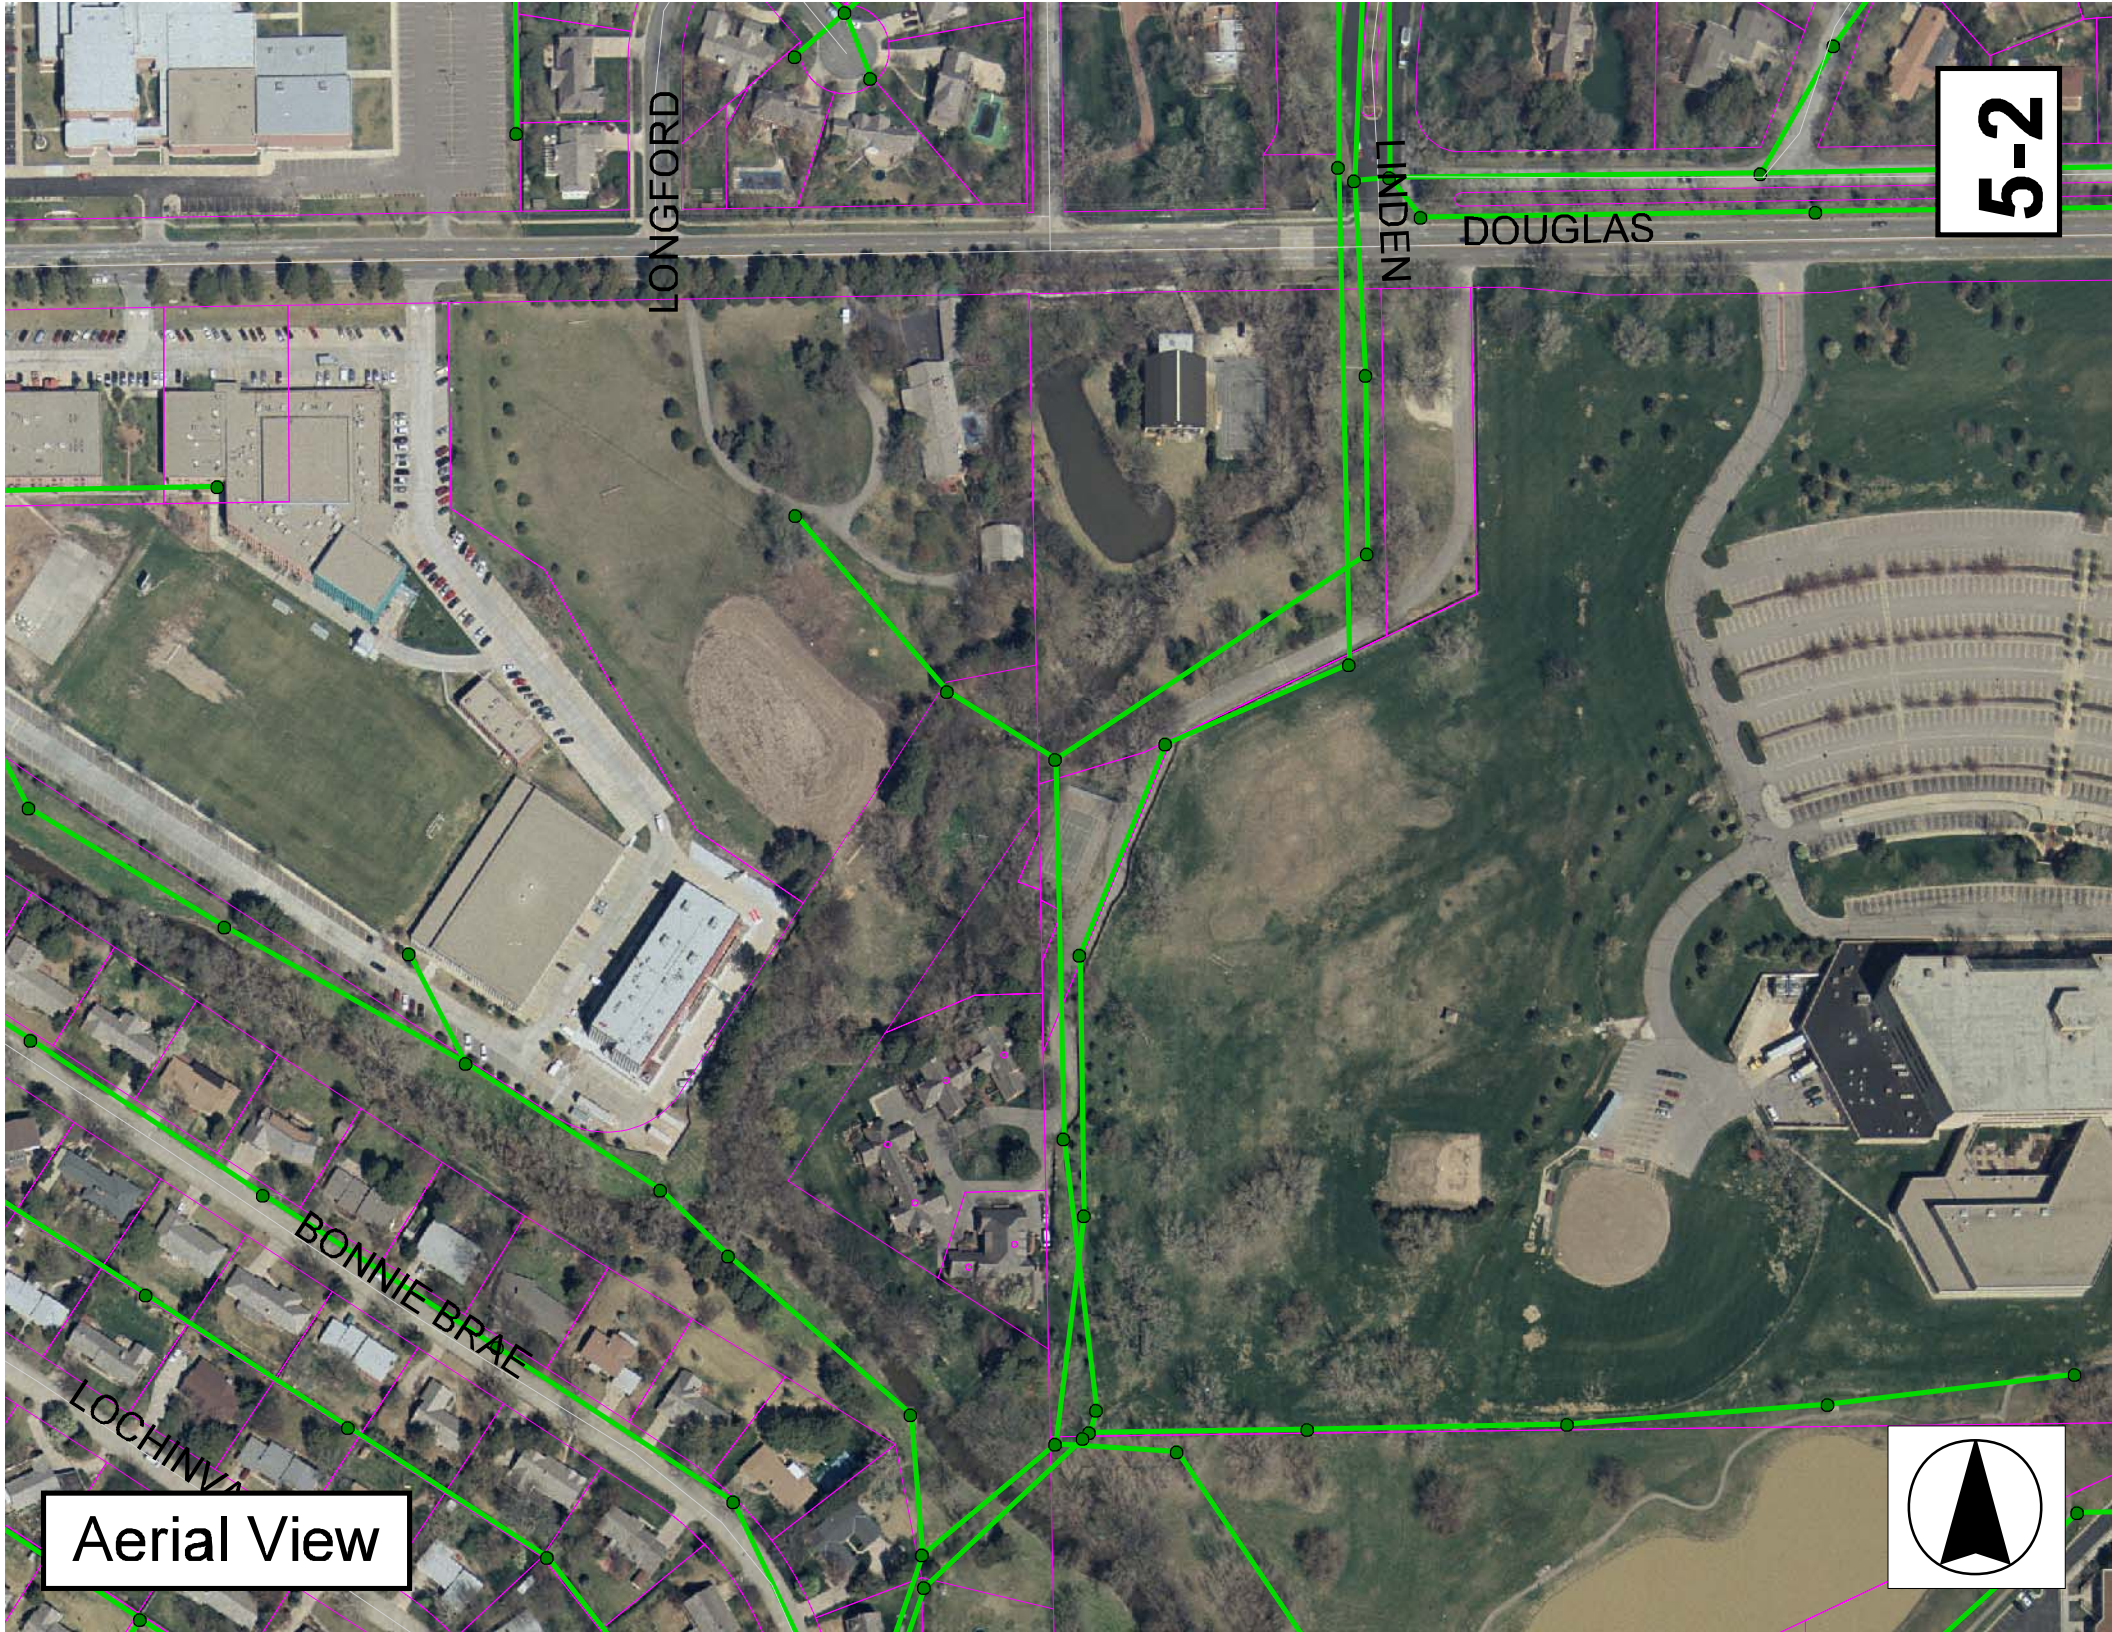
Aerial View

NOTE: The 21" line does reduce to a 12" line as
shown on the south end. Contractor may bypass
pump to the 21" line. If a rain event does occur,
bypass would need to be carefully monitored.
