**SITE 9**

# Television Inspection Master Report

US Structure: 5450-260      2522 N WELLINGTON PL      Date Insp: 3/6/2007      Basin: C04A  
DS Structure: 5450-259      116 W 24TH ST      Dir Televised: Upstream To Downstream

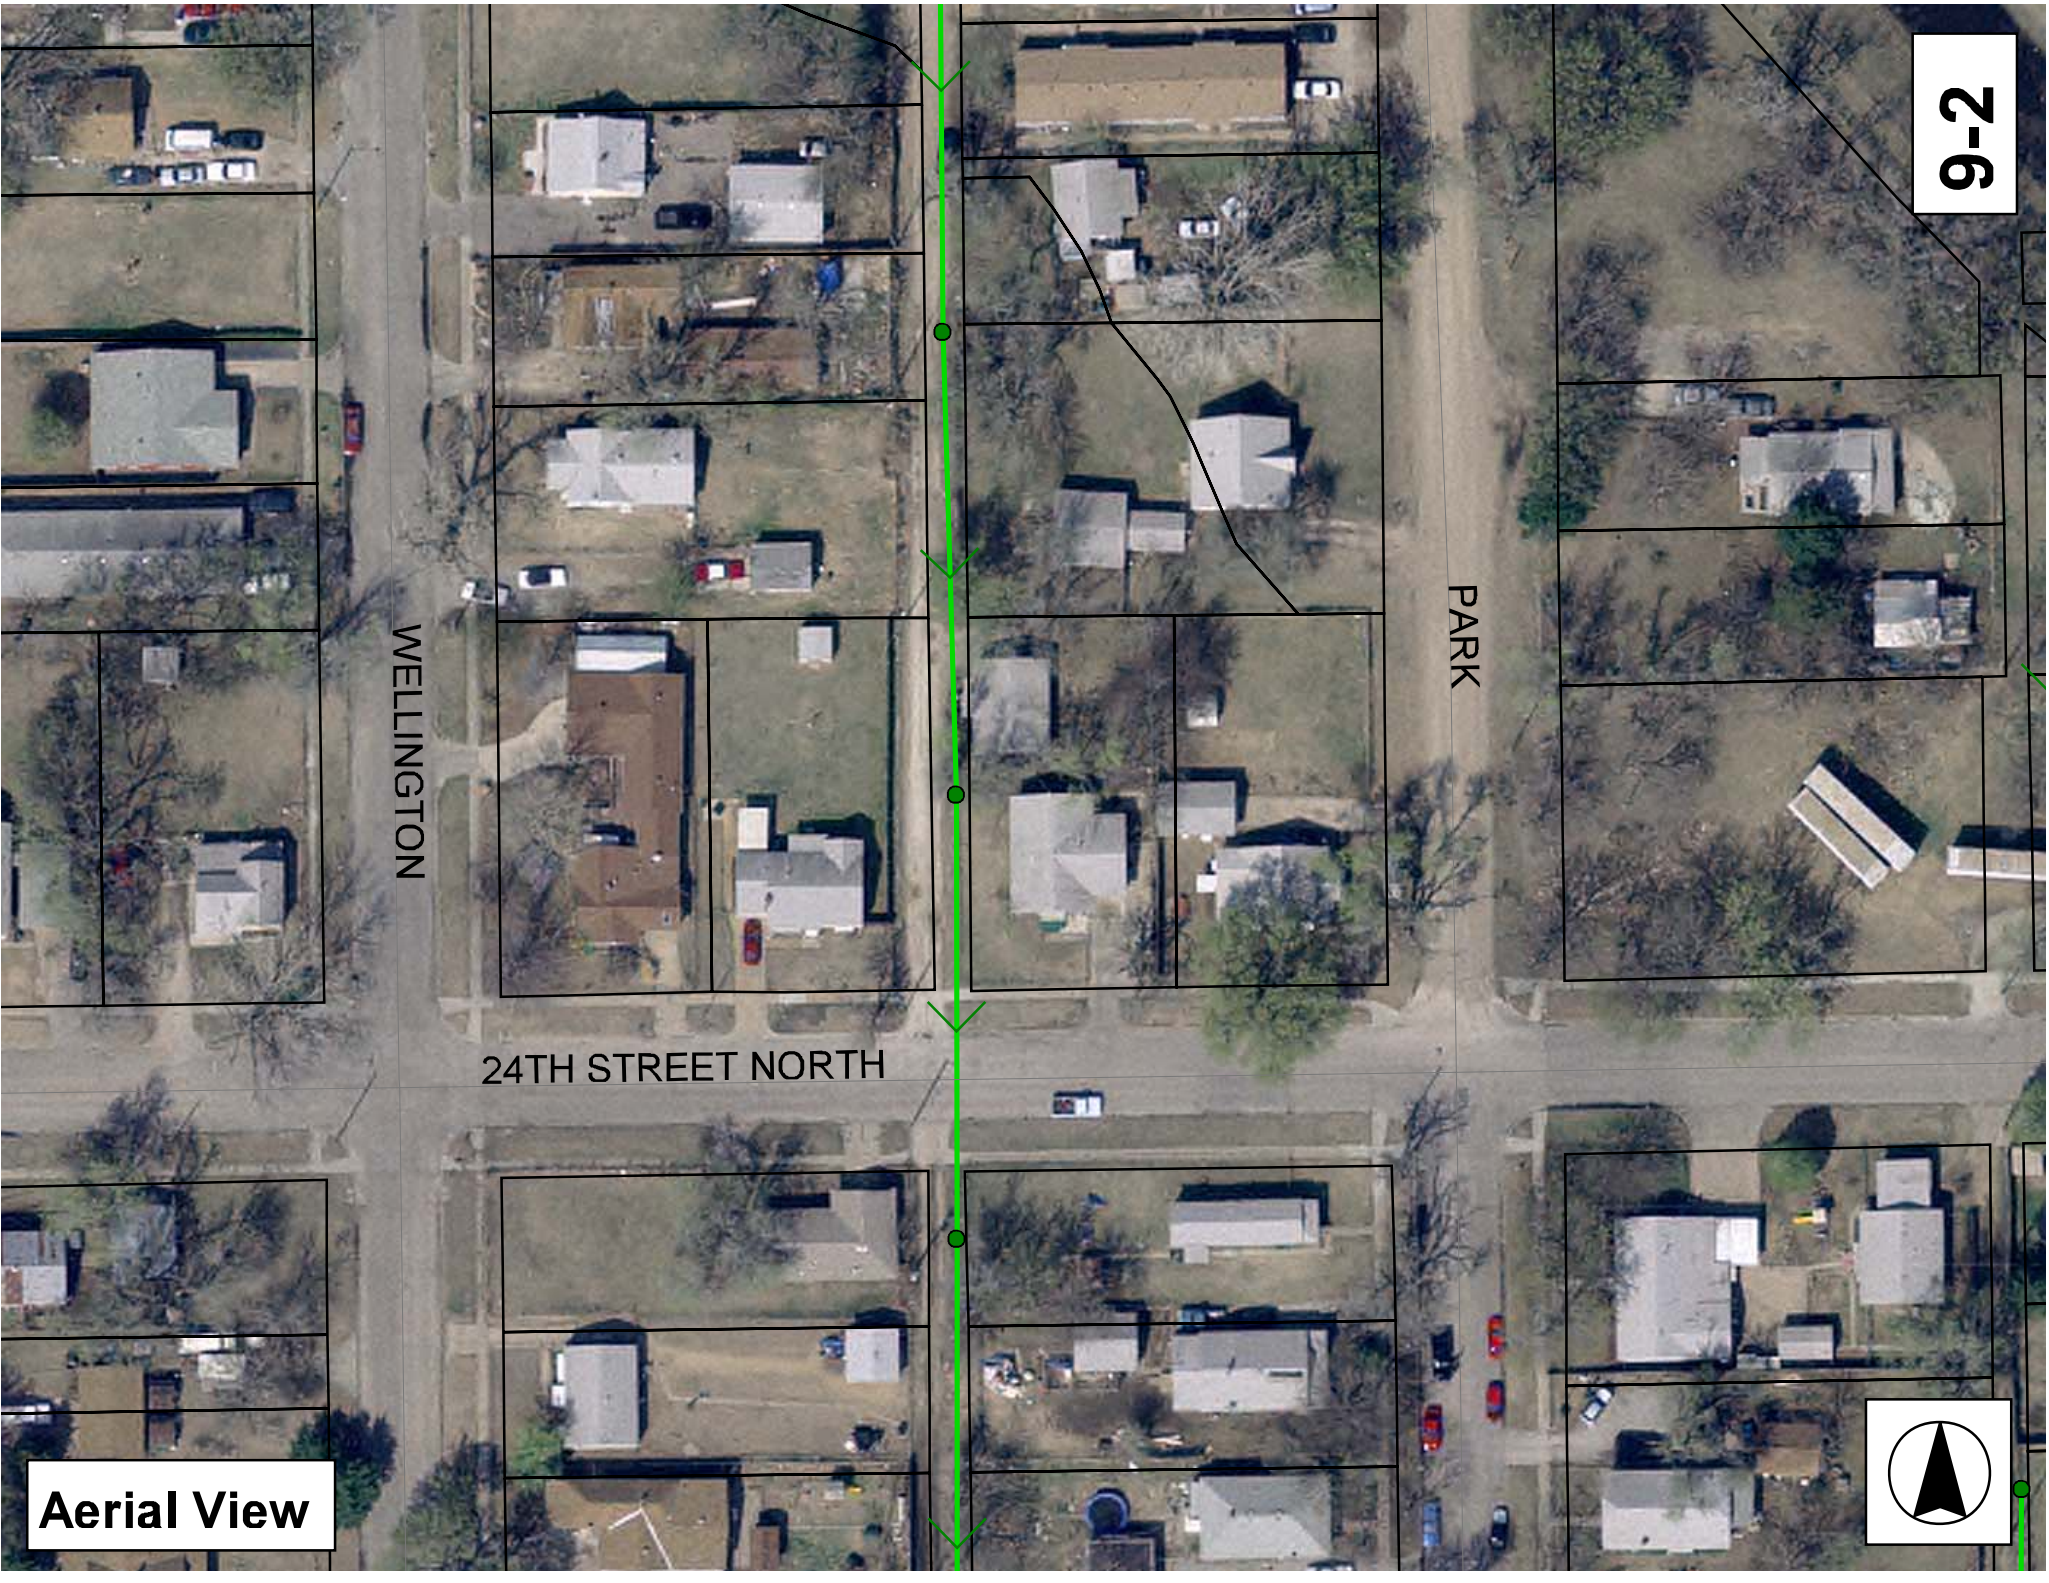
Aerial View

MH # 5450-260  
Remove and Replace Manhole Bench & Invert  
Approx depth = 6.5 ft

Remove and Replace 309 lf of 8" Pipe  
from MH 5450-260 to MH 5450-258

MH # 5450-259  
Remove Manhole

MH # 5450-258  
Replace Manhole Frame & Cover  
Approx depth = 8.1 ft

Remove & Replace 15 lf of Concrete Approach (N)  
Remove & Replace 31 lf of Pavement  
Remove & Replace 15 lf of Concrete Approach (S)
