CITY OF WICHITA, KS.

ARKANSAS RIVER  
BANK RESTORATION PLAN  
SITE PLAN  
EXISTING CONDITIONS

Sheet 2  
of 4

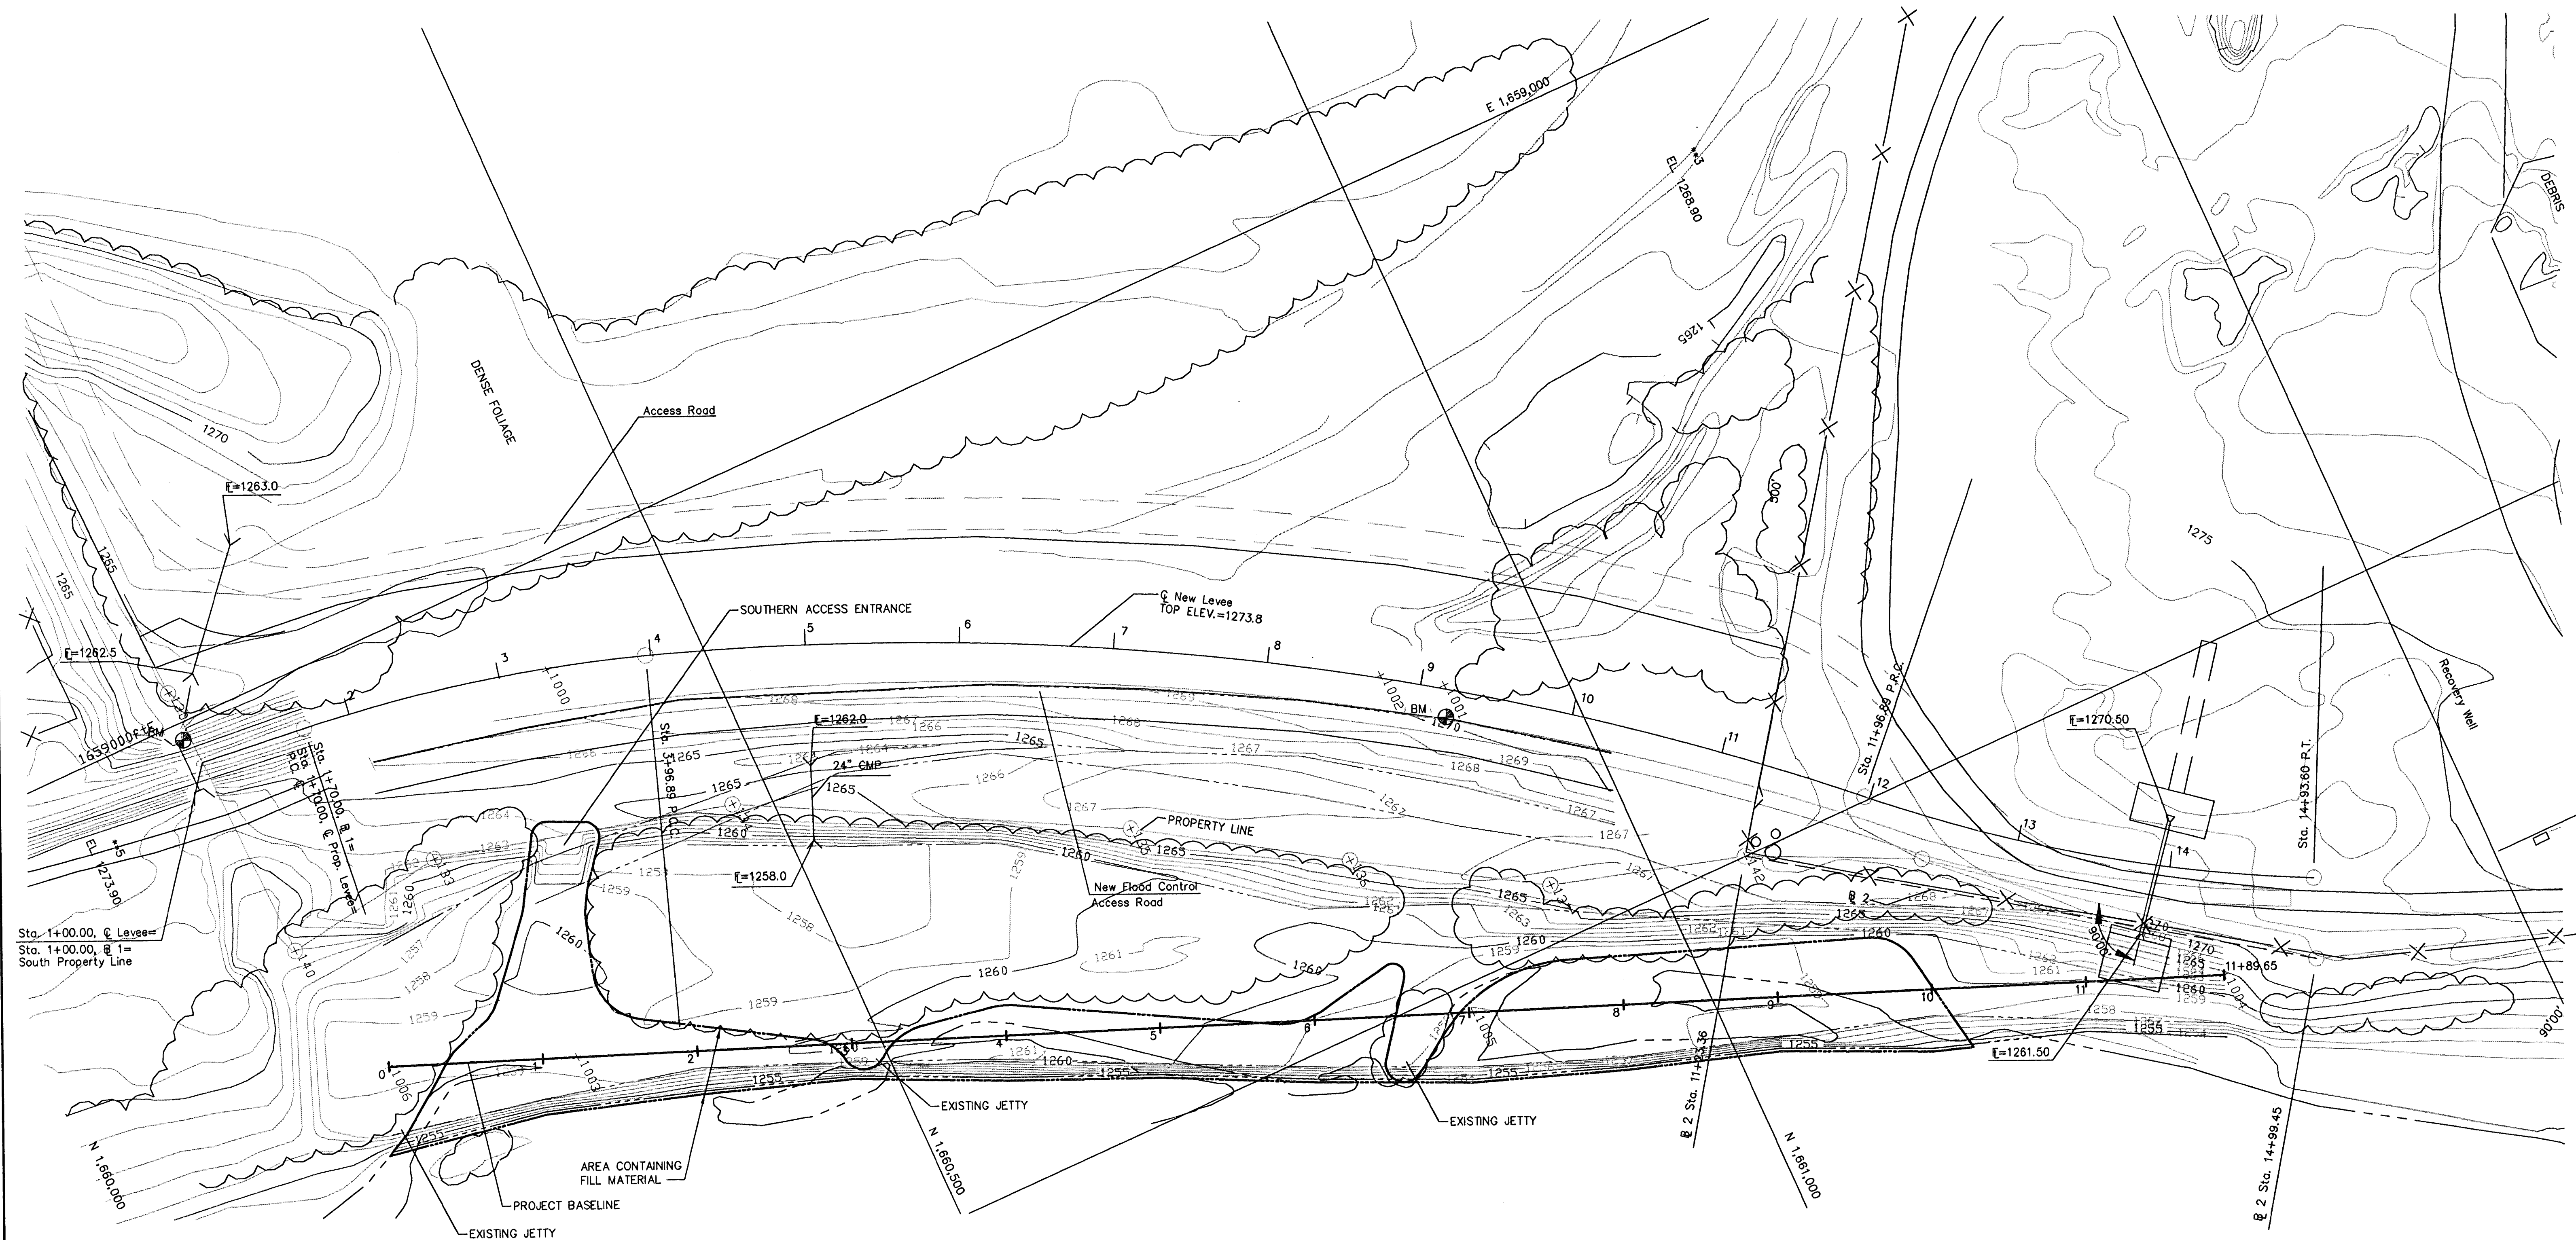
P.O.T. @ 1 STA. 0+39.98  
1. 1/2" REBAR CAPPED "PEC PA"  
2. "□" ON N.W. CORNER WEST HEADWALL OF RCP 55.8' NNW

P.O.T. @ 1 STA. 2+00.00 (@ EXISTING LEVEE)  
1. 1/2" REBAR CAPPED "PEC PA"  
2. "□" ON N.W. CORNER WEST HEADWALL OF RCP 107.71' S  
3. 60d NAIL IN NORTH FACE 18" COTTONWOOD 49.40' W

P.O.T. @ 1 STA. 7+53.61 (@ EXISTING LEVEE)  
1. FOUND 1/2" BAR  
2. NAIL AND SHINER IN TOP OF BRACED FENCE POST 49.14' W

1. THE ORDINARY HIGH WATER MARK (OHWM) ACROSS THE PROJECT SITE IS AT ELEV. 1255 AT BASE LINE STATION 0+00 AND ELEV. 1257 AT STATION 11+89.65.
2. THE PROJECT SITE, AND ALL AREA RIVERWARD FROM THE LEVEE IS WITHIN A 100 YEAR FLOODWAY, AS DEFINED BY FEMA.
3. THE AREA SHOWN AS THE LOCATION OF FILL MATERIAL WAS PREVIOUSLY A RELATIVELY FLAT AREA. SOIL TYPE IS RIVER DEPOSITS, PRIMARILY SAND. THE AREA WAS PARTIALLY SUBMERGED BY SHALLOW WATER. GRASSES AND SHRUBS GREW ON DRY PORTIONS OF THE AREA.

B.M.: "□" ON N.W. CORNER WEST HEADWALL OF PIPE UNDER DIKE (STA. 0+93, 17.5' LT.) ELEV. 1268.27

B.M.: T-POST AT SOUTH SIDE GRAVEL ROAD (STA. 9+20, 17.4' RT.) ELEV. 1266.29
