The original sewer in this alley flowed to the south. In 1949, the current sewer was installed to redirect the flow to the north. There is no record of this change, other than notes written in the Book & Page in Central Inspection. The old sewer pipe is presumed abandoned in place and the exact location is unknown. When laying the new pipe in a straight line between manholes 177 and 004, it's possible that some abandoned sewer could need removed and/or capped off, which shall be subsidiary to the bid item for pipe removal.

Remove 583 lf of 8" Pipe
 Install 583 lf of 8" Pipe
 (new pipe will be a straight line between manholes)

SITE 1

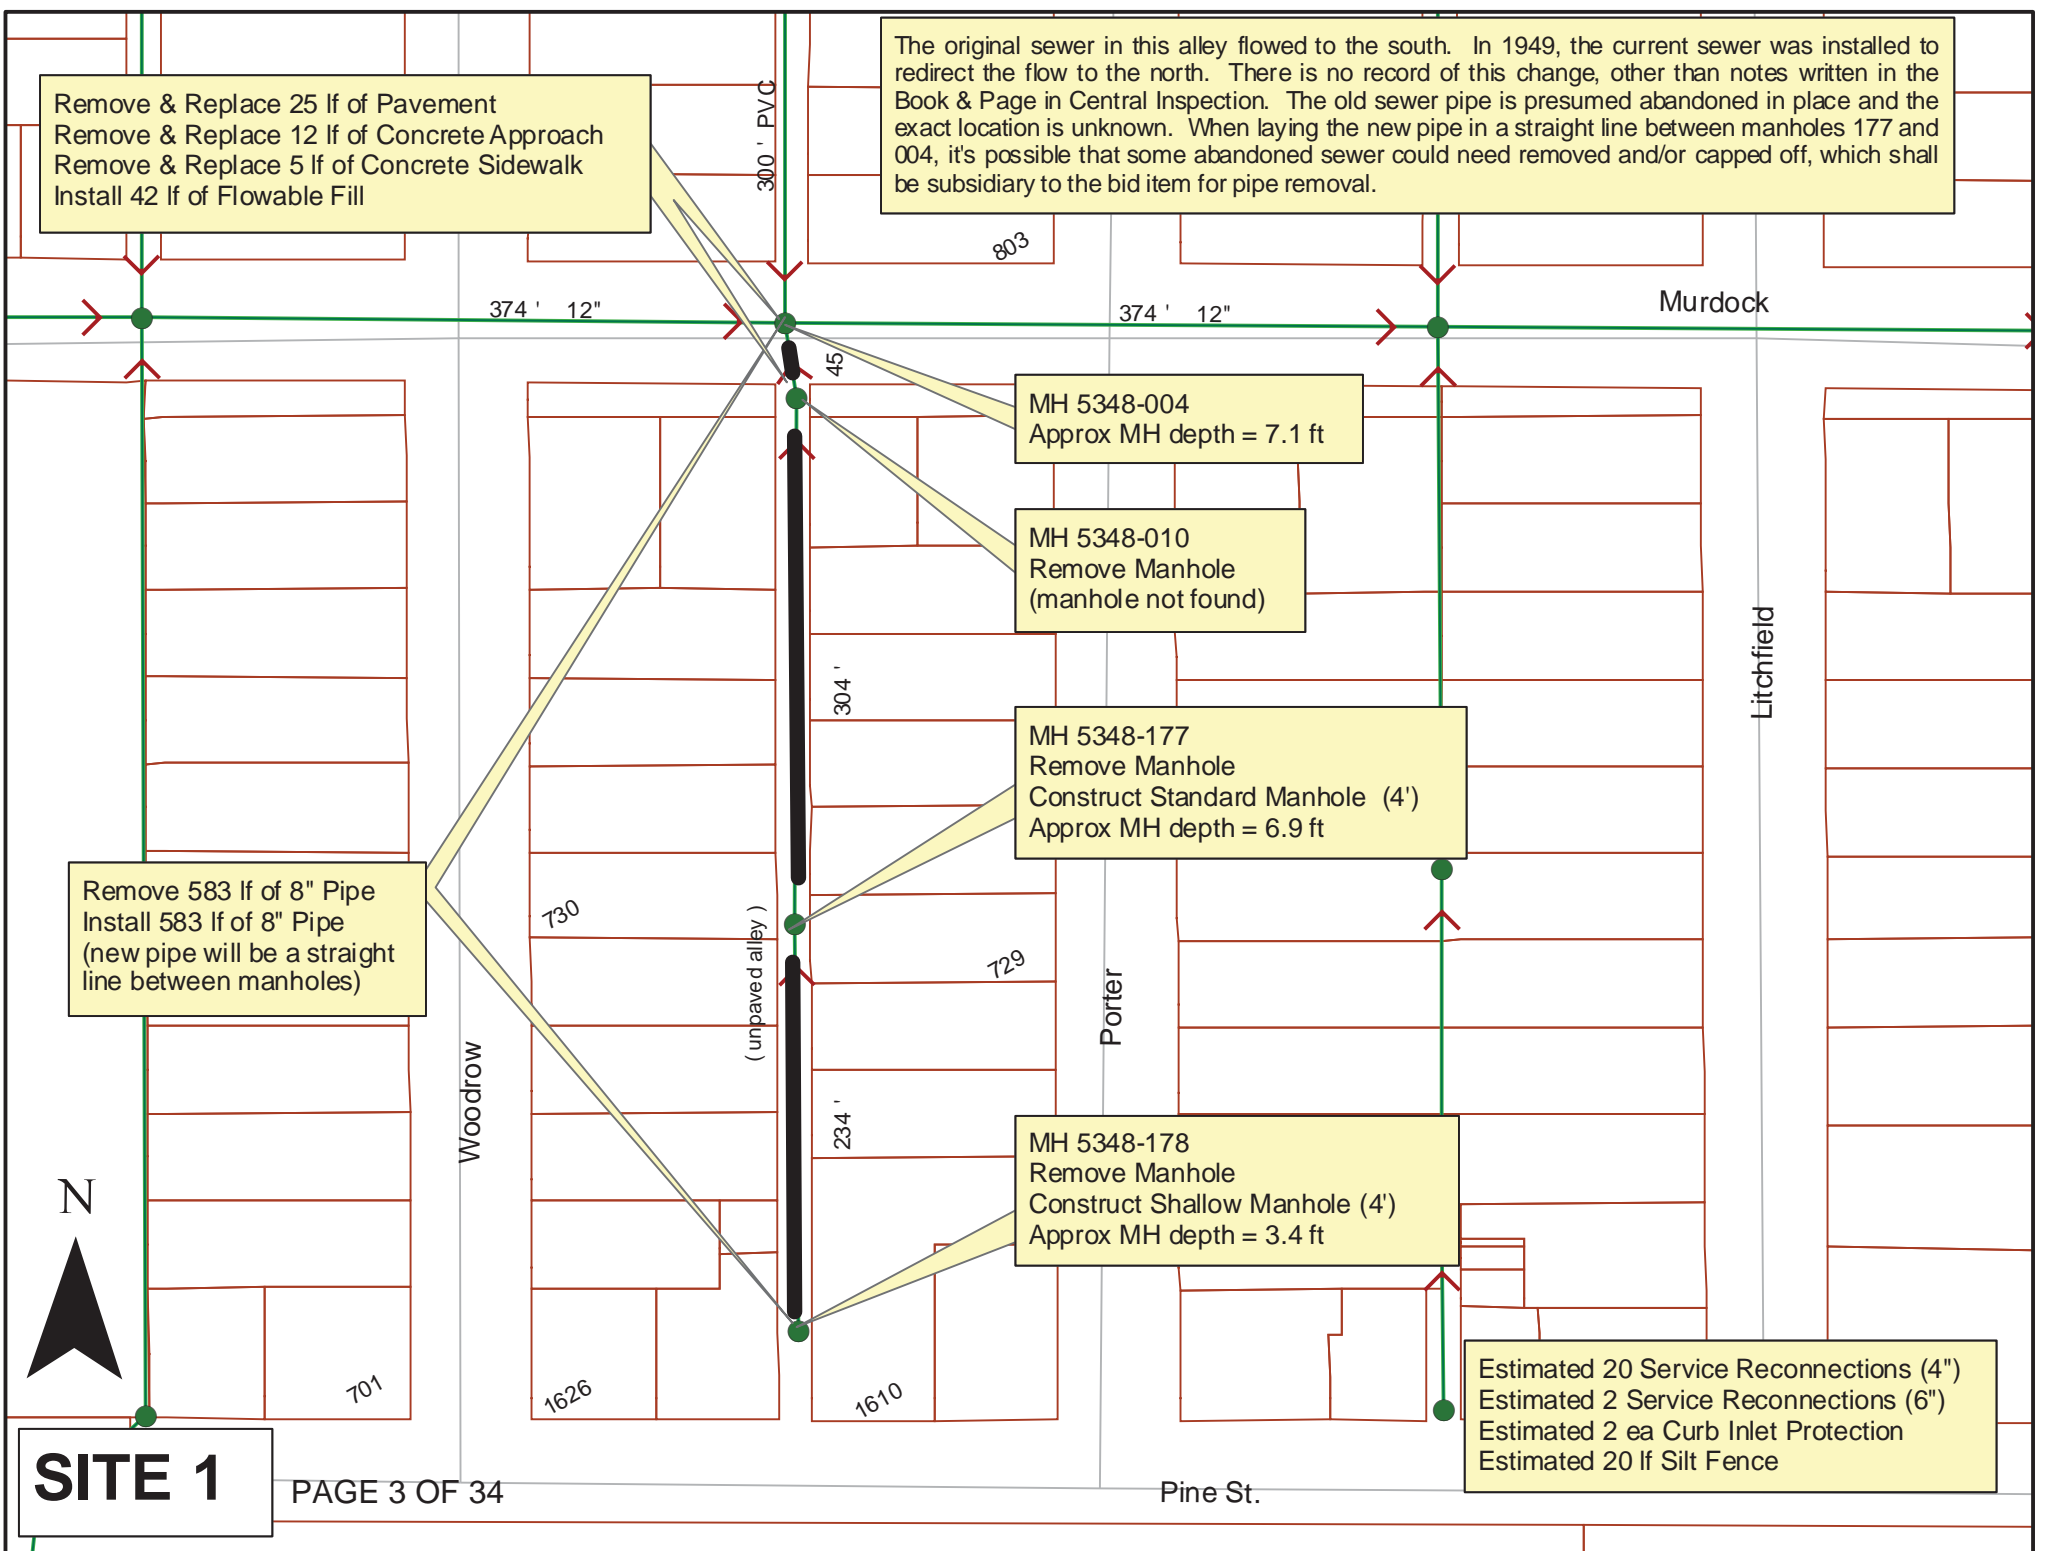
Remove & Replace 25 lf of Pavement
 Remove & Replace 12 lf of Concrete Approach
 Remove & Replace 5 lf of Concrete Sidewalk
 Install 42 lf of Flowable Fill

MH 5348-004
 Approx MH depth = 7.1 ft

MH 5348-010
 Remove Manhole
 (manhole not found)

MH 5348-177
 Remove Manhole
 Construct Standard Manhole (4')
 Approx MH depth = 6.9 ft

MH 5348-178
 Remove Manhole
 Construct Shallow Manhole (4')
 Approx MH depth = 3.4 ft

Estimated 20 Service Reconnections (4")
 Estimated 2 Service Reconnections (6")
 Estimated 2 ea Curb Inlet Protection
 Estimated 20 lf Silt Fence
