**SITE 2**

## Video Inspection Master Report

US Structure: 5448-447      831 N SPAULDING AVE      Date Insp.: 4/11/2012      Basin: C03E  
 DS Structure: 5448-430      1116 W MURDOCK ST      Dir Televised:      Upstream To Downstream

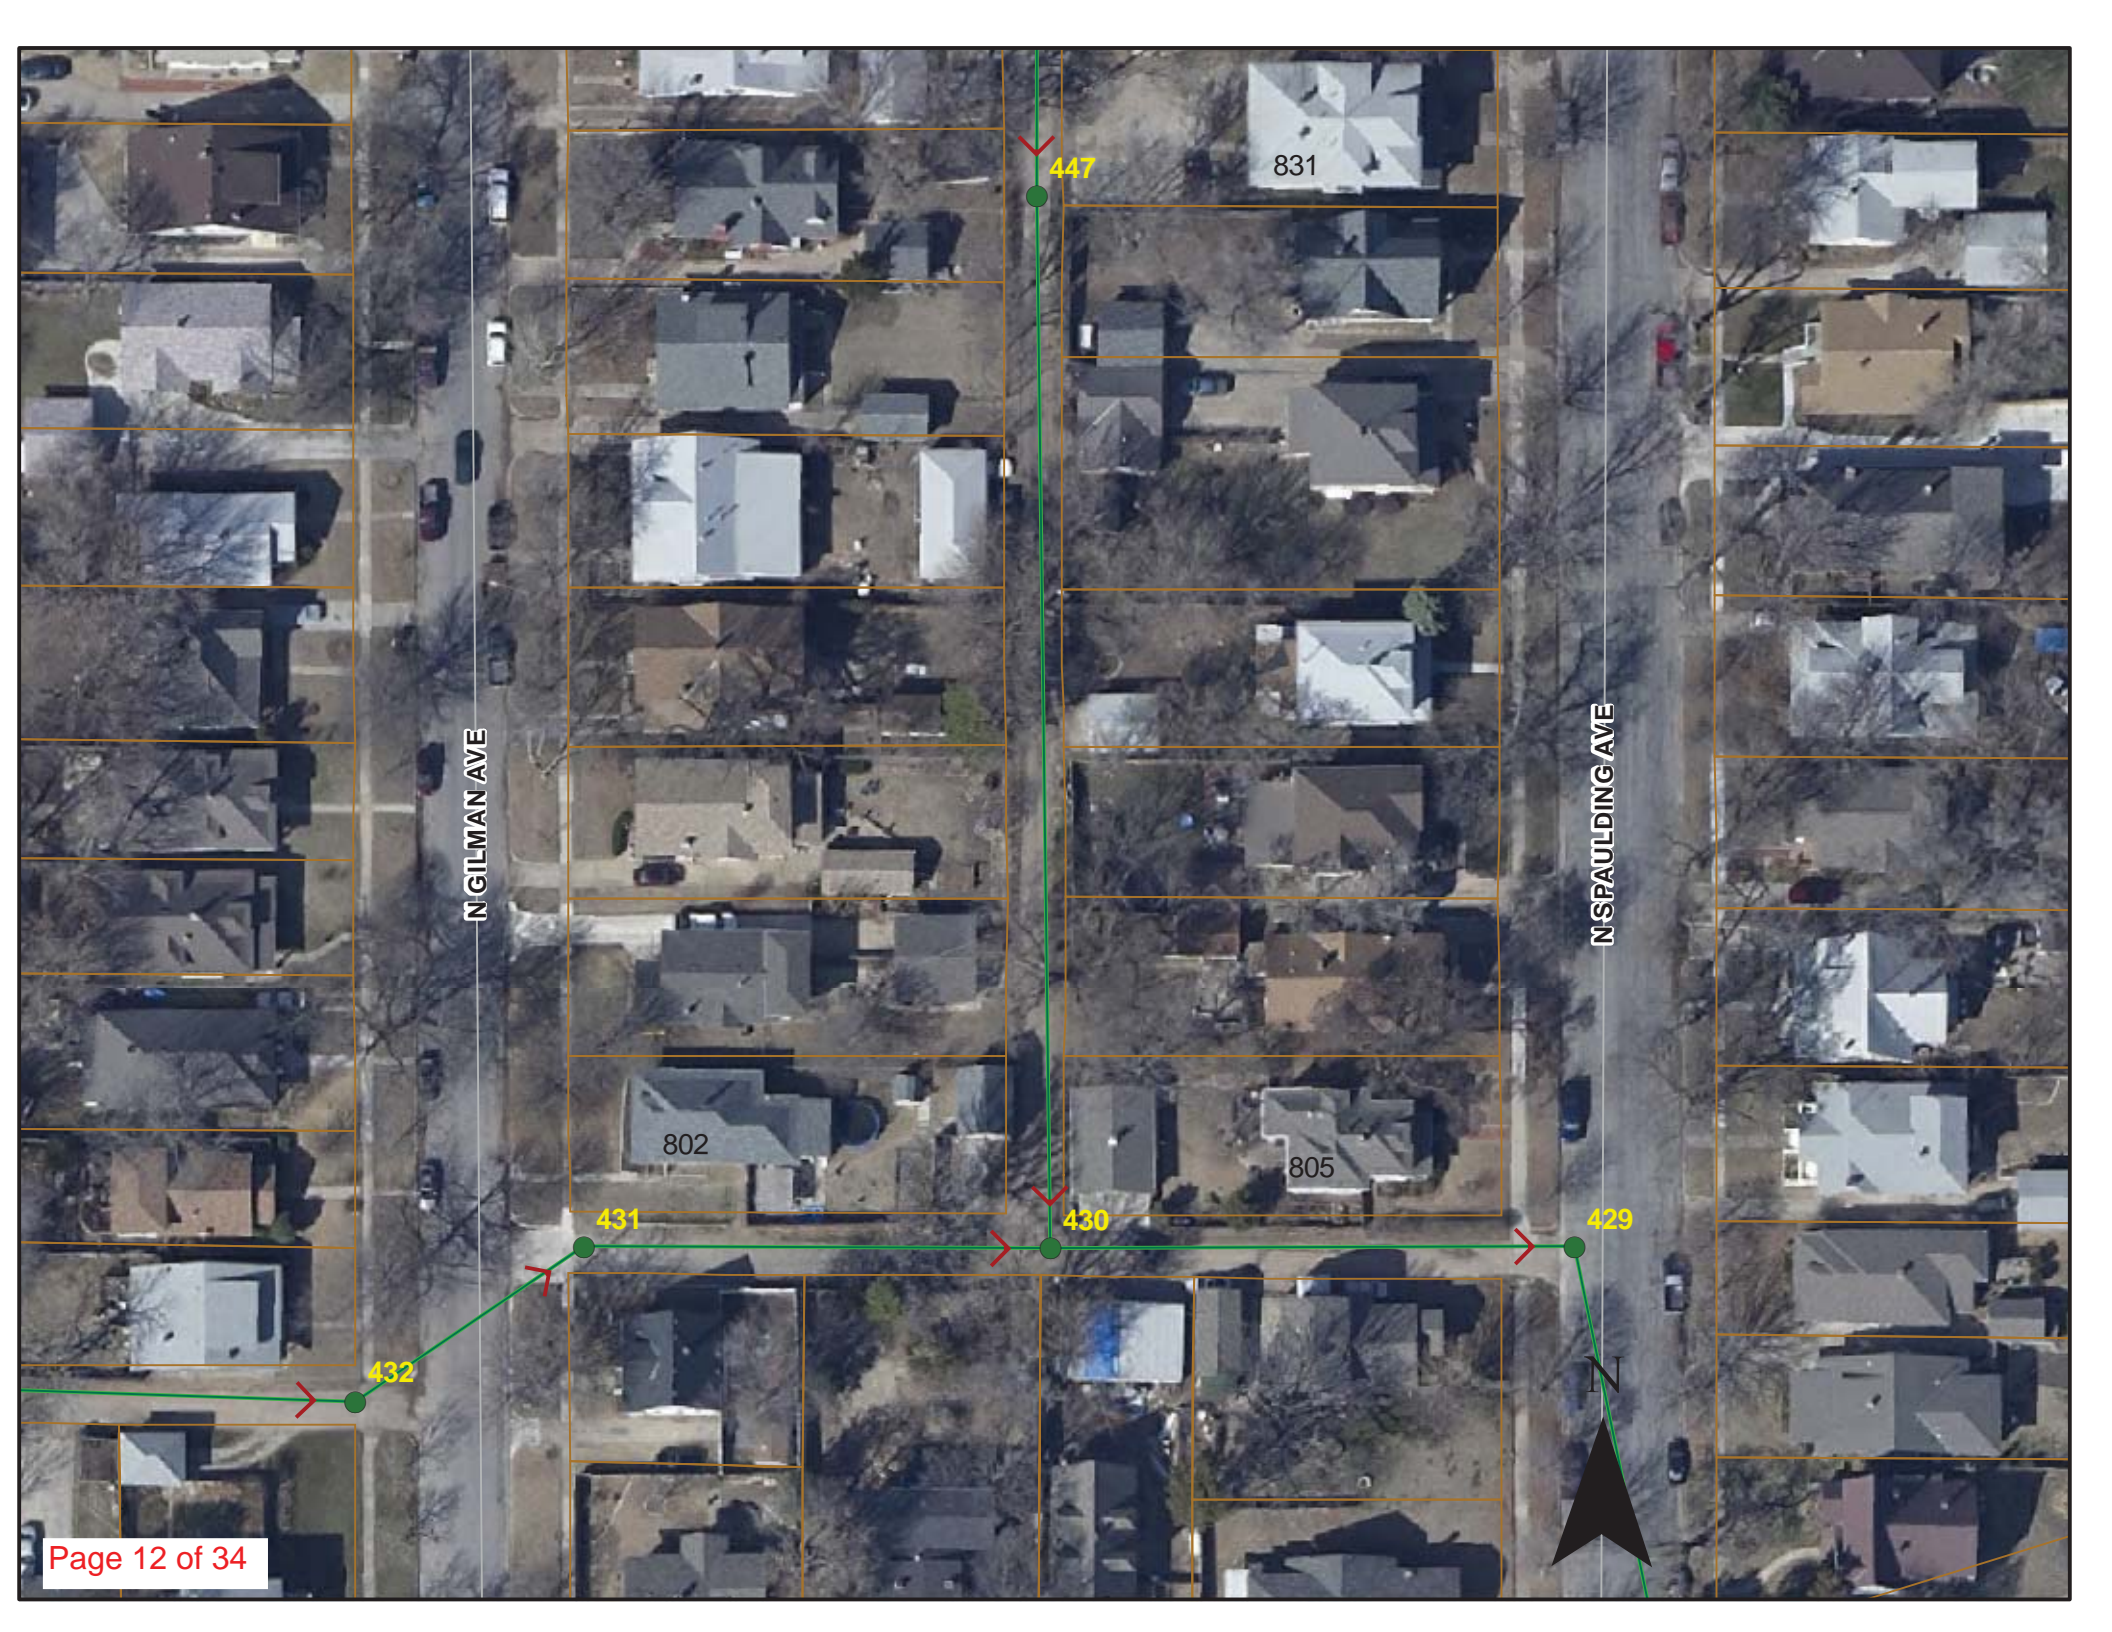
N GILMAN AVE

N SPAULDING AVE

447

831

431

430

Shape: Round      Length Status:      Project No. : B-214  
 Dia/Ht: 8      Material: VCP      Index:  
 Length: 336.9      Slope: 0.002      DVD #0706
