SITE 3
Map 1 of 2

Remove 623 lf of 15" Pipe
Install 623 lf of 15" Pipe
From MH 5348-001 to MH 5448-431

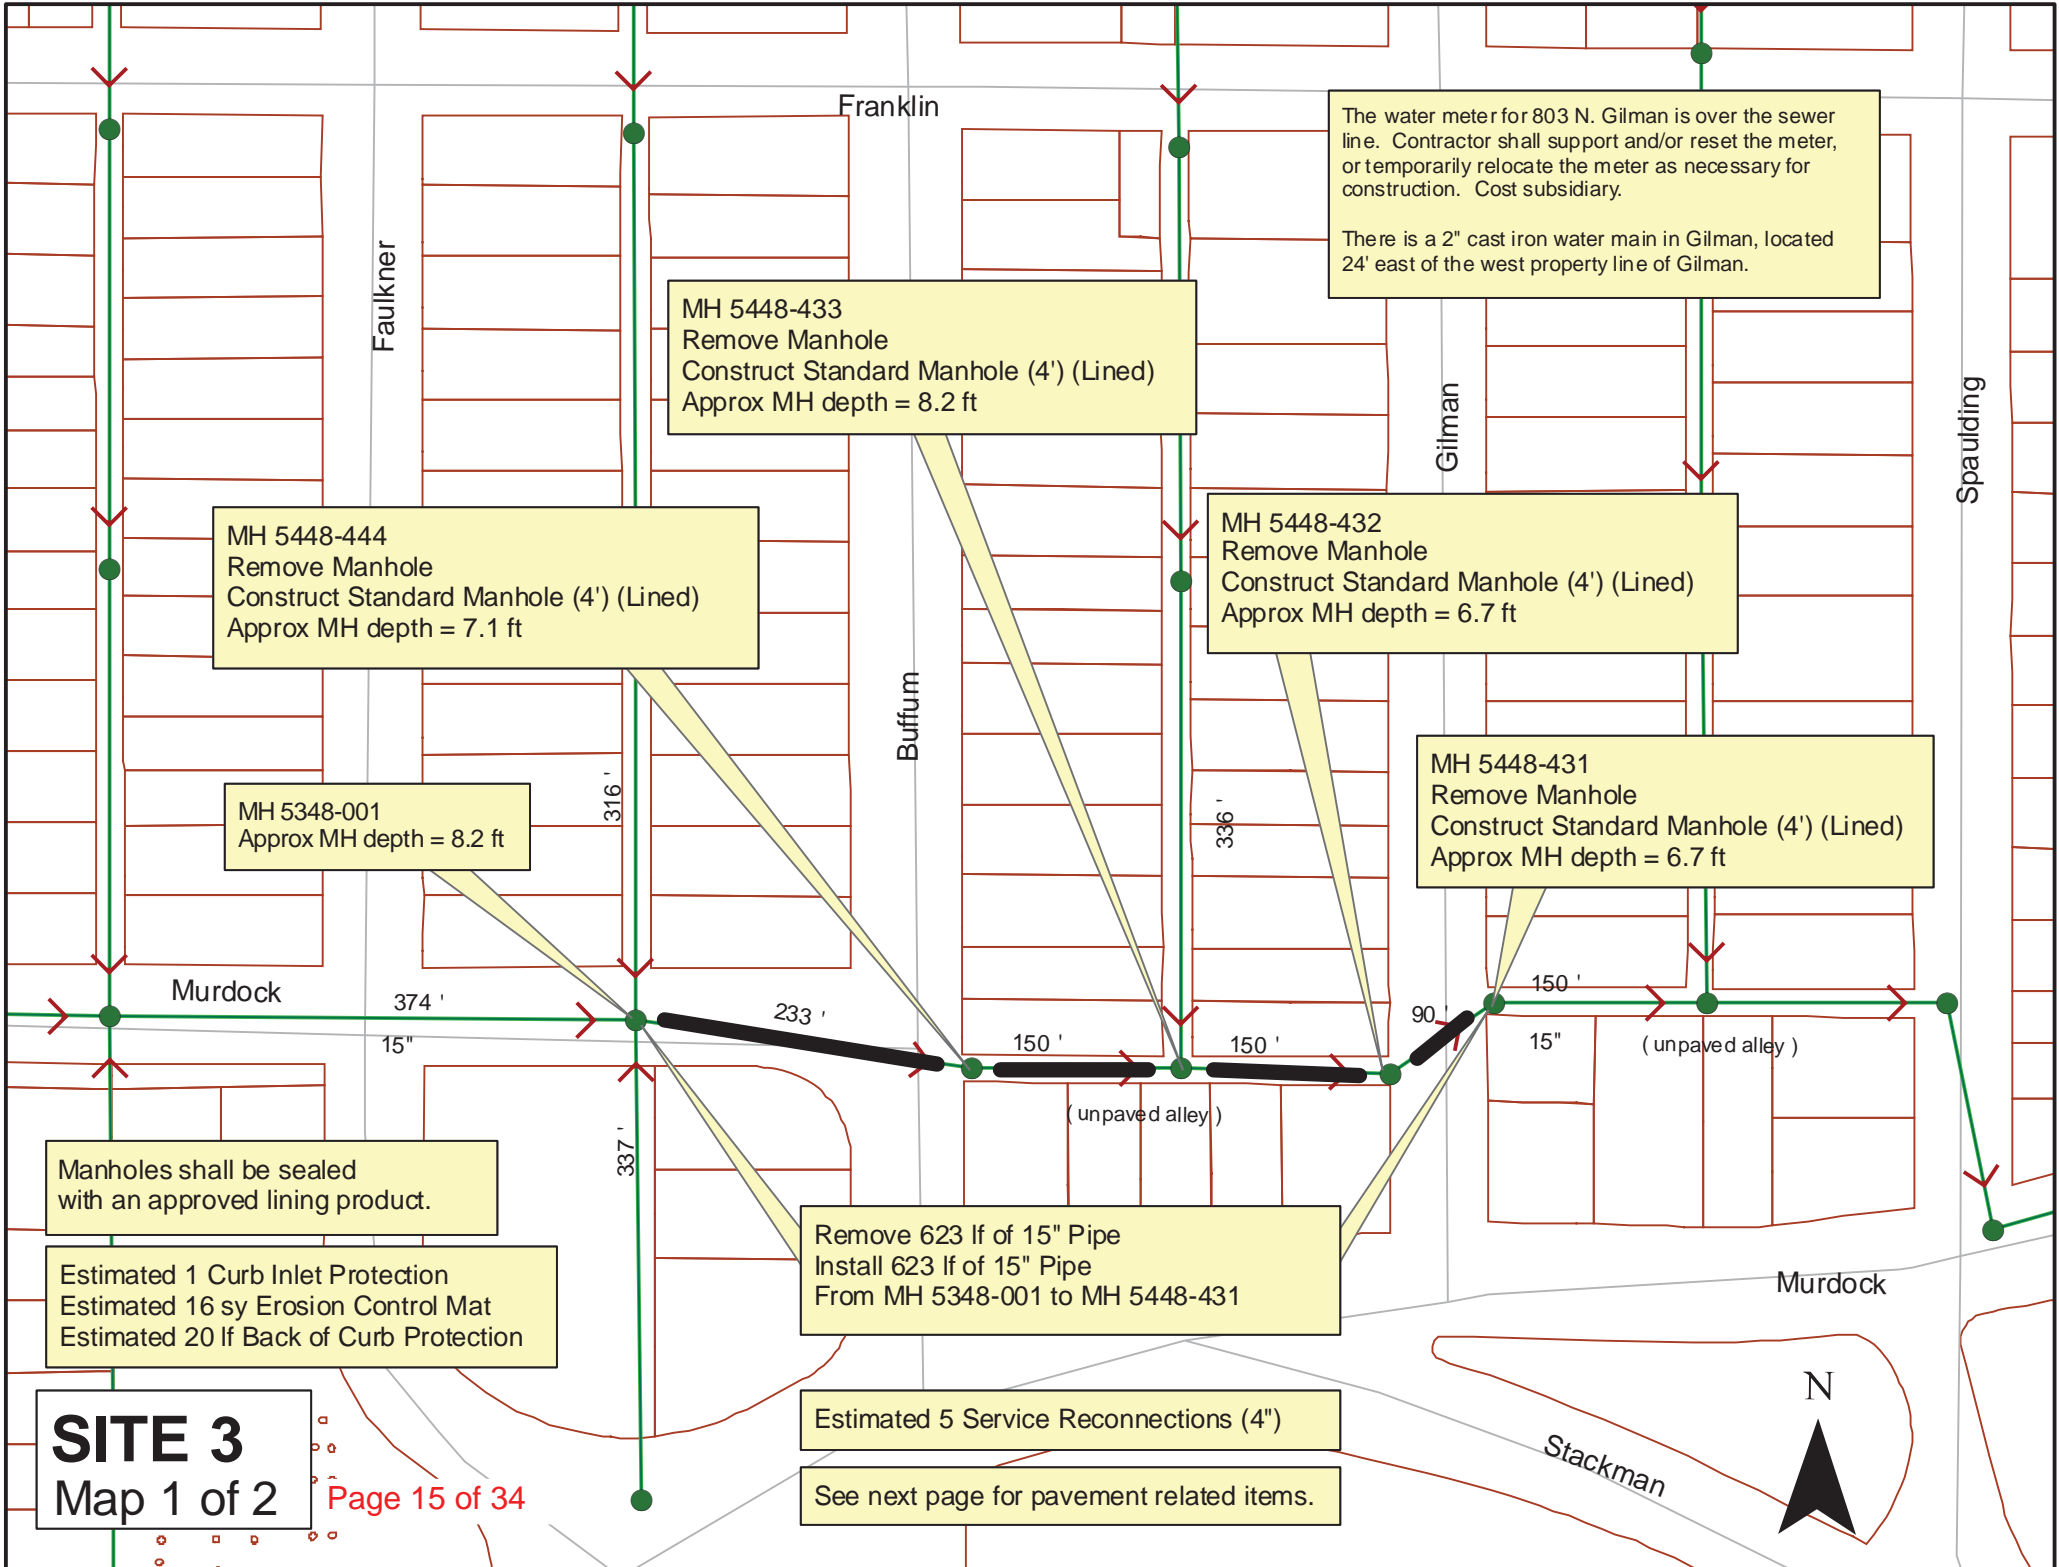
Estimated 5 Service Reconnections (4")

The water meter for 803 N. Gilman is over the sewer line. Contractor shall support and/or reset the meter, or temporarily relocate the meter as necessary for construction. Cost subsidiary.

There is a 2" cast iron water main in Gilman, located 24' east of the west property line of Gilman.

MH 5448-444
Remove Manhole
Construct Standard Manhole (4') (Lined)
Approx MH depth = 7.1 ft

MH 5448-433
Remove Manhole
Construct Standard Manhole (4') (Lined)
Approx MH depth = 8.2 ft

MH 5448-432
Remove Manhole
Construct Standard Manhole (4') (Lined)
Approx MH depth = 6.7 ft

MH 5448-431
Remove Manhole
Construct Standard Manhole (4') (Lined)
Approx MH depth = 6.7 ft

MH 5348-001
Approx MH depth = 8.2 ft

Manholes shall be sealed with an approved lining product.

Estimated 1 Curb Inlet Protection
Estimated 16 sy Erosion Control Mat
Estimated 20 lf Back of Curb Protection
