SITE 6

Sheet 27 of 42

Video Inspection Master Report

US Structure: 5747-146 158 N ROOSEVELT ST Date Insp: 4/12/2010 Basin: EC01G
 DS Structure: 5747-145 149 N QUENTIN AVE Dir Televised: Upstream To Downstream

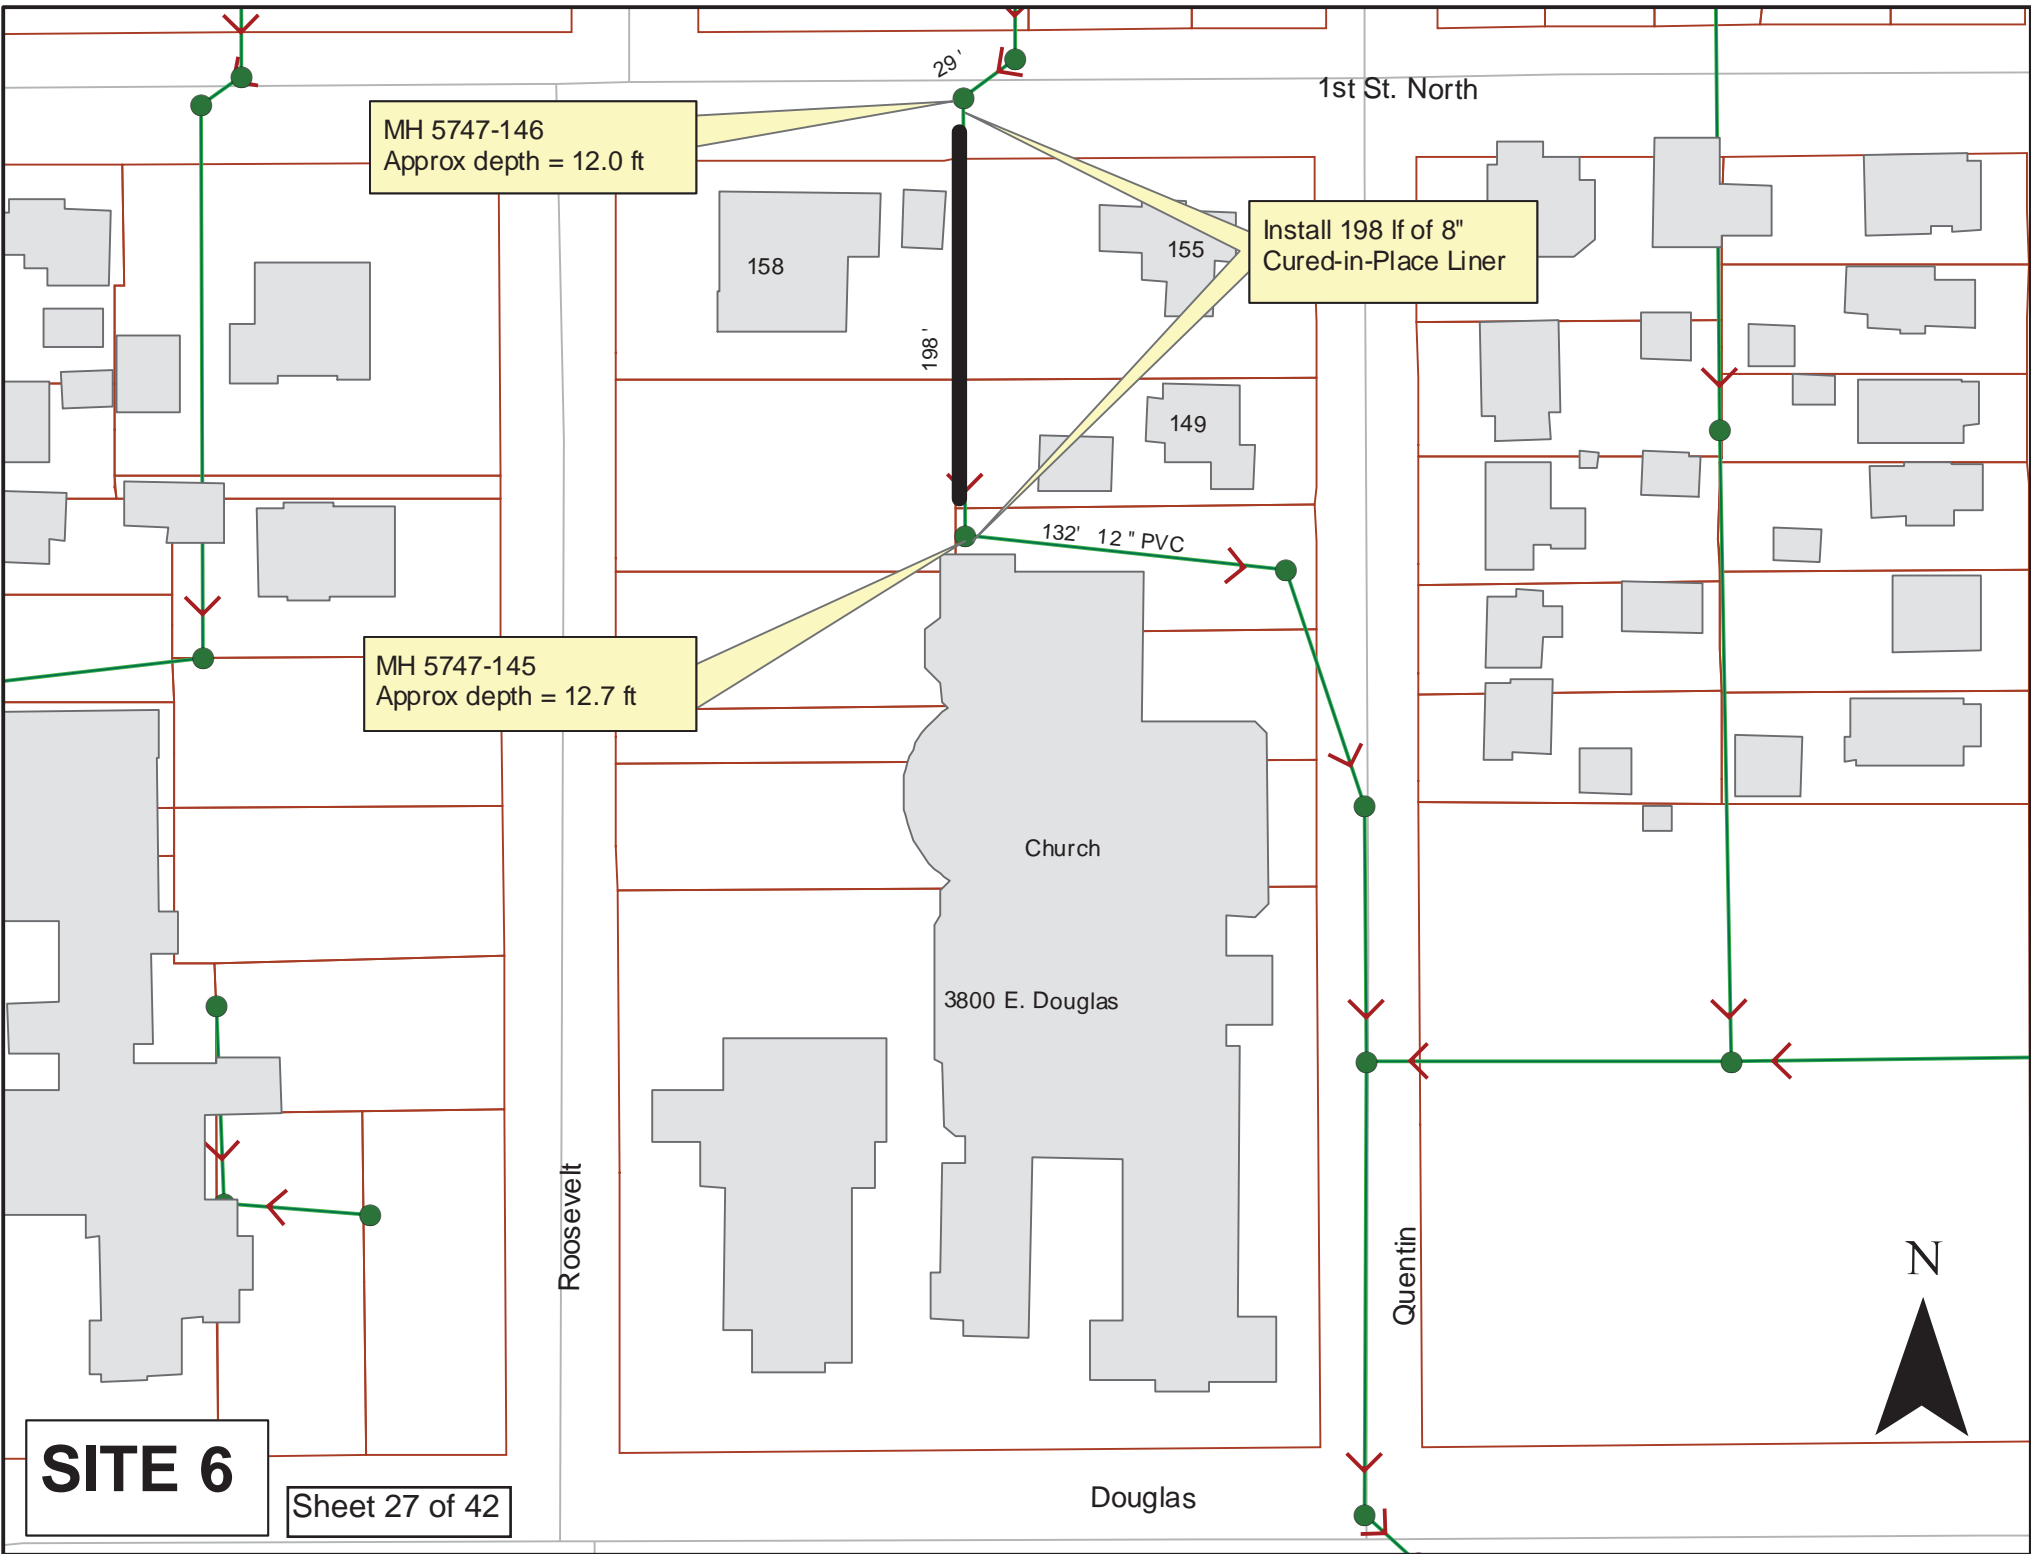
Shape: Round Length Status: Record Drawings
 Dia/Ht: 8 Material: VCP Project No. : C-104
 Length: 198.0 Slope: 0.400 DVD #0570 Index:
