**SITE 3**

# Television Inspection Master Report

US Structure: 5747-448      4719      LEWIS ST      Date Insp: 2/13/2008      Basin: E04C  
 DS Structure: 5747-447      414      DELLROSE ST      Dir Televised:      Upstream To Downstream

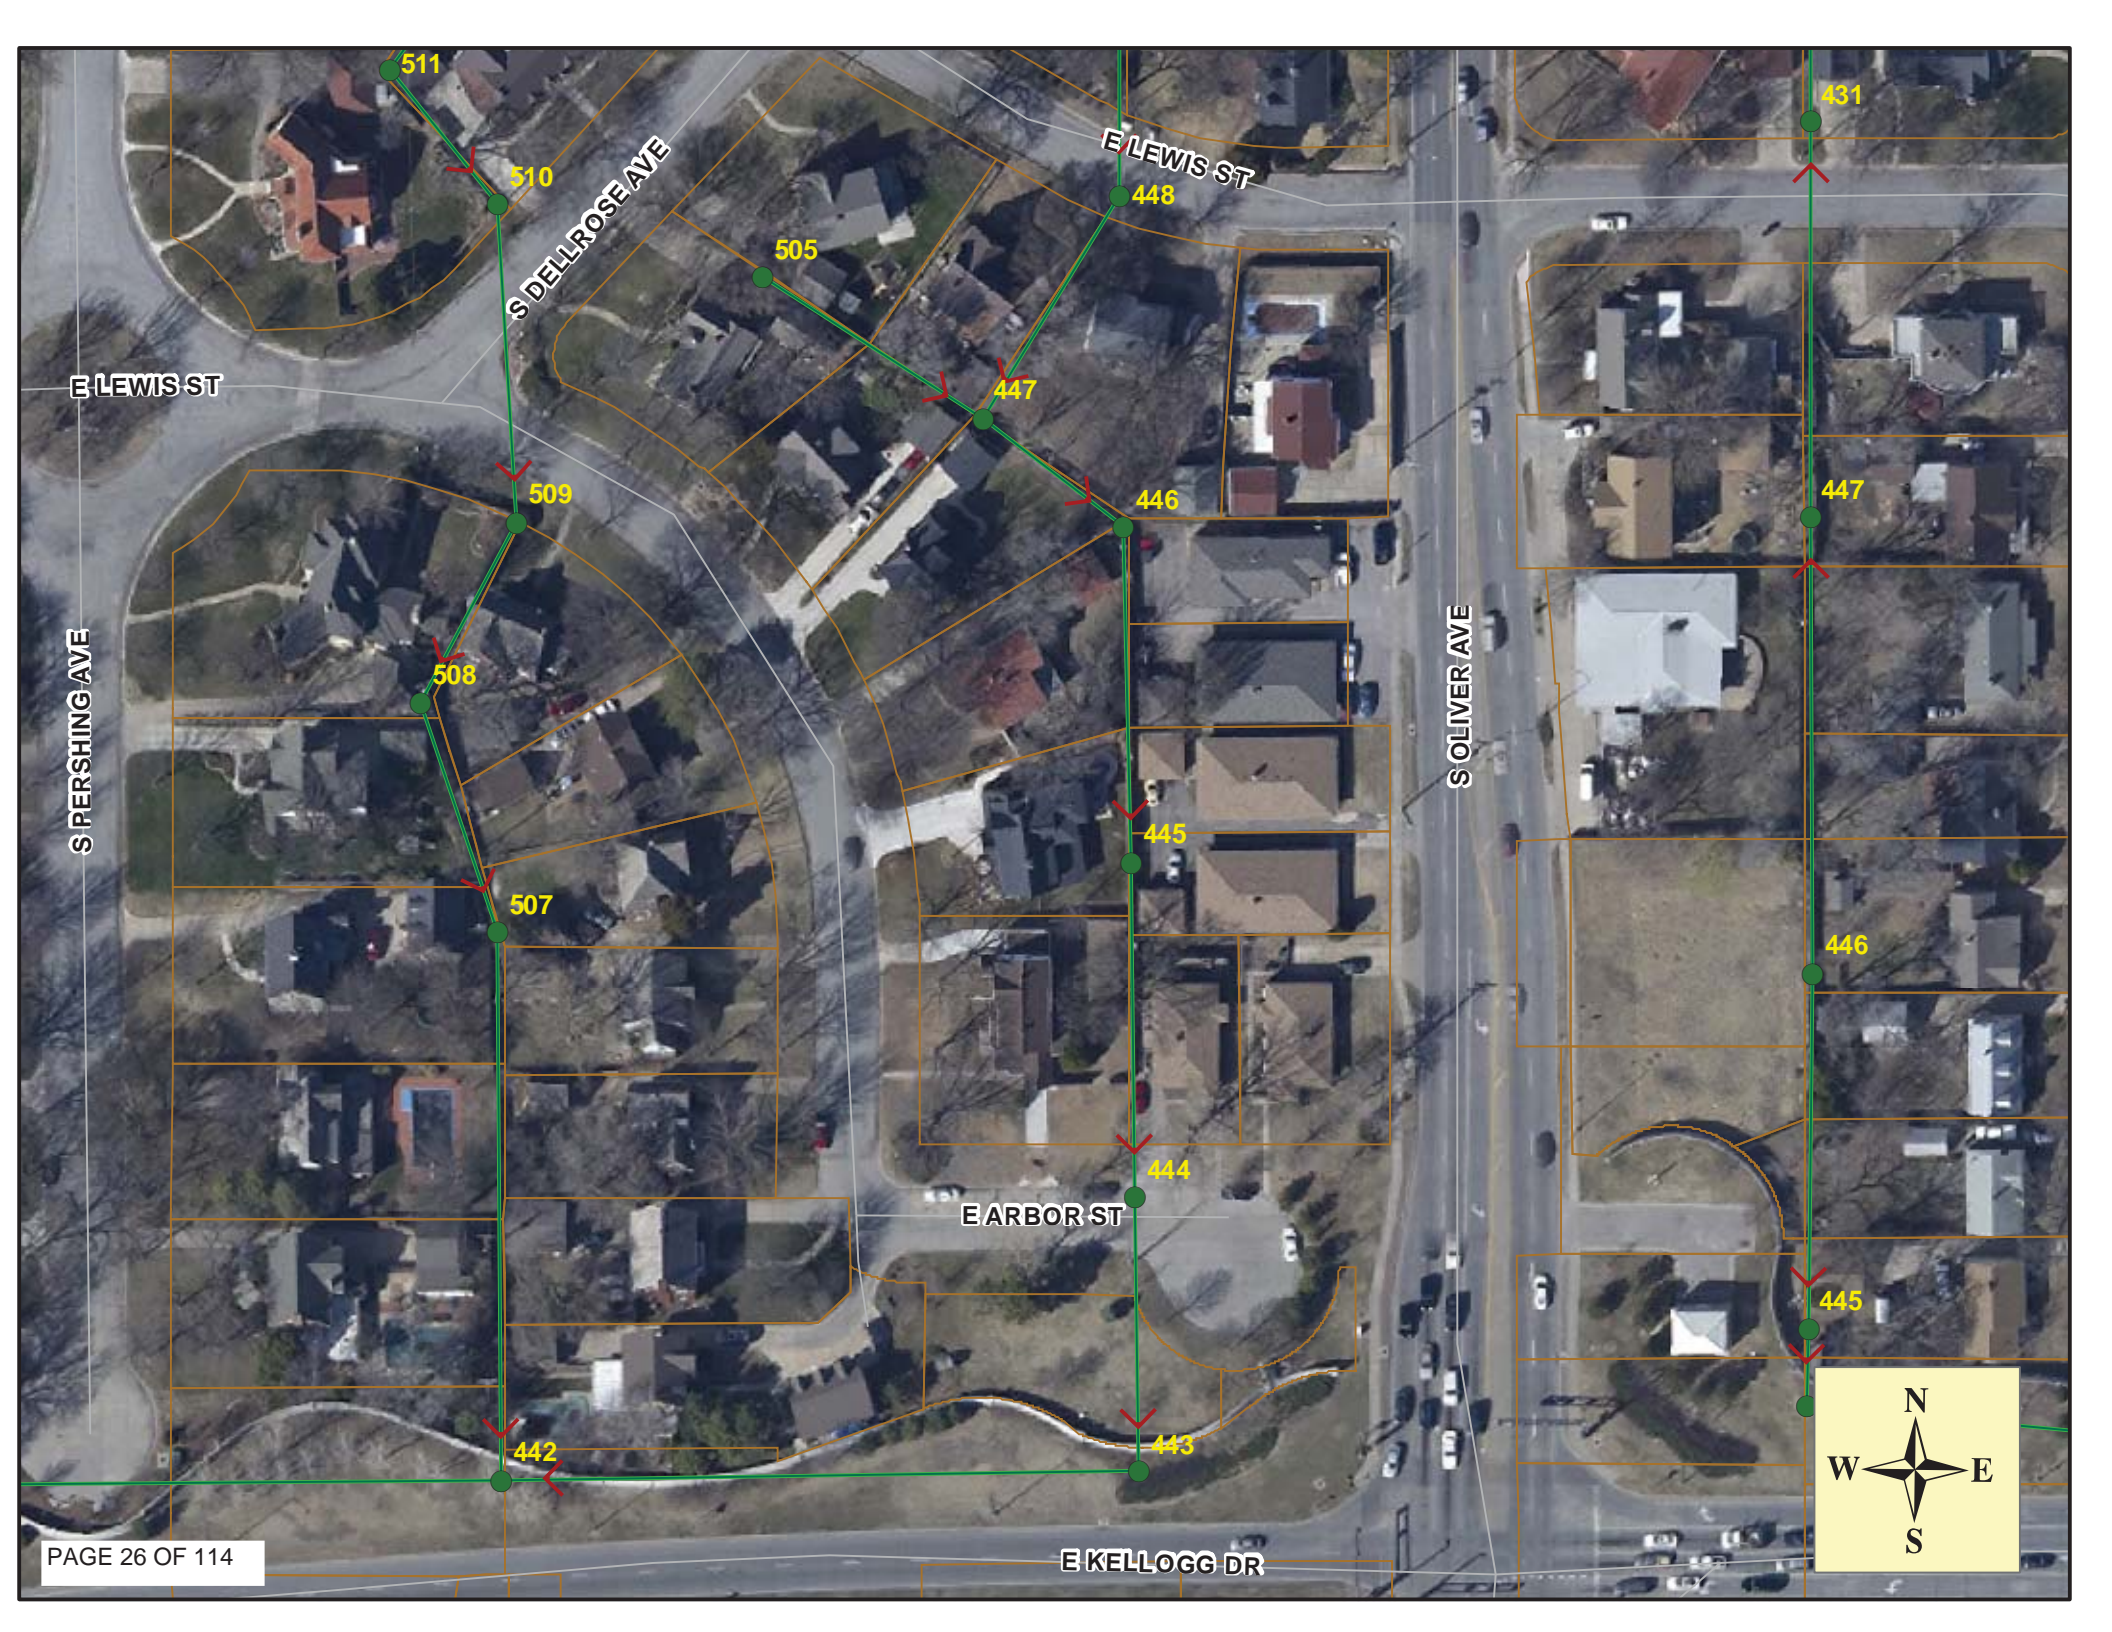
Shape: Round      Length Status:      Project No. : C-037  
 Dia/Ht: 8      Material: VCP      Index:  
 Length: 125.3      Slope: 0.002      Surface:

Obs. #	VTR	Counter	Distance	Location	Description	Rating	Ratings		
							Obsrvd (gpm)	Est. (gpm)	Struct Clean
1			0.0	US Manhole	5747-448	1	0.000	0	0.000
2			4.2	Upper Left	Crack-Horizontal	3	0.004	5	0.004
3			5.2	Upper Left	Crack-Radial	3	0.004	5	0.004
4			11.9	Lower Left	Crack-Horizontal	3	0.004	5	0.004
5			14.1	Crown	Crack-Horizontal	3	0.004	5	0.004
6			16.8	Lower Left	Crack-Radial	3	0.004	5	0.004
7			30.2	West	Wye Service			SEALED OFF4" Clay Wye Connection	
8			32.9	East	Wye Service			SEALED OFF4" Clay Wye Connection	
9			41.6	Lower Left	MINERAL DEPOSIT IN JOINT				
10			51.8	Lower Left	MINERAL DEPOSITS IN JOINT				
11			54.3	Lower Left	MINERAL DEPOSITS IN JOINT				
12			55.4	West	Wye Service			SEALED OFF 4" Clay Wye Connection	
13			56.8	Lower Left	MINERAL DEPOSITS IN JOINT				
14			58.1	East	Wye Service			SEALED OFF4" Clay Wye Connection	
15			59.4	Lower Left	MINERAL DEPOSITS IN JOINT				
16			61.8	Lower Left	MINERAL DEPOSITS IN JOINT
