Sims Park Golf Course

SITE 3

Video Inspection Master Report

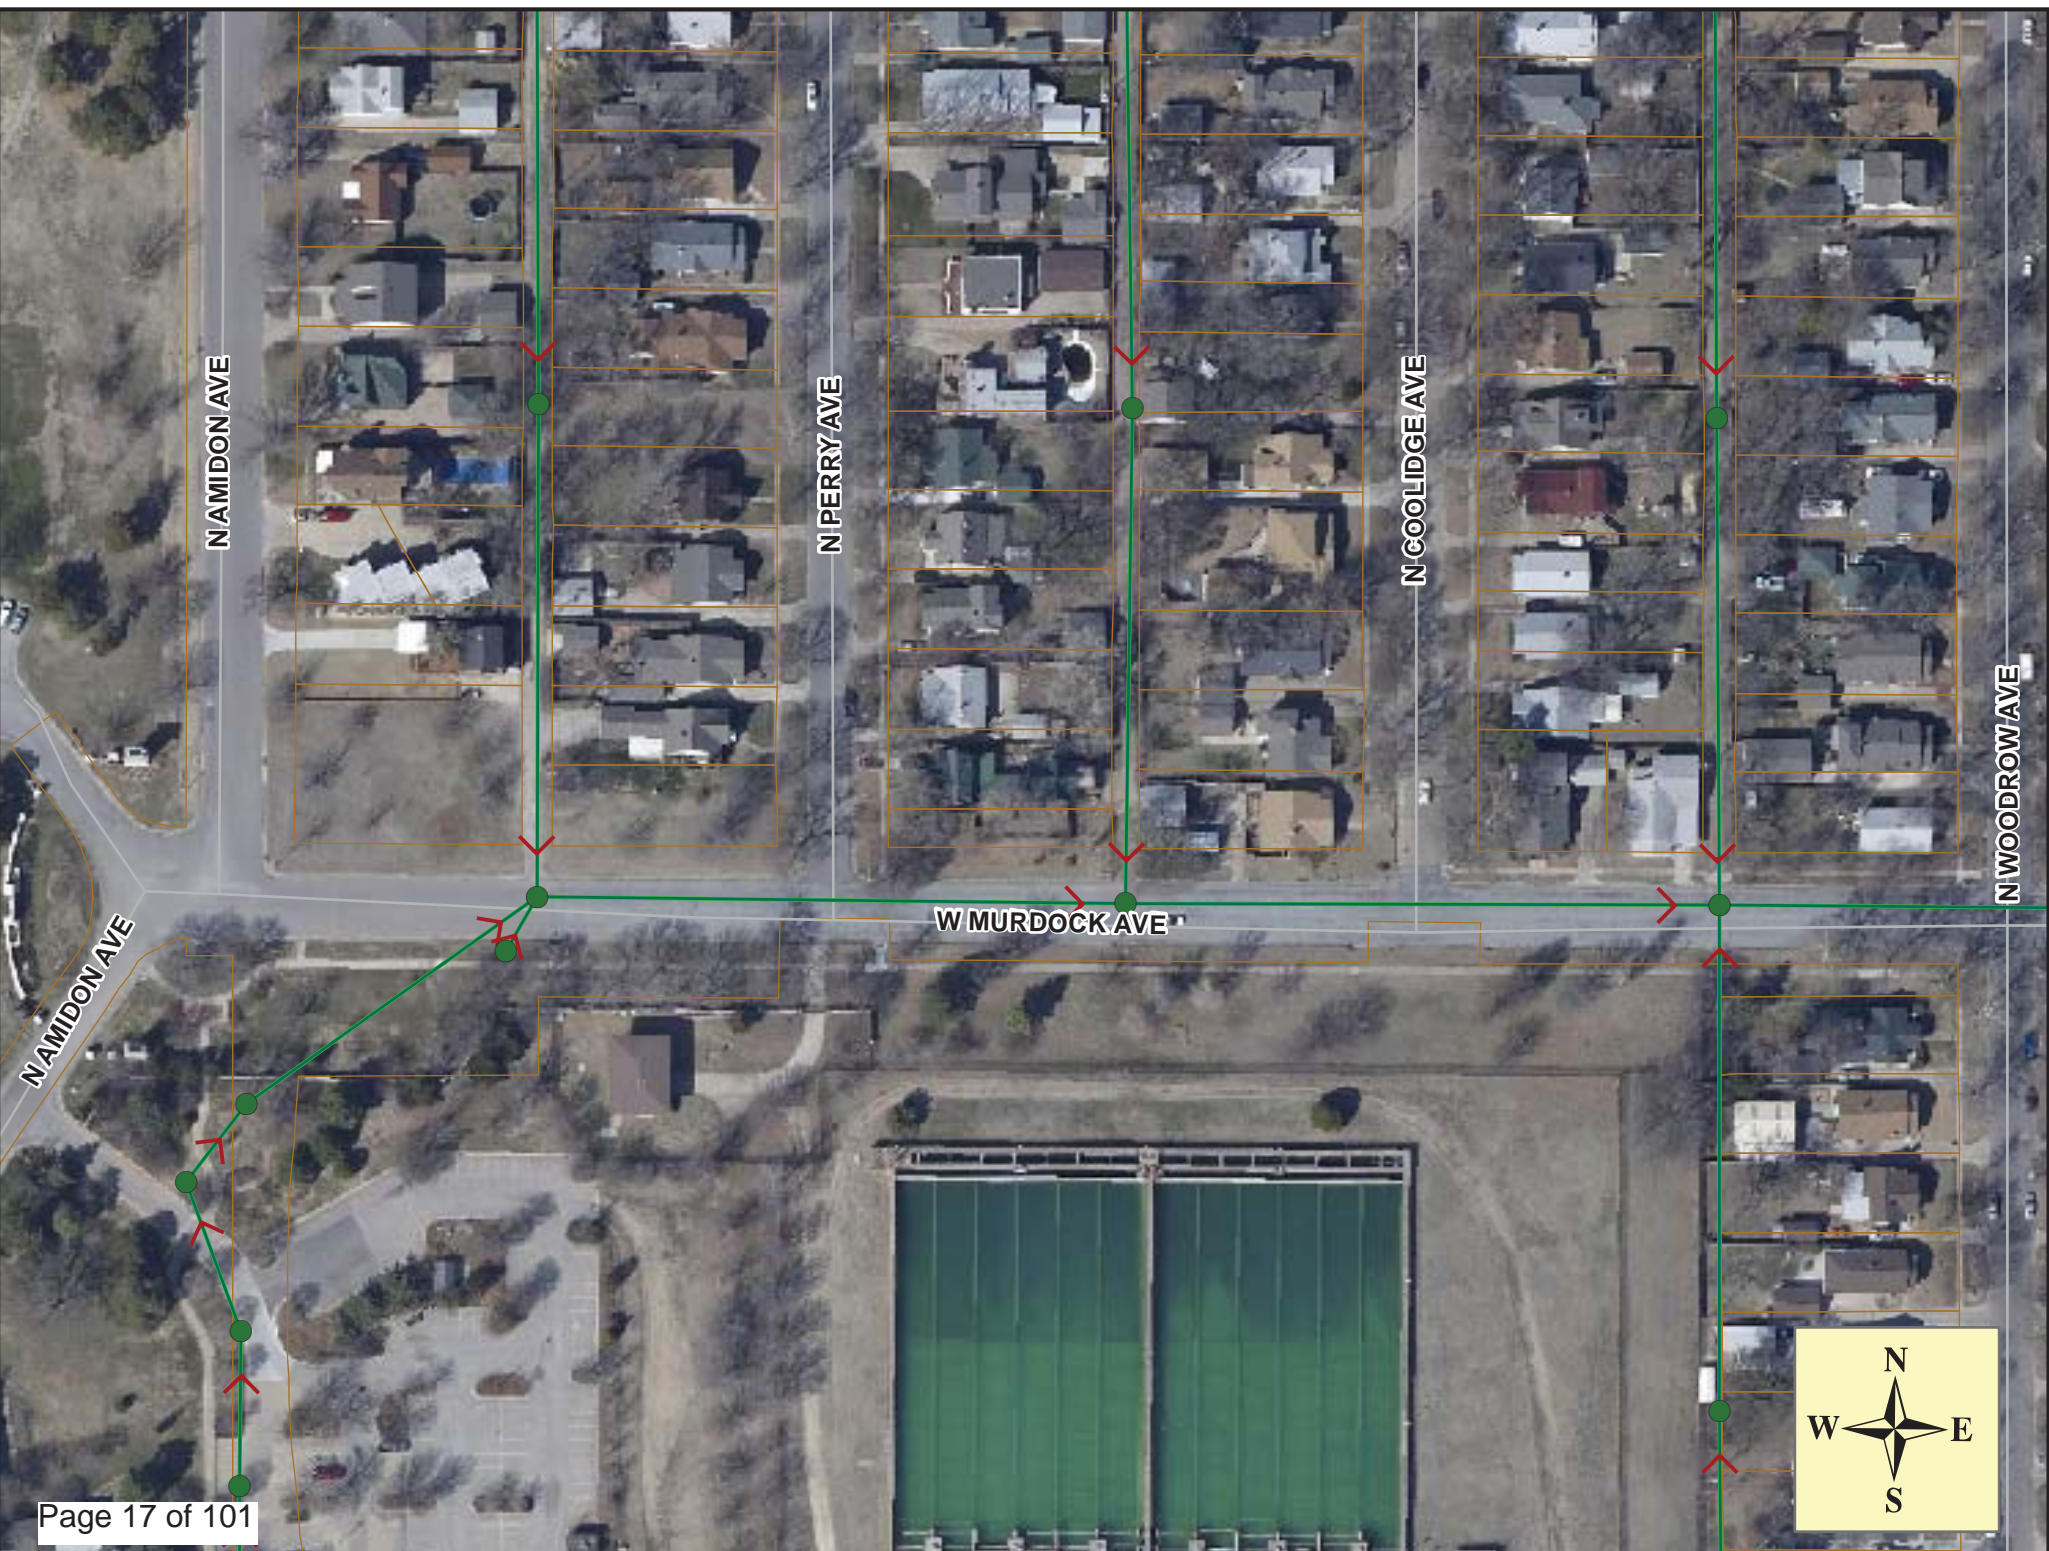
Install 308 lf of 8" Cured-in-Place Liner

Install 305 lf of 8" Cured-in-Place Liner

MH 5348-055
Approx. MH depth = 6.2 ft

MH 5348-091
Approx. MH depth = 7.3 ft

MH 5348-006
Est. MH depth = 6.2 ft

MH 5348-005
Approx. MH depth = 6.2 ft

MH 5348-007
Est. MH depth = 4.8 ft

Install 740 lf of 10" Cured-in-Place Liner
