SITE 3

Sheet 12 of 22

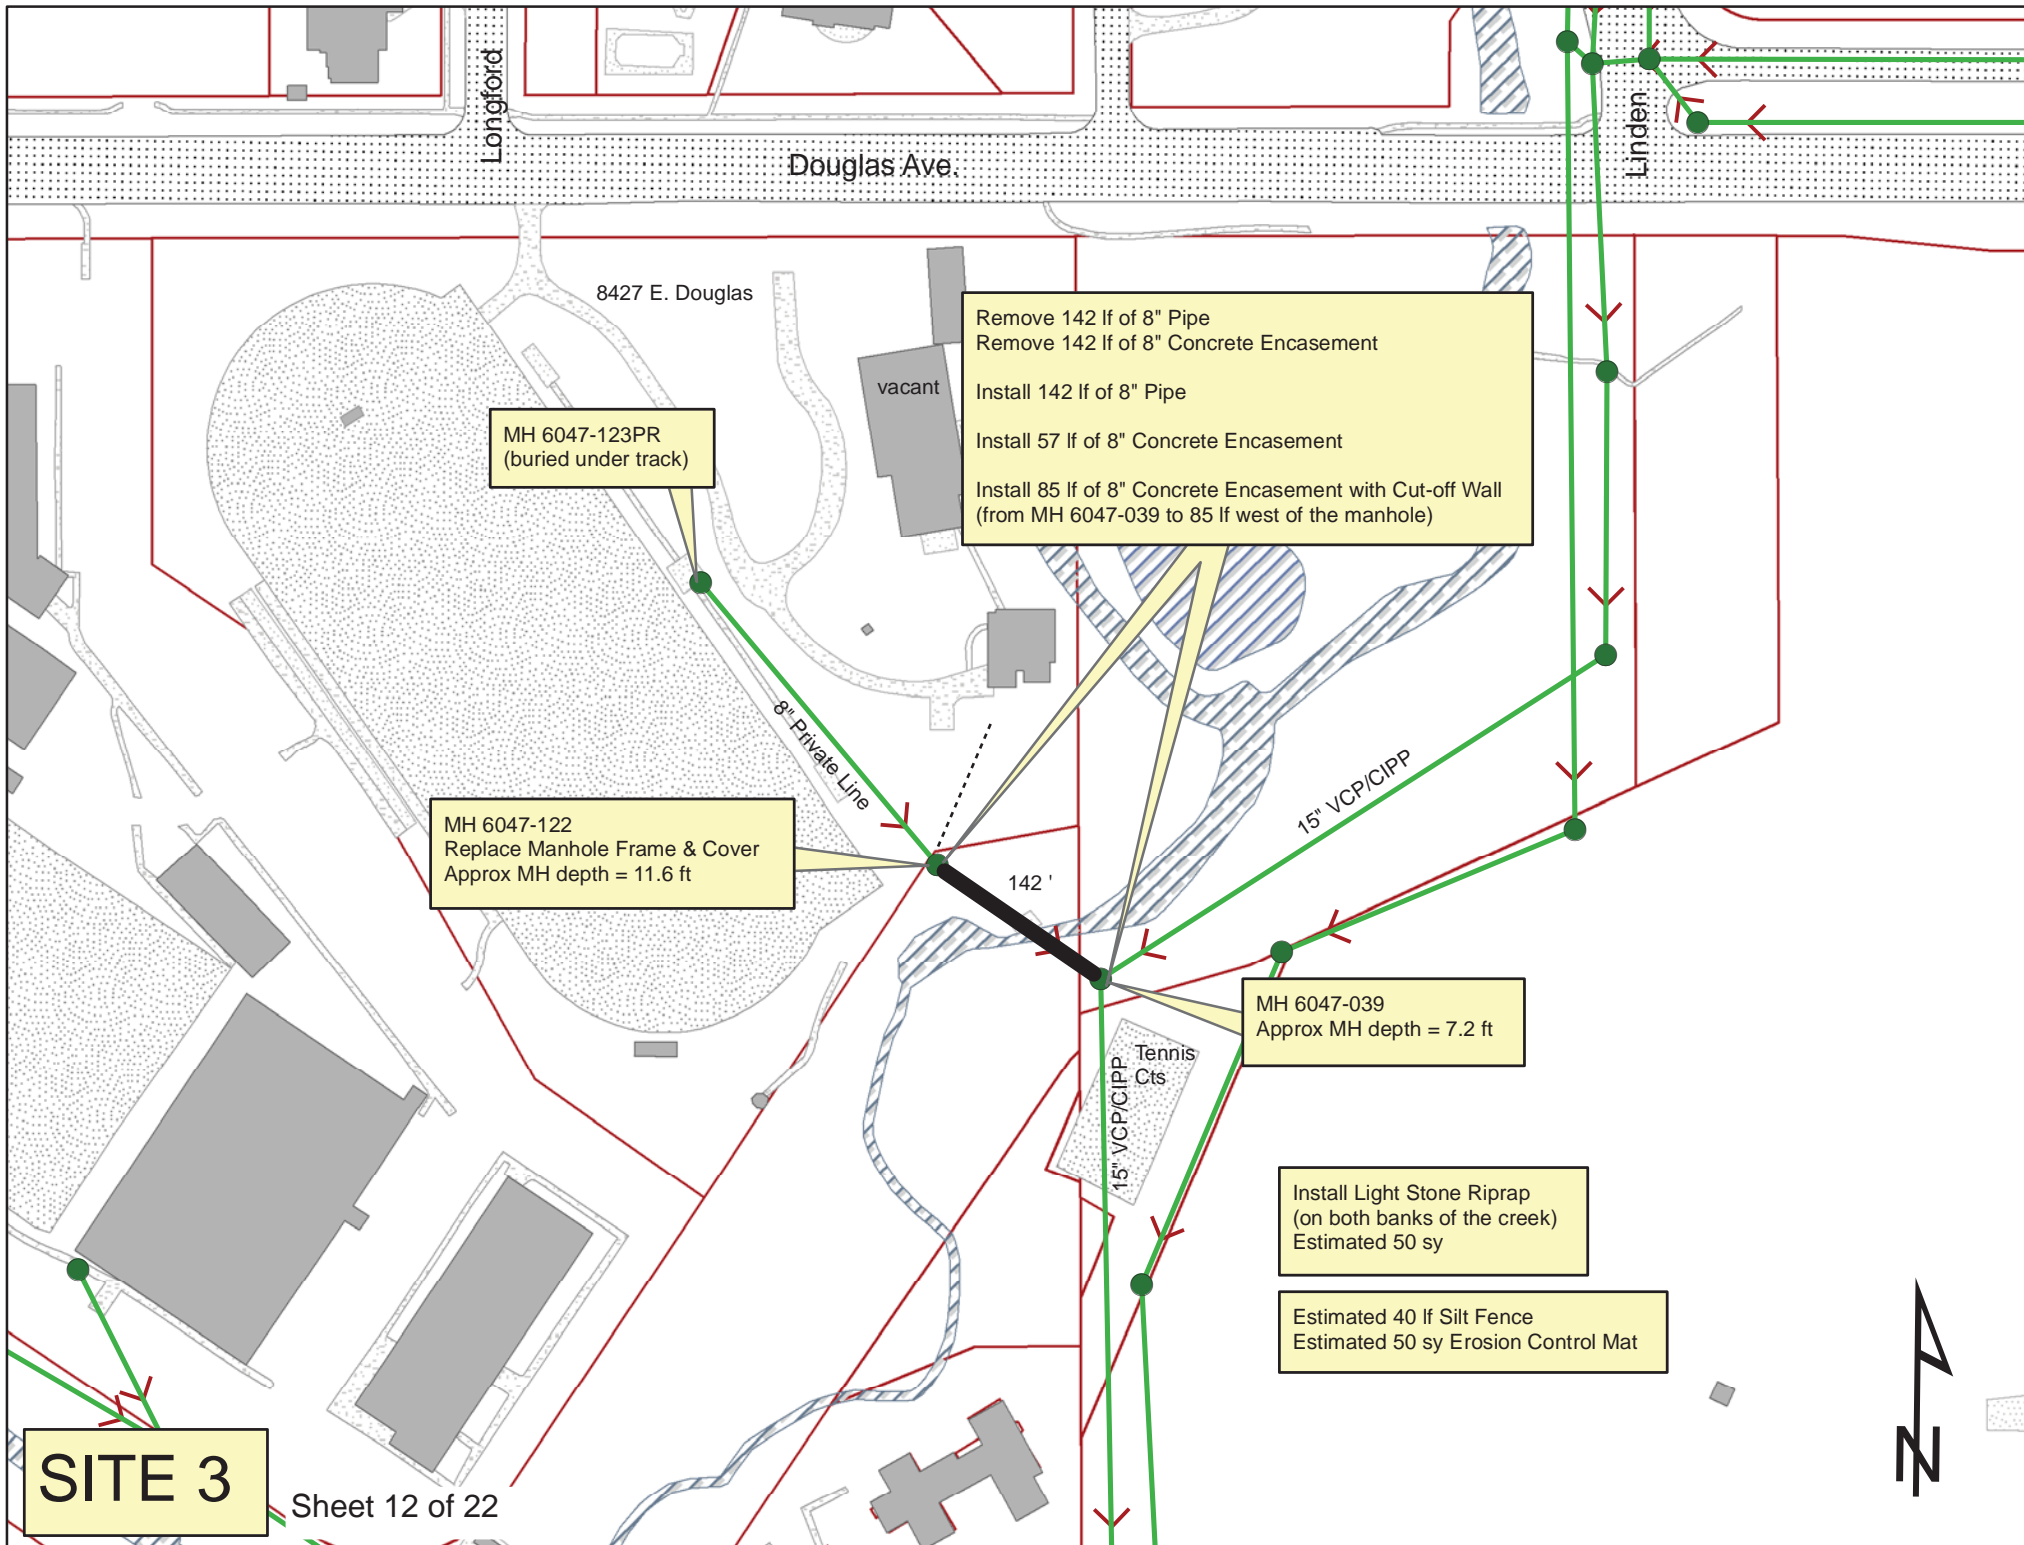
Remove 142 lf of 8" Pipe
Remove 142 lf of 8" Concrete Encasement
Install 142 lf of 8" Pipe
Install 57 lf of 8" Concrete Encasement
Install 85 lf of 8" Concrete Encasement with Cut-off Wall
(from MH 6047-039 to 85 lf west of the manhole)

MH 6047-122
Replace Manhole Frame & Cover
Approx MH depth = 11.6 ft

MH 6047-039
Approx MH depth = 7.2 ft

Install Light Stone Riprap
(on both banks of the creek)
Estimated 50 sy

Estimated 40 lf Silt Fence
Estimated 50 sy Erosion Control Mat

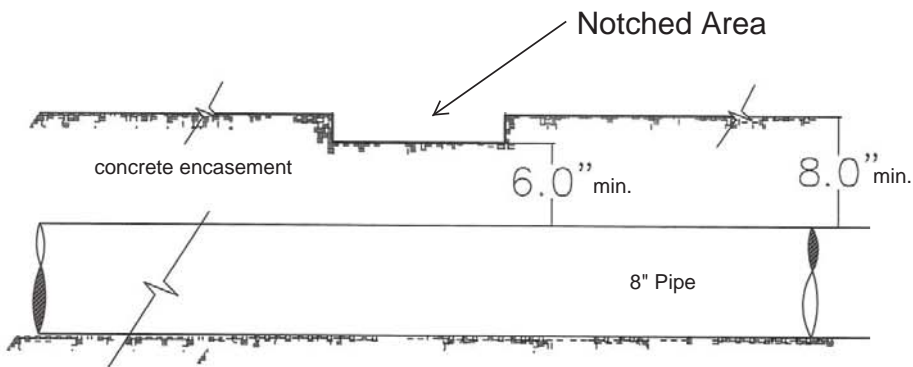
CONCRETE ENCASEMENT FRONT VIEW THROUGH CREEK

Concrete encasement shall be formed with a notched out area, centered on the creek. The depth of the notched area shall be two inches lower than the minimum 8" height of the encasement. The width of the notched area shall be 1/3 the width of the channel, or approx. 15 ft wide.

The original sewer plan is enclosed in this project. There is no indication that there is an existing cutoff wall at the creek.

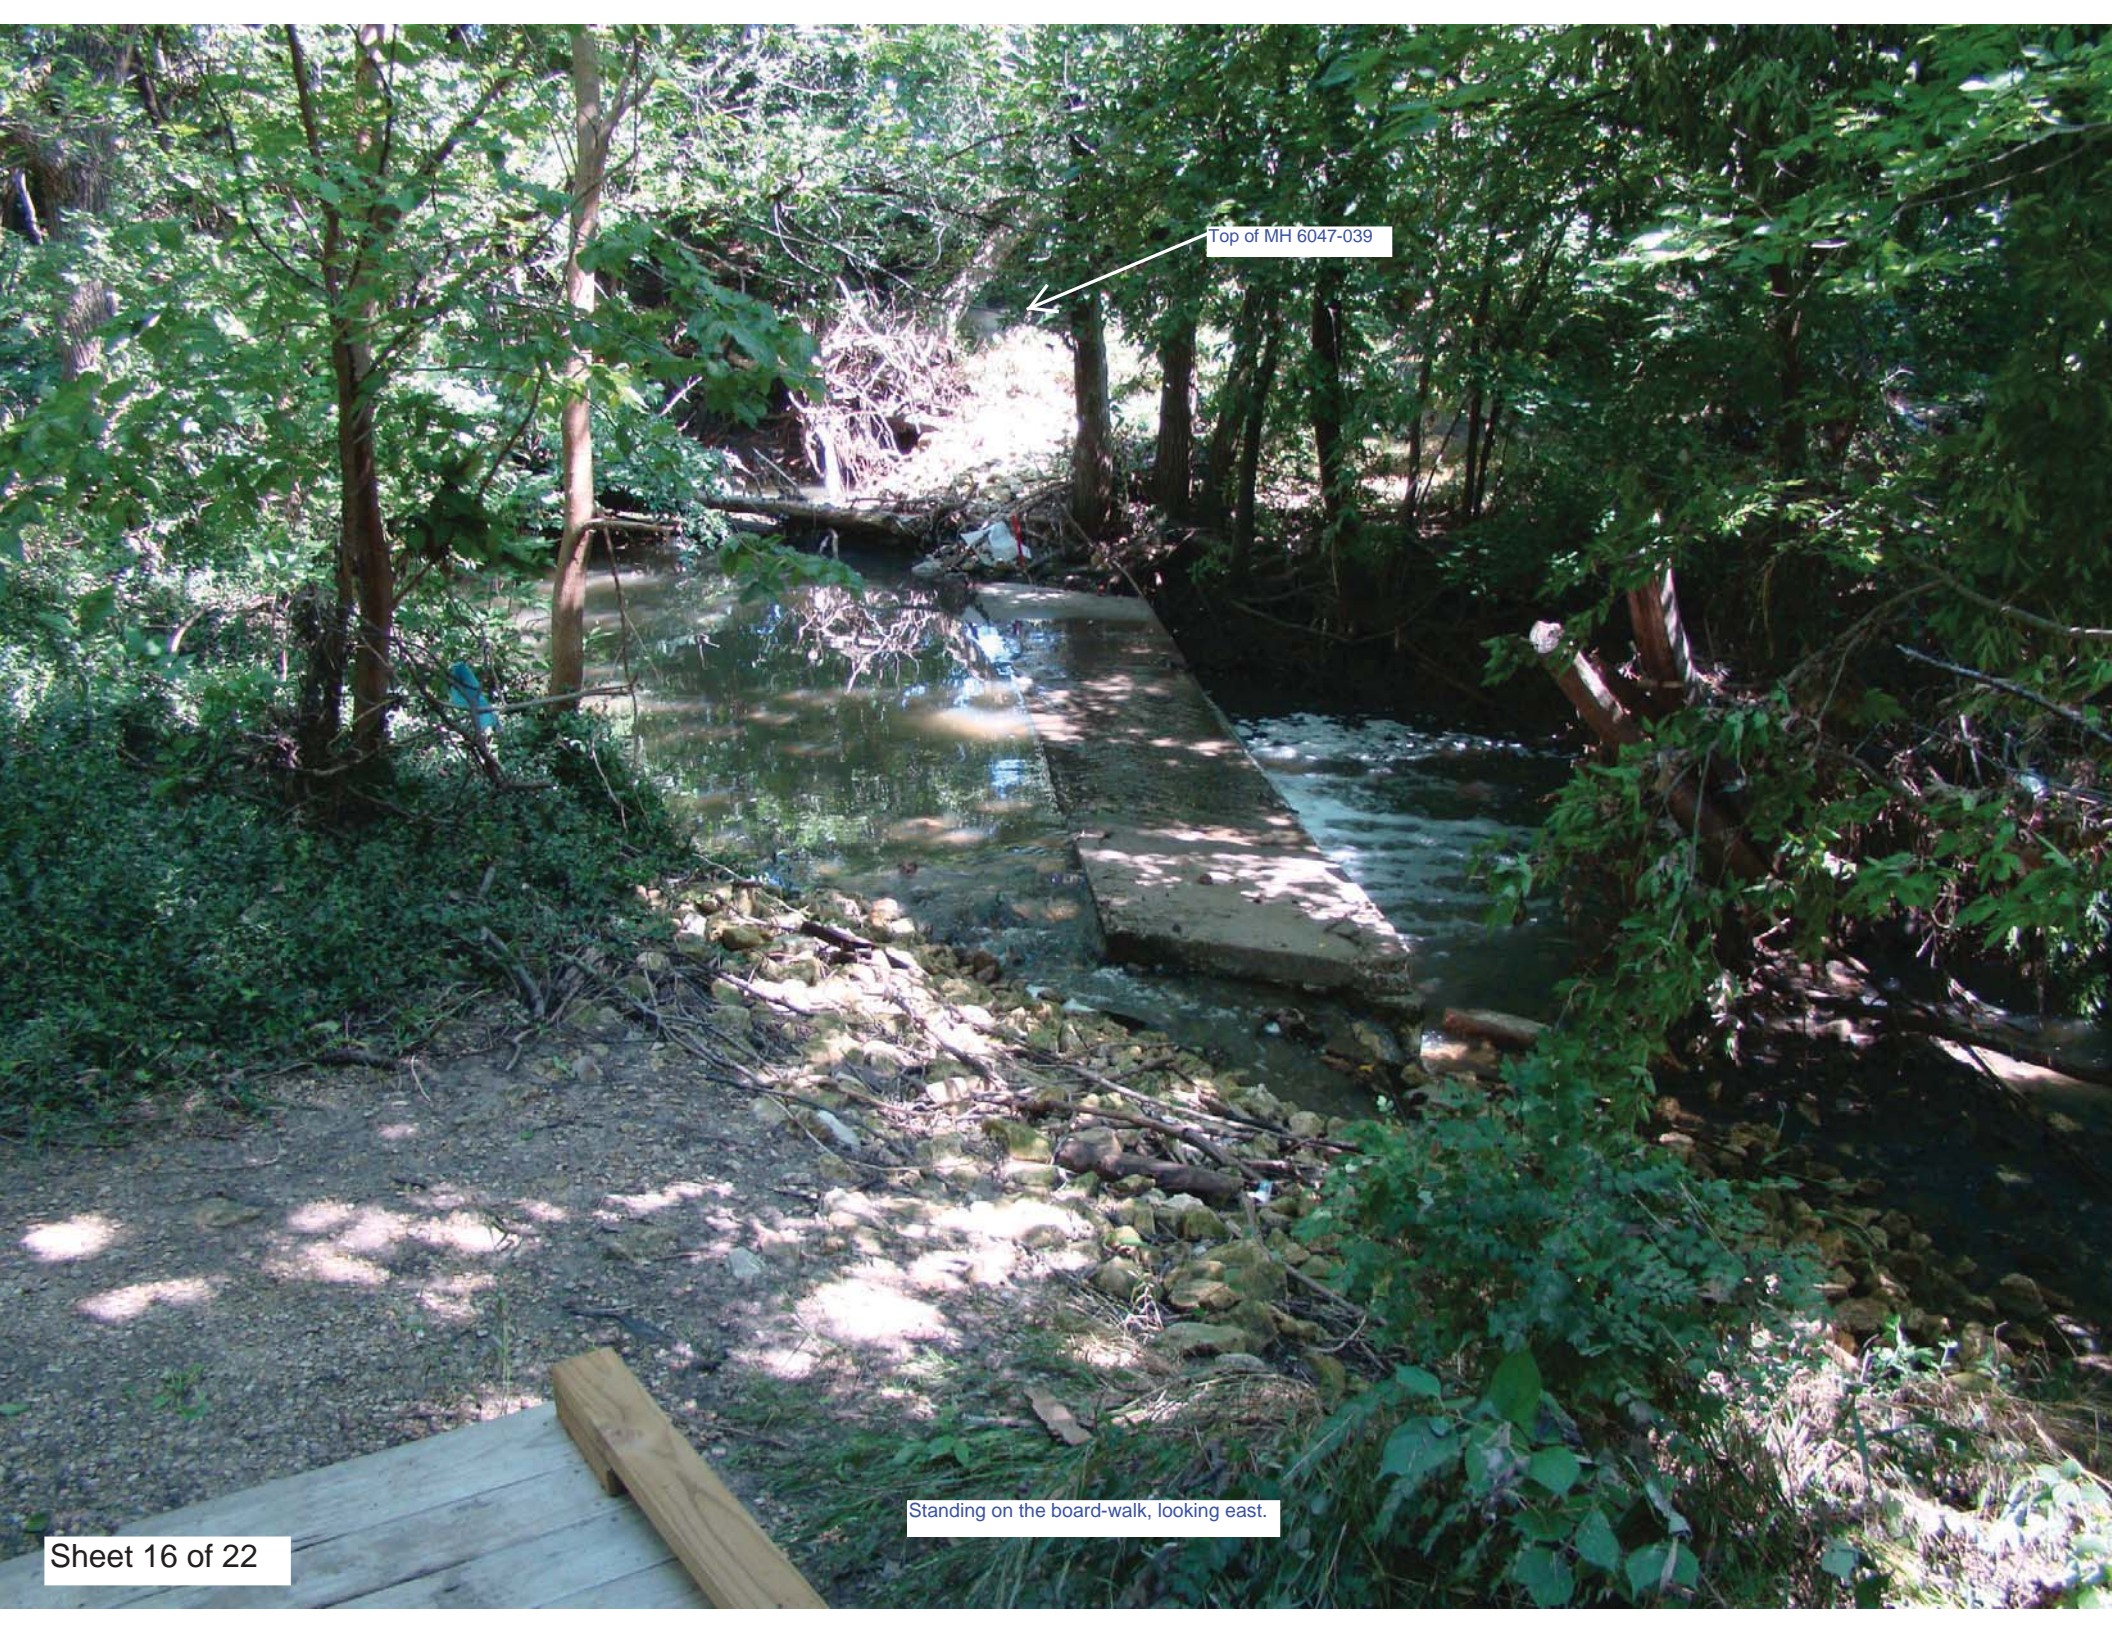
Top of MH 6047-039

Standing on the board-walk, looking east.

There is a board-walk constructed over the sewer line on the west bank. Contractor shall remove and reassemble the board-walk with associated costs to be subsidiary to Site Restoration.

A site picture is enclosed in this project but contractors should look at the site prior to bidding.
