**45TH & HILLSIDE  
 INTERSECTION IMPROVEMENT**  
 WICHITA, KANSAS

PROJ NO: 87 N-0616-01	
SCALE: 1"=20'	
DATE: 10/9/2017	
DESIGNED BY: TAU	
DRAWN BY: TAU	
CHECKED BY: MDB	
SHEET TITLE:	
<b>HILLSIDE AVE.    PLAN &amp; PROFILE</b>	
STA. 114+10.12 TO STA. 119+00.00	
SHEET NO.	
14	
SHEET 14 OF 166

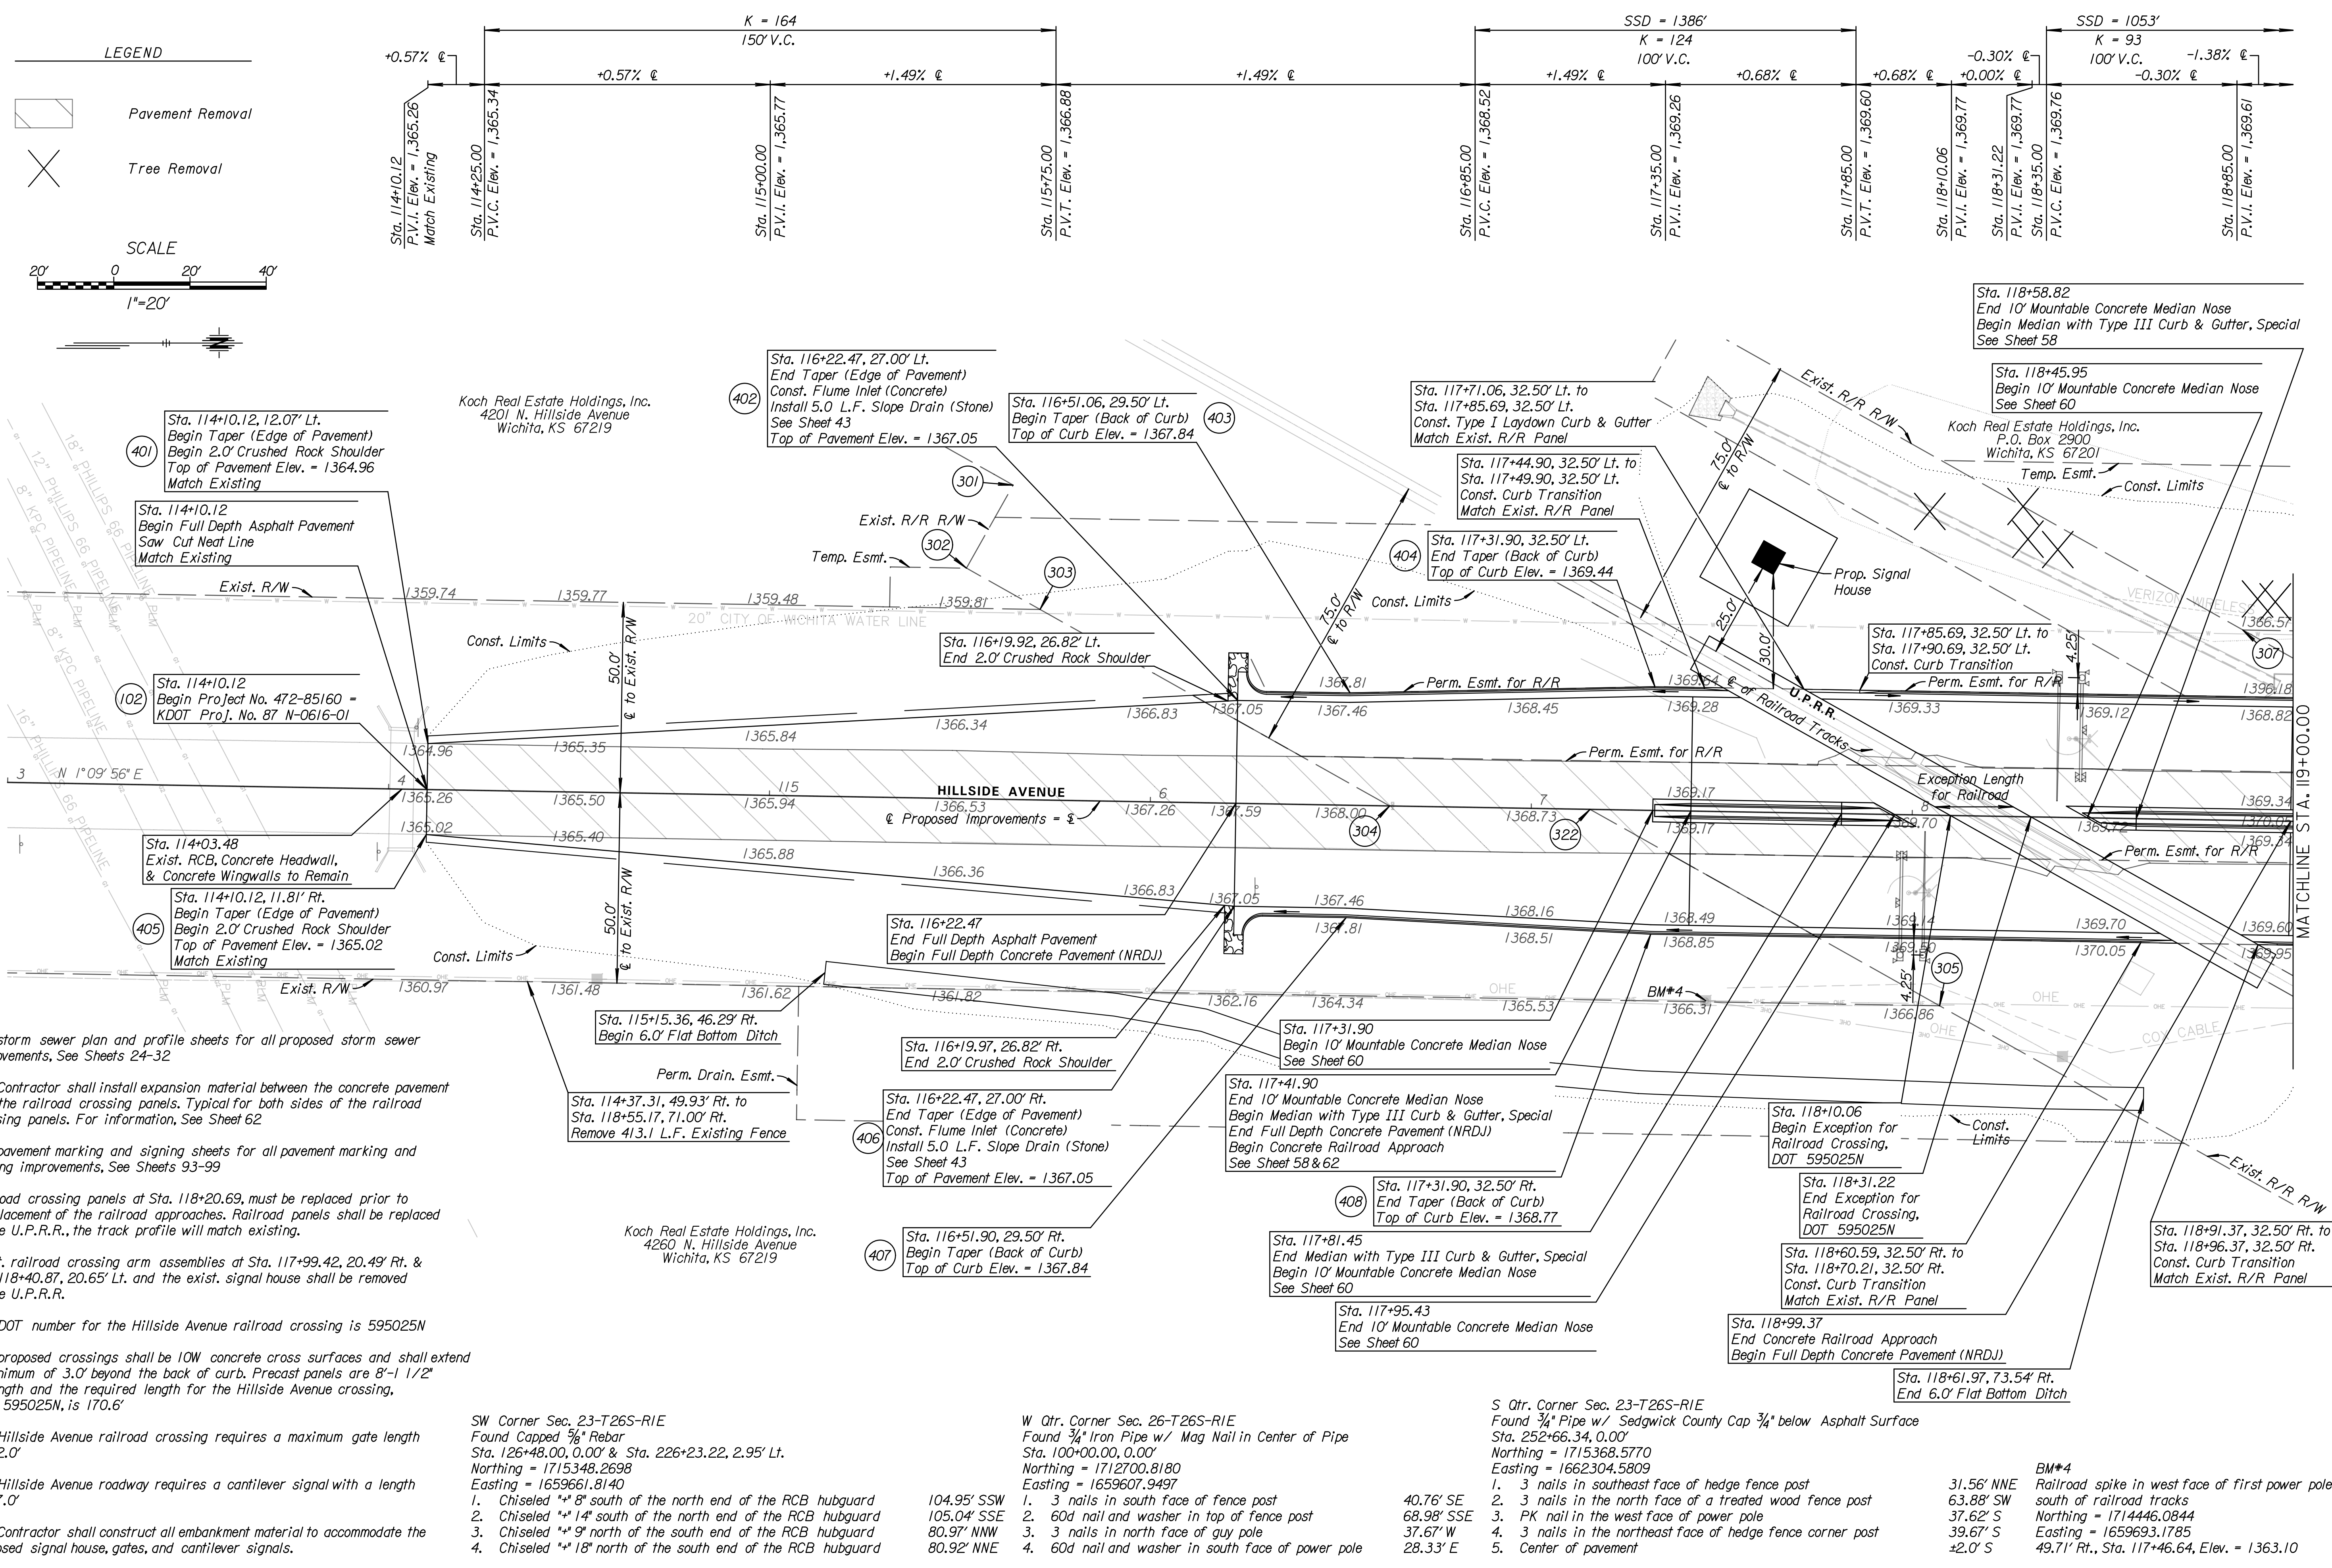
The Contractor shall install expansion material between the concrete pavement and the railroad crossing panels. Typical for both sides of the railroad crossing panels. For information, See Sheet 62

Railroad crossing panels at Sta. 118+20.69, must be replaced prior to the placement of the railroad approaches. Railroad panels shall be replaced by the U.P.R.R., the track profile will match existing.

Exist. railroad crossing arm assemblies at Sta. 117+99.42, 20.49' Rt. & Sta. 118+40.87, 20.65' Lt. and the exist. signal house shall be removed by the U.P.R.R.

The proposed crossings shall be 10W concrete cross surfaces and shall extend a minimum of 3.0' beyond the back of curb. Precast panels are 8'-1 1/2' in length and the required length for the Hillside Avenue crossing, DOT 595025N, is 170.6'

The Hillside Avenue railroad crossing requires a maximum gate length of 32.0'

The Hillside Avenue roadway requires a cantilever signal with a length of 27.0'

The Contractor shall construct all embankment material to accommodate the proposed signal house, gates, and cantilever signals.
