SITE 4

Estimated 3 Service Reconnections (4")

Video Inspection Master Report

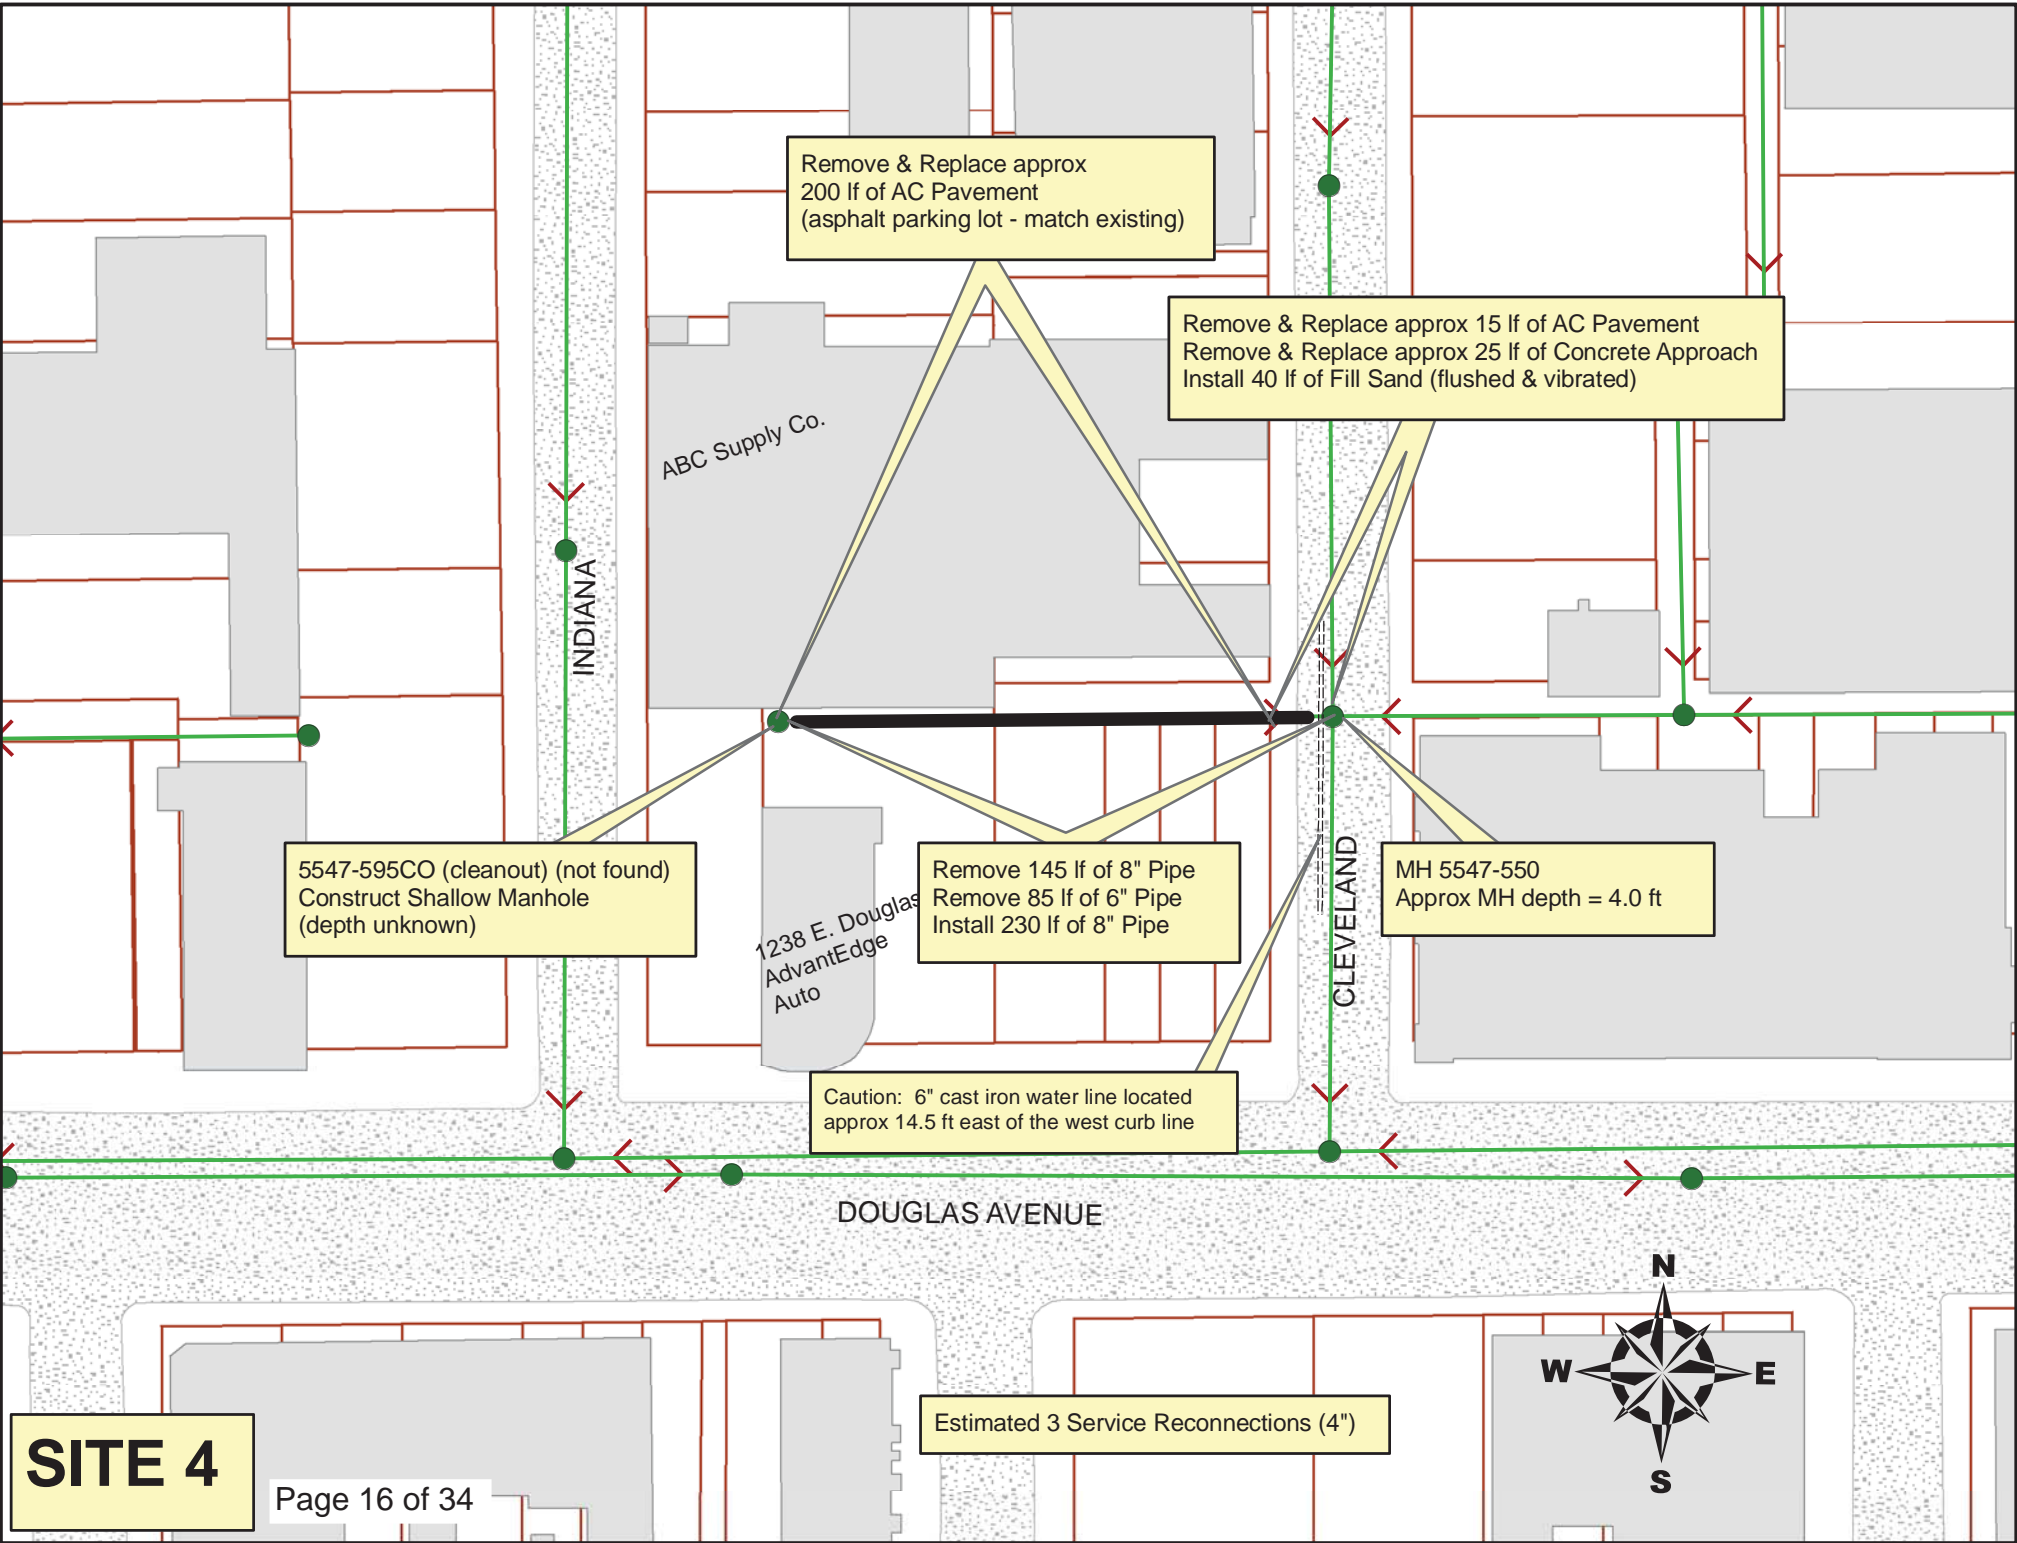
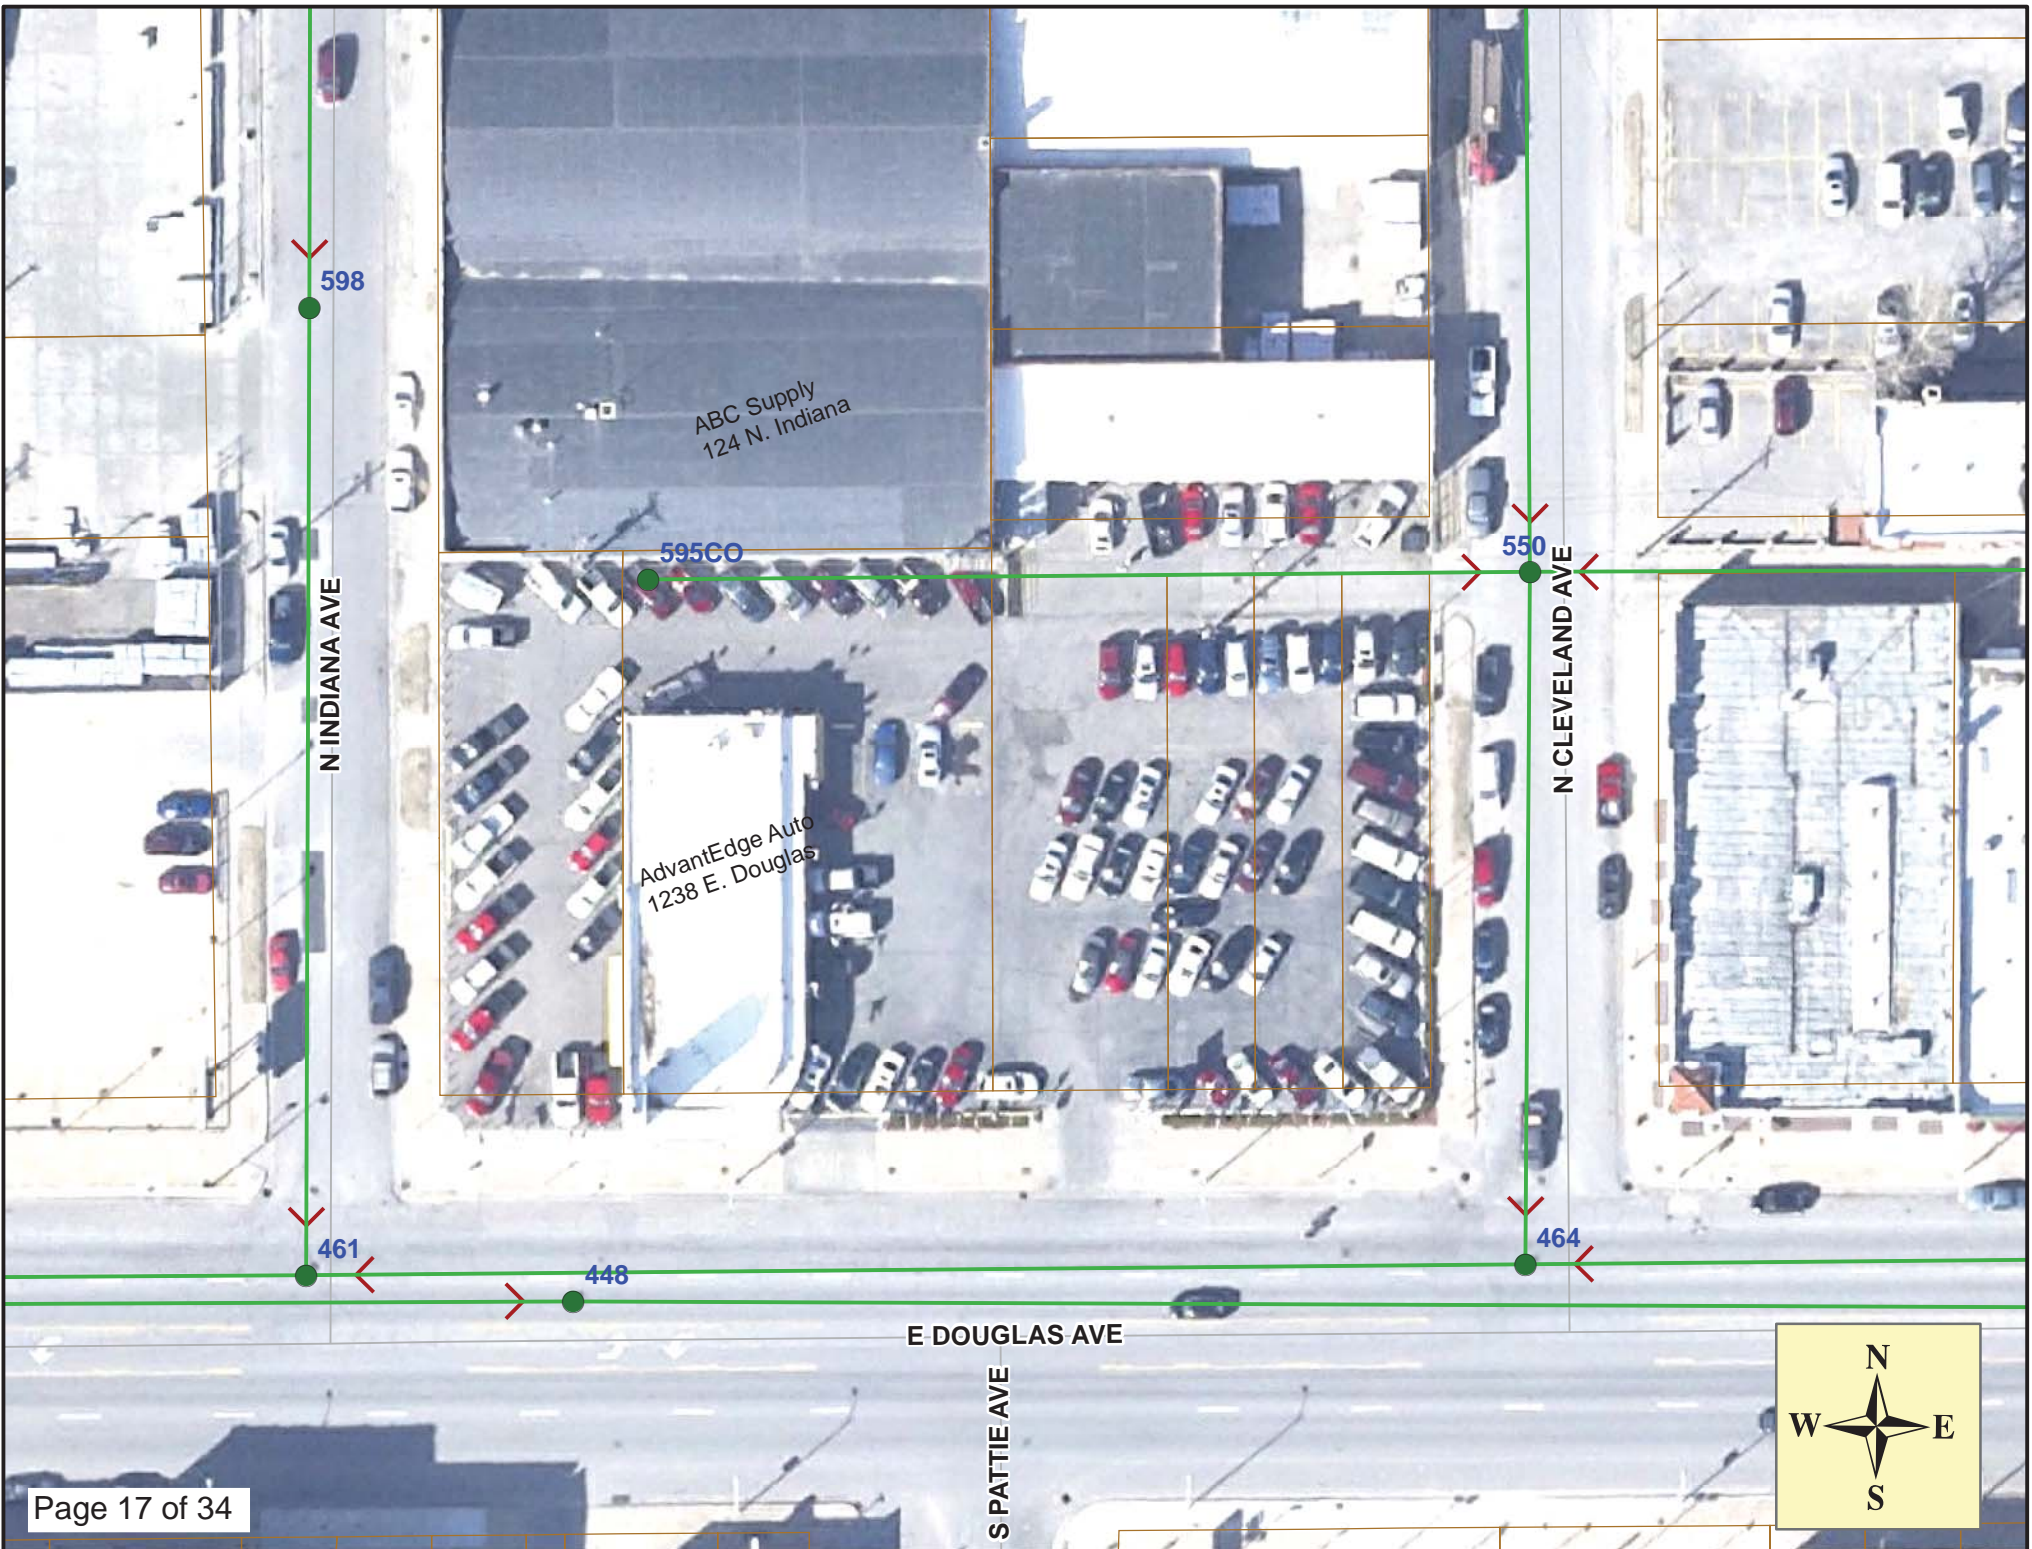
ABC Supply
124 N. Indiana

AdvantEdge Auto
1238 E. Douglas

N INDIANA AVE

E DOUGLAS AVE

US Structure: 5547-595CO 1224 E DOUGLAS AVE Date Insp: 4/5/2013 Basin: C03A
 DS Structure: 5547-550 1300 E DOUGLAS AVE Dir Televised: Downstream To Upstream

A mini camera was installed in the observation hole at the open grate, located at 75' west of MH 5547-550, in an attempt to televise the remaining 6" pipe. The mini camera cannot pan/tilt to look around. The following footages are approximate: - LML

- 157.0 South facing wye
- 182.0 Tap for 1238 Douglas (obviously active)
- 207.0 South facing wye
- 210.0 North facing wye (looks like it could be active – needs verified by contractor)
- 230.0 North facing wye
- 230.0 Camera can't proceed / sand or debris in the pipe / this should be where a cleanout ended the line (either the cleanout has collapsed or the pipe was capped off and that seal is broken)
