MH # 5744-688
Rework Manhole Bench & Invert
Approx depth = 13.8 ft

MAP 2

Aerial View

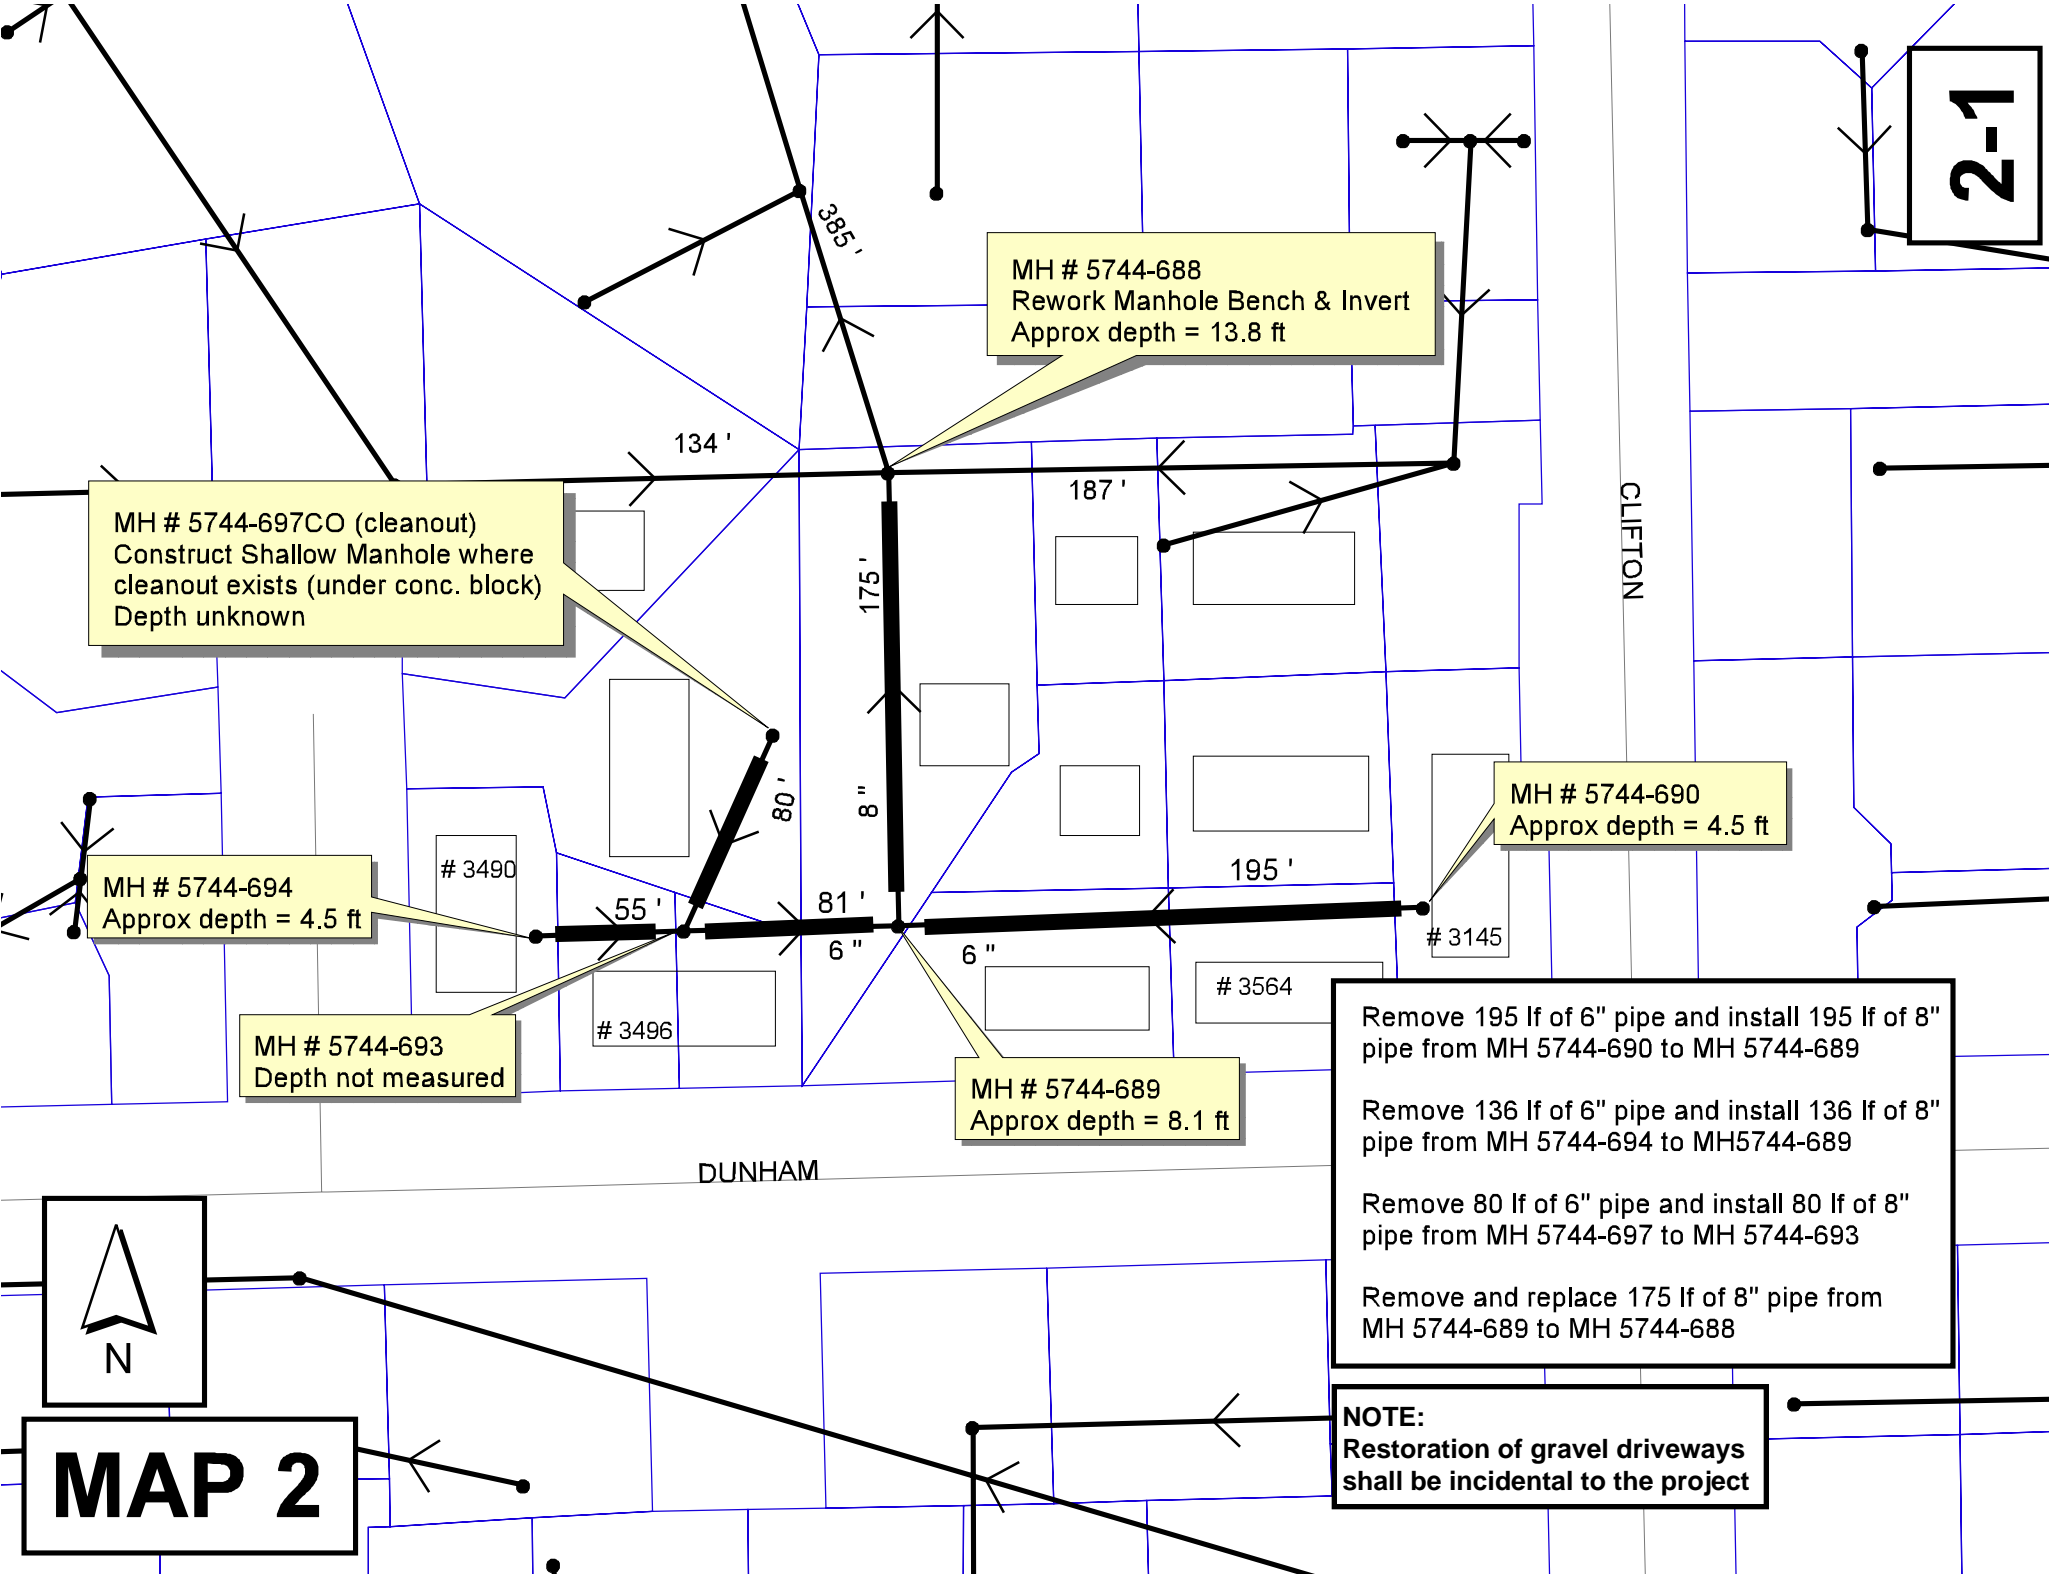
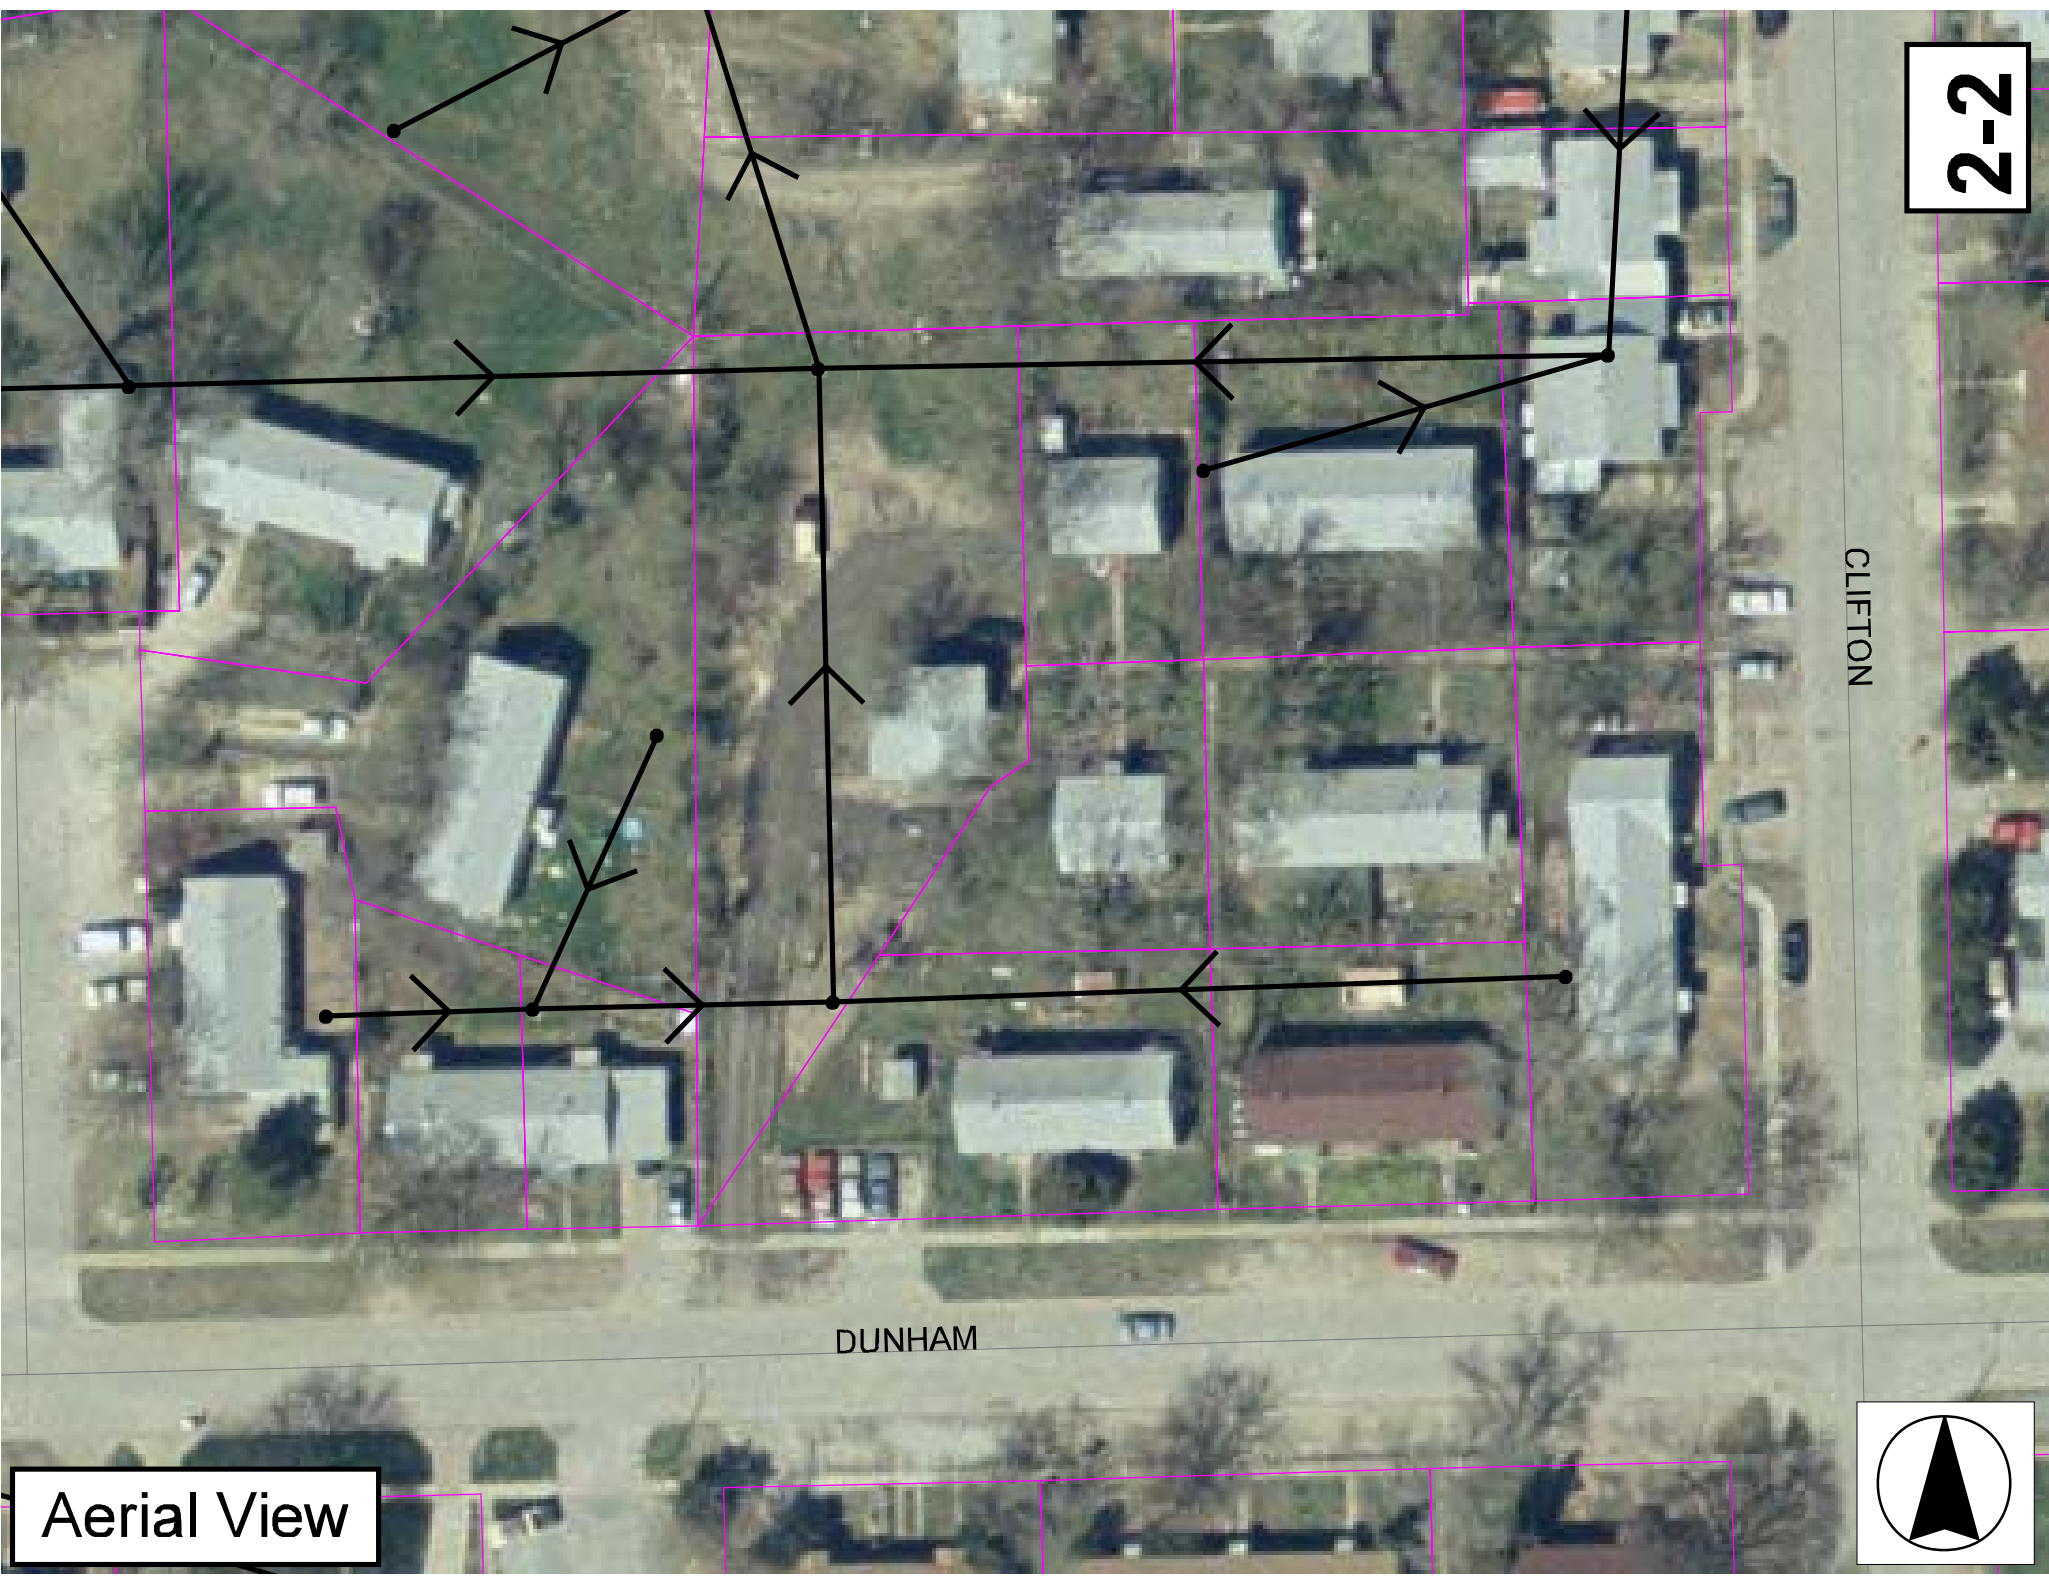
MH # 5744-697CO (cleanout)
Construct Shallow Manhole where
cleanout exists (under conc. block)
Depth unknown

MH # 5744-694
Approx depth = 4.5 ft

MH # 5744-693
Depth not measured

MH # 5744-689
Approx depth = 8.1 ft

MH # 5744-690
Approx depth = 4.5 ft

Remove 195 lf of 6" pipe and install 195 lf of 8" pipe from MH 5744-690 to MH 5744-689

Remove 136 lf of 6" pipe and install 136 lf of 8" pipe from MH 5744-694 to MH5744-689

Remove 80 lf of 6" pipe and install 80 lf of 8" pipe from MH 5744-697 to MH 5744-693

Remove and replace 175 lf of 8" pipe from MH 5744-689 to MH 5744-688
