KANSAS DEPARTMENT OF TRANSPORTATION  
 Br. No. 54-81-25.80(142) Bridge Repair  
 CONSTRUCTION LAYOUT  
 Proj. No. 54-81-5942(2) Sedawick Co.

SHEET NO. 3 OF 32 SCALE	APPD.
DESIGNED BY: RAM	QUANTITIES: 503
DESIGN CK: 205	TRACED: TRACE CK.

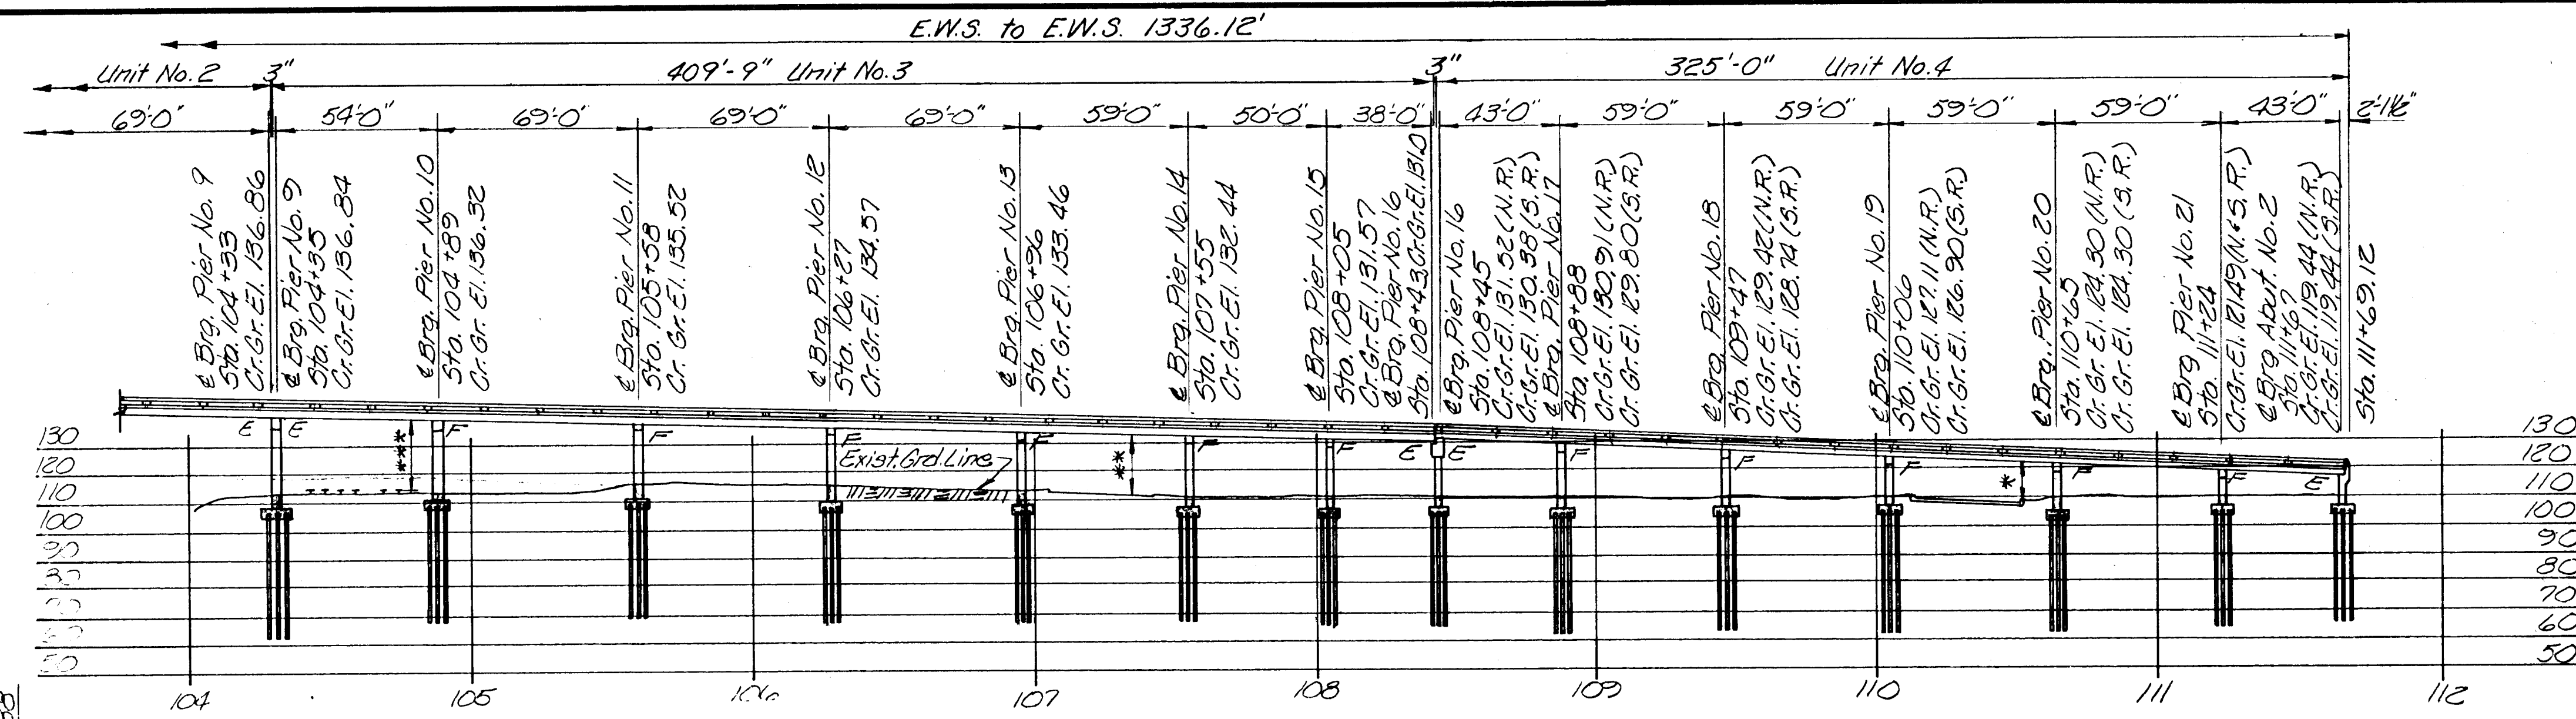
**Elevation**  
 54'-3" to 59'-50" Cont. RC. Hollow Girder Spans  
 43'-4" to 59'-43" RC. Hollow Slab Spans  
 Pedestal Type Piers 28'-0" Roadway  
 26'-0" Roadway (Ramps)

\* Min. Vert. Cl. = 14.3'  
 \*\* Min. Vert. Cl. = 22.2'  
 \*\*\* Min. Vert. Cl. = 23.6'

**Curve Data**  
 A = 6°-20'-08" Rt.  
 D = 0°-33'  
 L = 1151.92'  
 P = 10,417.42'  
 T = 576.55'  
 P.I. Sta. 110+79  
 S = 0.021 Ft/Ft
