SITE 1

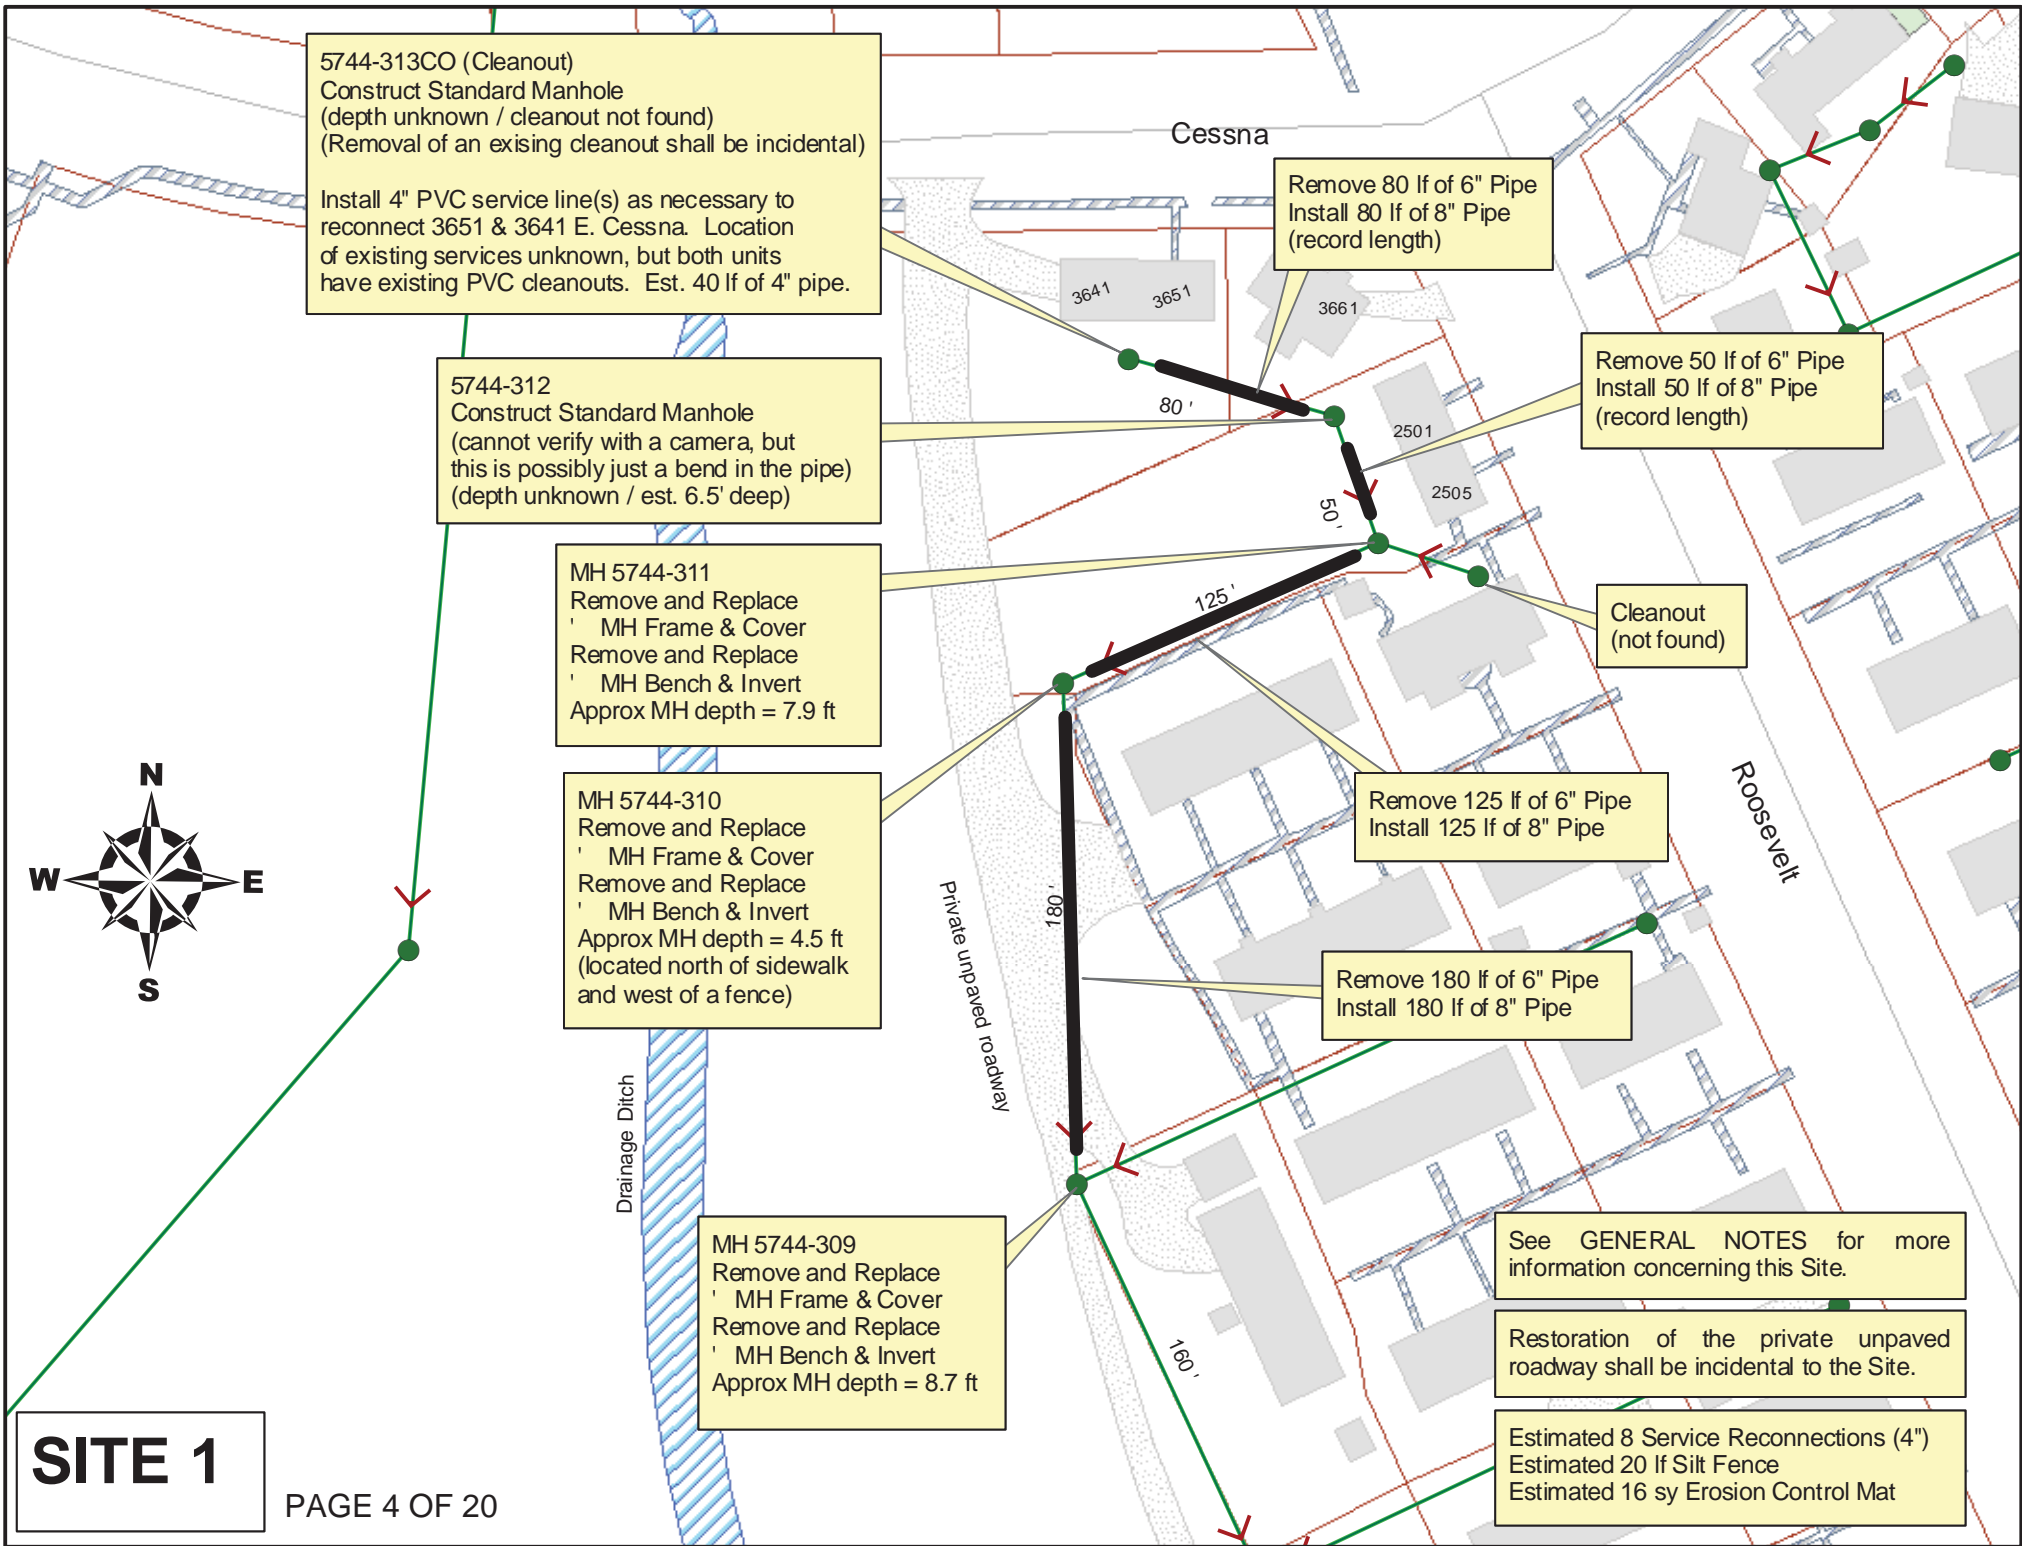
5744-313CO (Cleanout)
 Construct Standard Manhole
 (depth unknown / cleanout not found)
 (Removal of an existing cleanout shall be incidental)

Install 4" PVC service line(s) as necessary to reconnect 3651 & 3641 E. Cessna. Location of existing services unknown, but both units have existing PVC cleanouts. Est. 40 lf of 4" pipe.

5744-312
 Construct Standard Manhole
 (cannot verify with a camera, but this is possibly just a bend in the pipe)
 (depth unknown / est. 6.5' deep)

MH 5744-311
 Remove and Replace
 ' MH Frame & Cover
 Remove and Replace
 ' MH Bench & Invert
 Approx MH depth = 7.9 ft

MH 5744-310
 Remove and Replace
 ' MH Frame & Cover
 Remove and Replace
 ' MH Bench & Invert
 Approx MH depth = 4.5 ft
 (located north of sidewalk and west of a fence)

MH 5744-309
 Remove and Replace
 ' MH Frame & Cover
 Remove and Replace
 ' MH Bench & Invert
 Approx MH depth = 8.7 ft

Remove 80 lf of 6" Pipe
 Install 80 lf of 8" Pipe
 (record length)

Remove 50 lf of 6" Pipe
 Install 50 lf of 8" Pipe
 (record length)

Cleanout
 (not found)

Remove 125 lf of 6" Pipe
 Install 125 lf of 8" Pipe

Remove 180 lf of 6" Pipe
 Install 180 lf of 8" Pipe

Restoration of the private unpaved roadway shall be incidental to the Site.

Estimated 8 Service Reconnections (4")
 Estimated 20 lf Silt Fence
 Estimated 16 sy Erosion Control Mat
