# 2013 Sanitary Sewer Reconstruction

## Phase 1

OCA 620632 / 468-84866

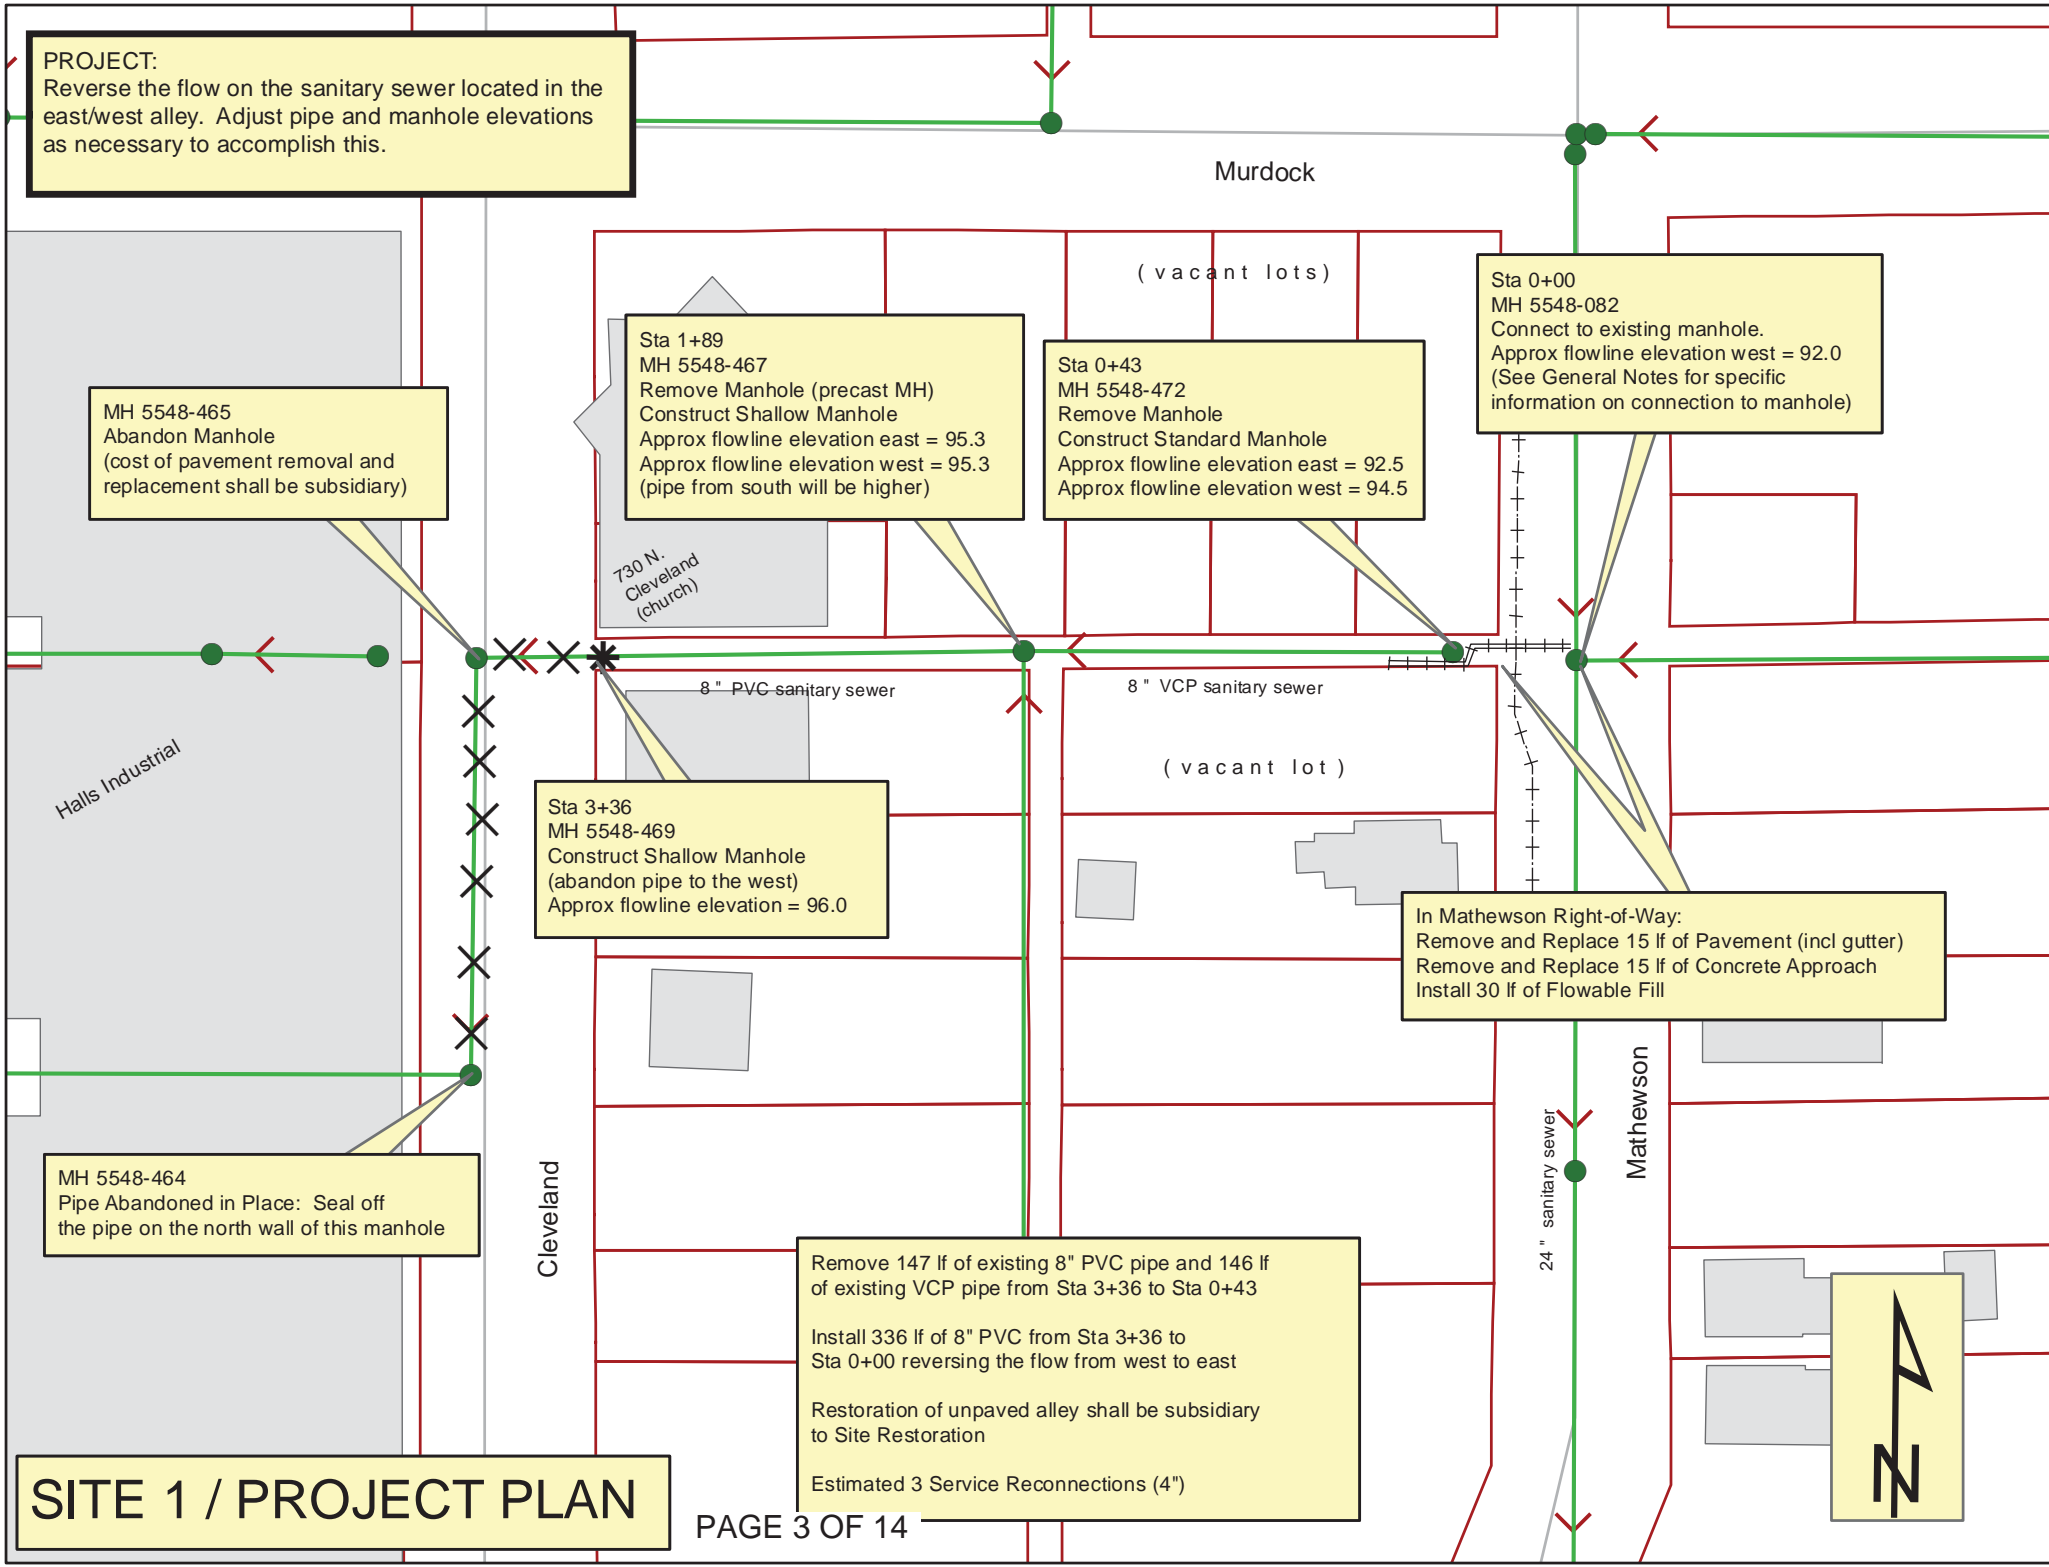
**SITE 1 / PROJECT PLAN**

**PROJECT:**  
Reverse the flow on the sanitary sewer located in the east/west alley. Adjust pipe and manhole elevations as necessary to accomplish this.

MH 5548-465  
Abandon Manhole  
(cost of pavement removal and replacement shall be subsidiary)

Sta 1+89  
MH 5548-467  
Remove Manhole (precast MH)  
Construct Shallow Manhole  
Approx flowline elevation east = 95.3  
Approx flowline elevation west = 95.3  
(pipe from south will be higher)

Sta 0+43  
MH 5548-472  
Remove Manhole  
Construct Standard Manhole  
Approx flowline elevation east = 92.5  
Approx flowline elevation west = 94.5

Sta 0+00  
MH 5548-082  
Connect to existing manhole.  
Approx flowline elevation west = 92.0  
(See General Notes for specific information on connection to manhole)

Sta 3+36  
MH 5548-469  
Construct Shallow Manhole  
(abandon pipe to the west)  
Approx flowline elevation = 96.0

Remove 147 lf of existing 8" PVC pipe and 146 lf of existing VCP pipe from Sta 3+36 to Sta 0+43

Install 336 lf of 8" PVC from Sta 3+36 to Sta 0+00 reversing the flow from west to east

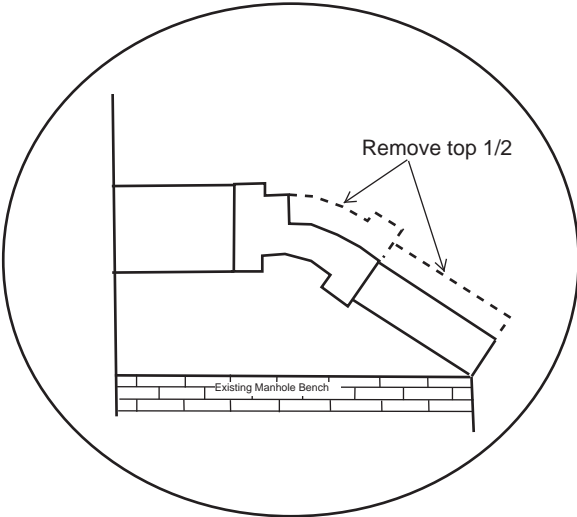
Example

MH 5548-082 is a brick manhole with tall, flat brick benches. The new pipe should stick into the manhole all the way to the edge of the brick bench. Do not match what has been done with the pipe from the east, as that would not allow room to get maintenance equipment into either of the 8 inch pipes. Contractor shall install fittings inside the manhole as necessary to lower the new pipe inside the manhole and get the flow line down to the top of the existing brick bench. Contractor shall then cut the top 1/2 off the new pipe and fittings within the manhole. Below is an example:

Use one or more fittings as necessary to carry the flow past the bench while allowing maintenance access.

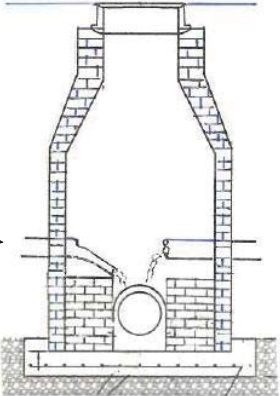
Existing pipe entering manhole from the east
