Raleigh

**SITE 2**

# Television Inspection Master Report

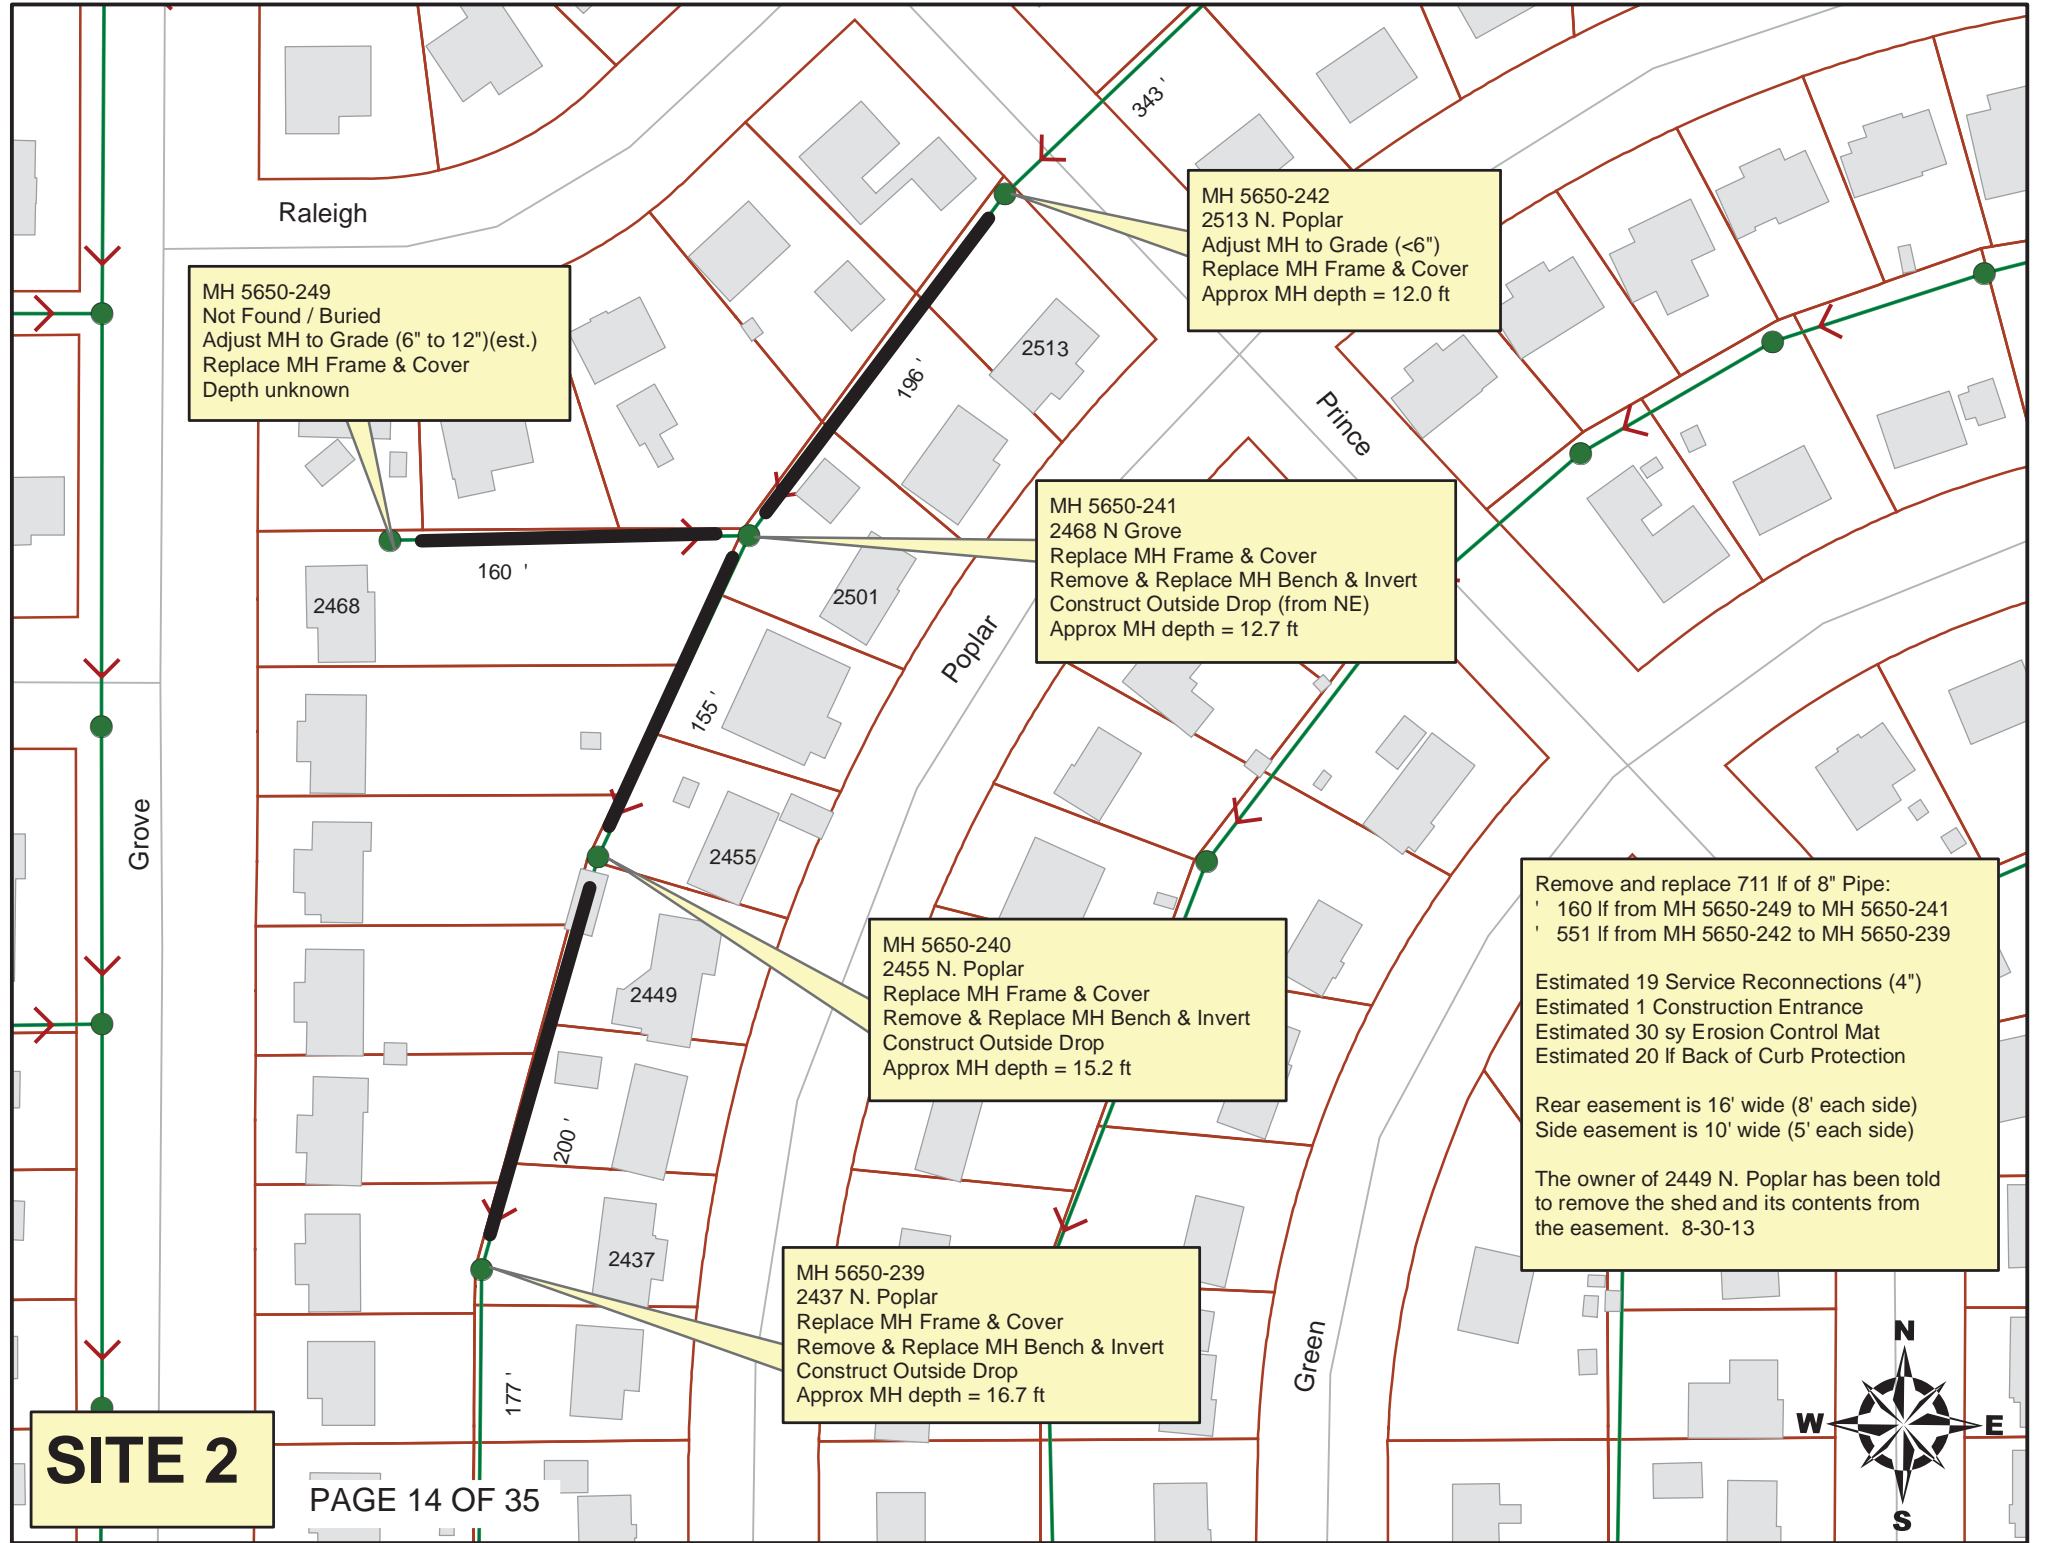
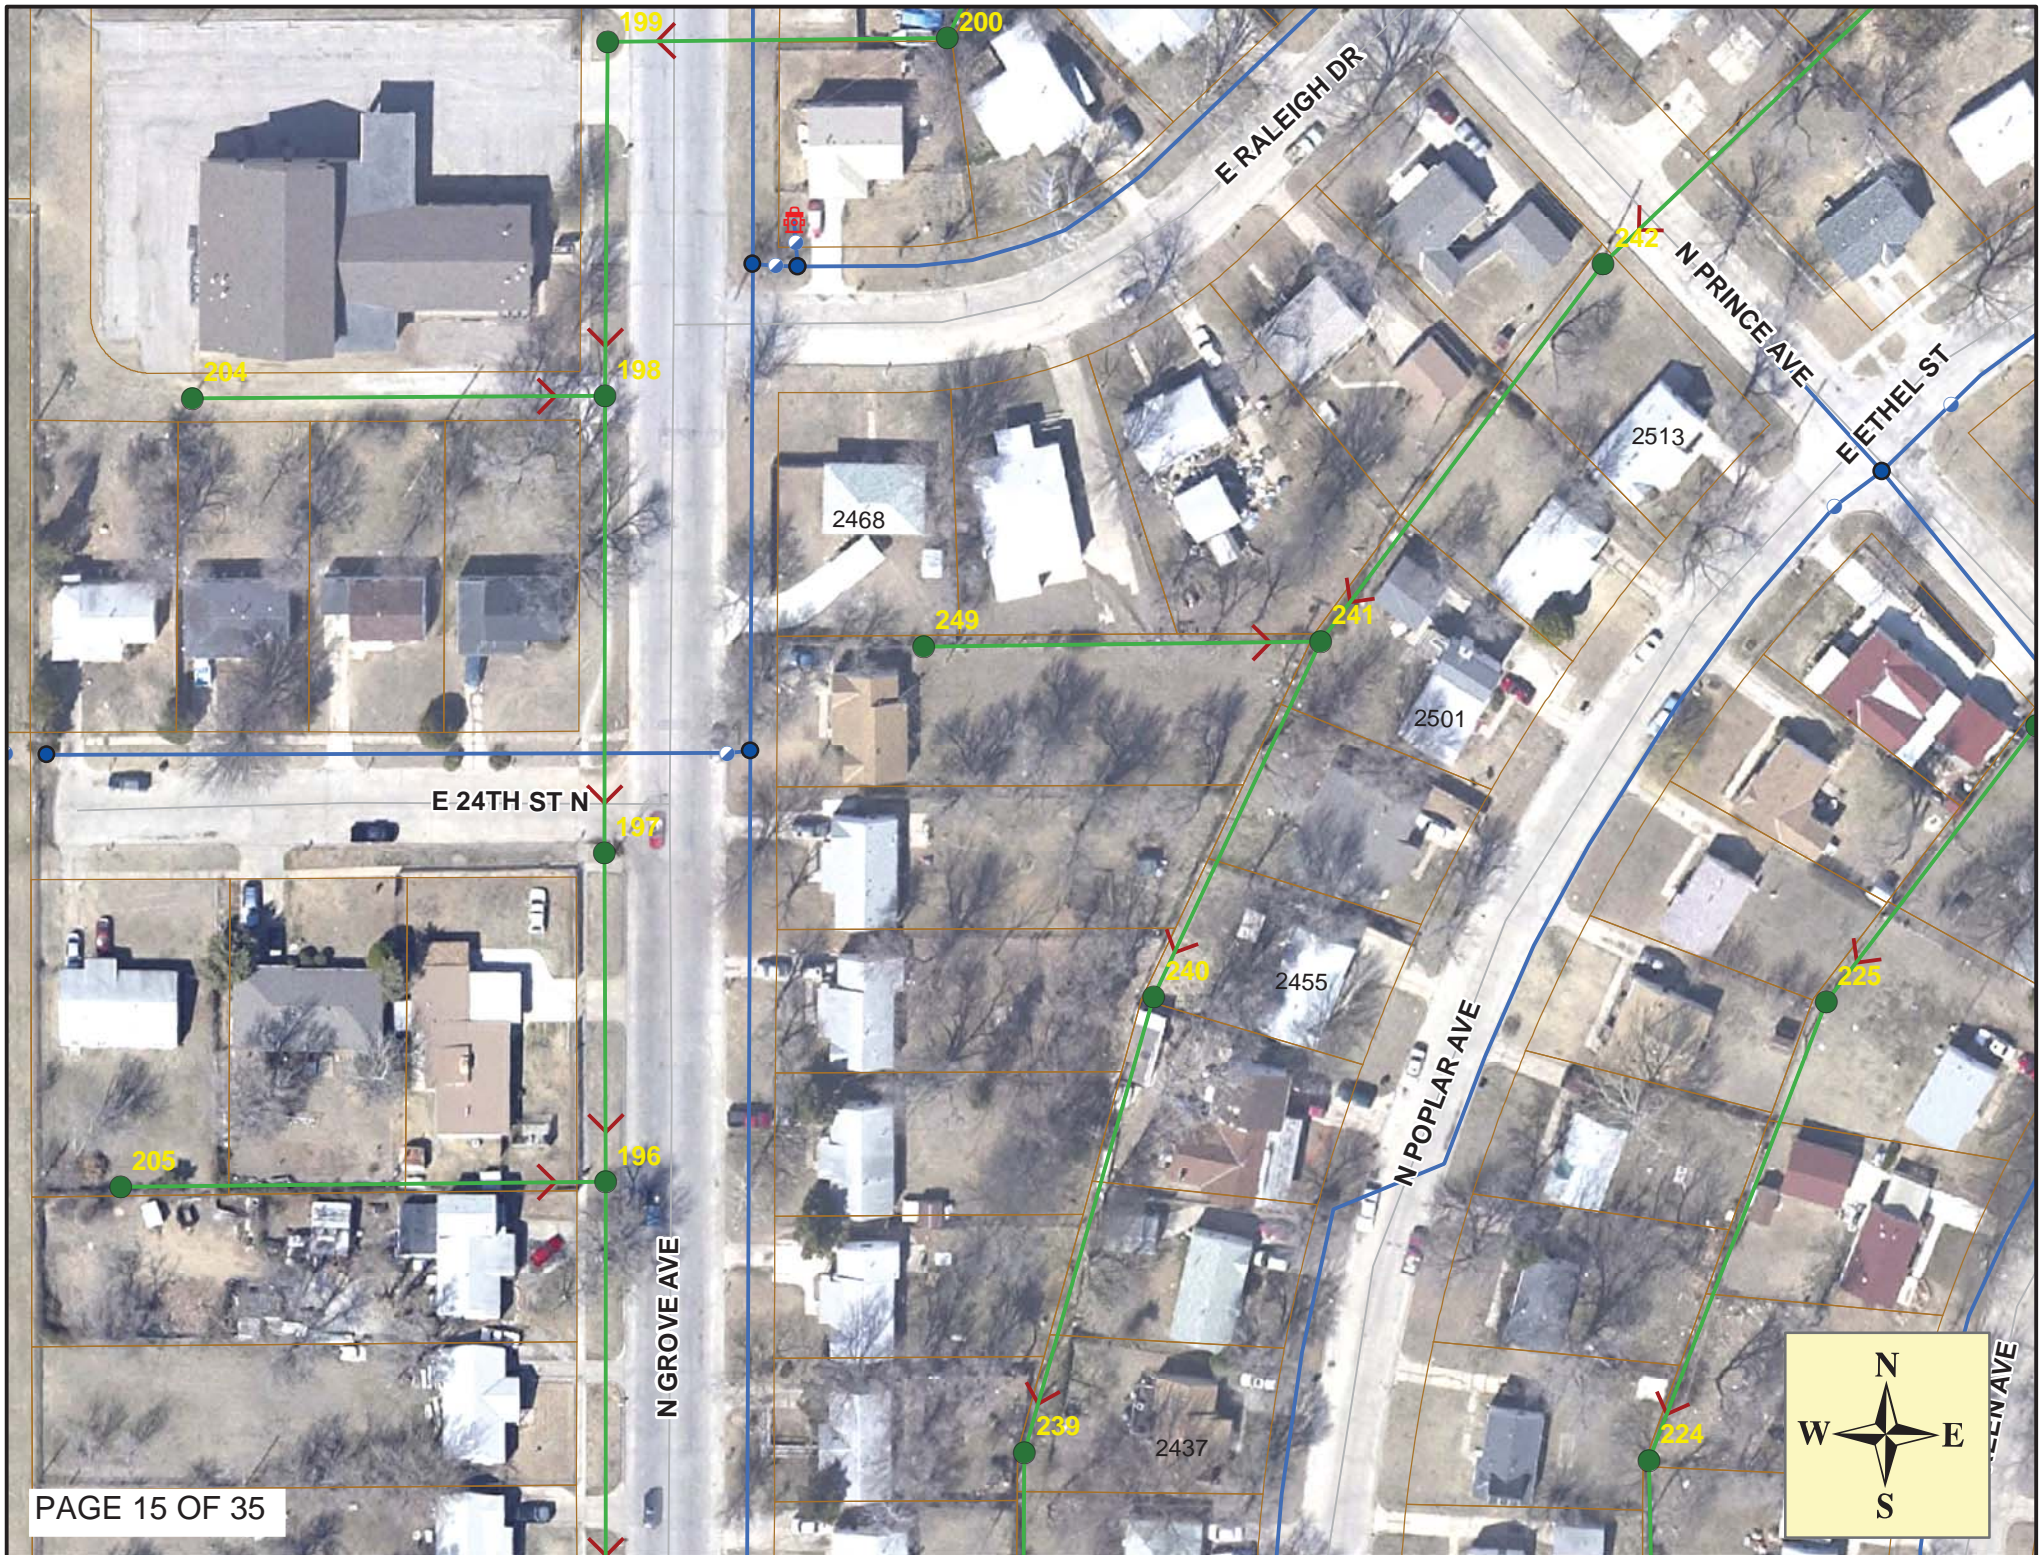
MH 5650-249  
Not Found / Buried  
Adjust MH to Grade (6" to 12")(est.)  
Replace MH Frame & Cover  
Depth unknown

MH 5650-242  
2513 N. Poplar  
Adjust MH to Grade (<6")  
Replace MH Frame & Cover  
Approx MH depth = 12.0 ft

MH 5650-241  
2468 N Grove  
Replace MH Frame & Cover  
Remove & Replace MH Bench & Invert  
Construct Outside Drop (from NE)  
Approx MH depth = 12.7 ft

MH 5650-240  
2455 N. Poplar  
Replace MH Frame & Cover  
Remove & Replace MH Bench & Invert  
Construct Outside Drop  
Approx MH depth = 15.2 ft

MH 5650-239  
2437 N. Poplar  
Replace MH Frame & Cover  
Remove & Replace MH Bench & Invert  
Construct Outside Drop  
Approx MH depth = 16.7 ft

Remove and replace 711 lf of 8" Pipe:  
160 lf from MH 5650-249 to MH 5650-241  
551 lf from MH 5650-242 to MH 5650-239

Estimated 19 Service Reconnections (4")  
Estimated 1 Construction Entrance  
Estimated 30 sy Erosion Control Mat  
Estimated 20 lf Back of Curb Protection

Rear easement is 16' wide (8' each side)  
Side easement is 10' wide (5' each side)

The owner of 2449 N. Poplar has been told  
to remove the shed and its contents from  
the easement. 8-30-13
