**SITE 6**

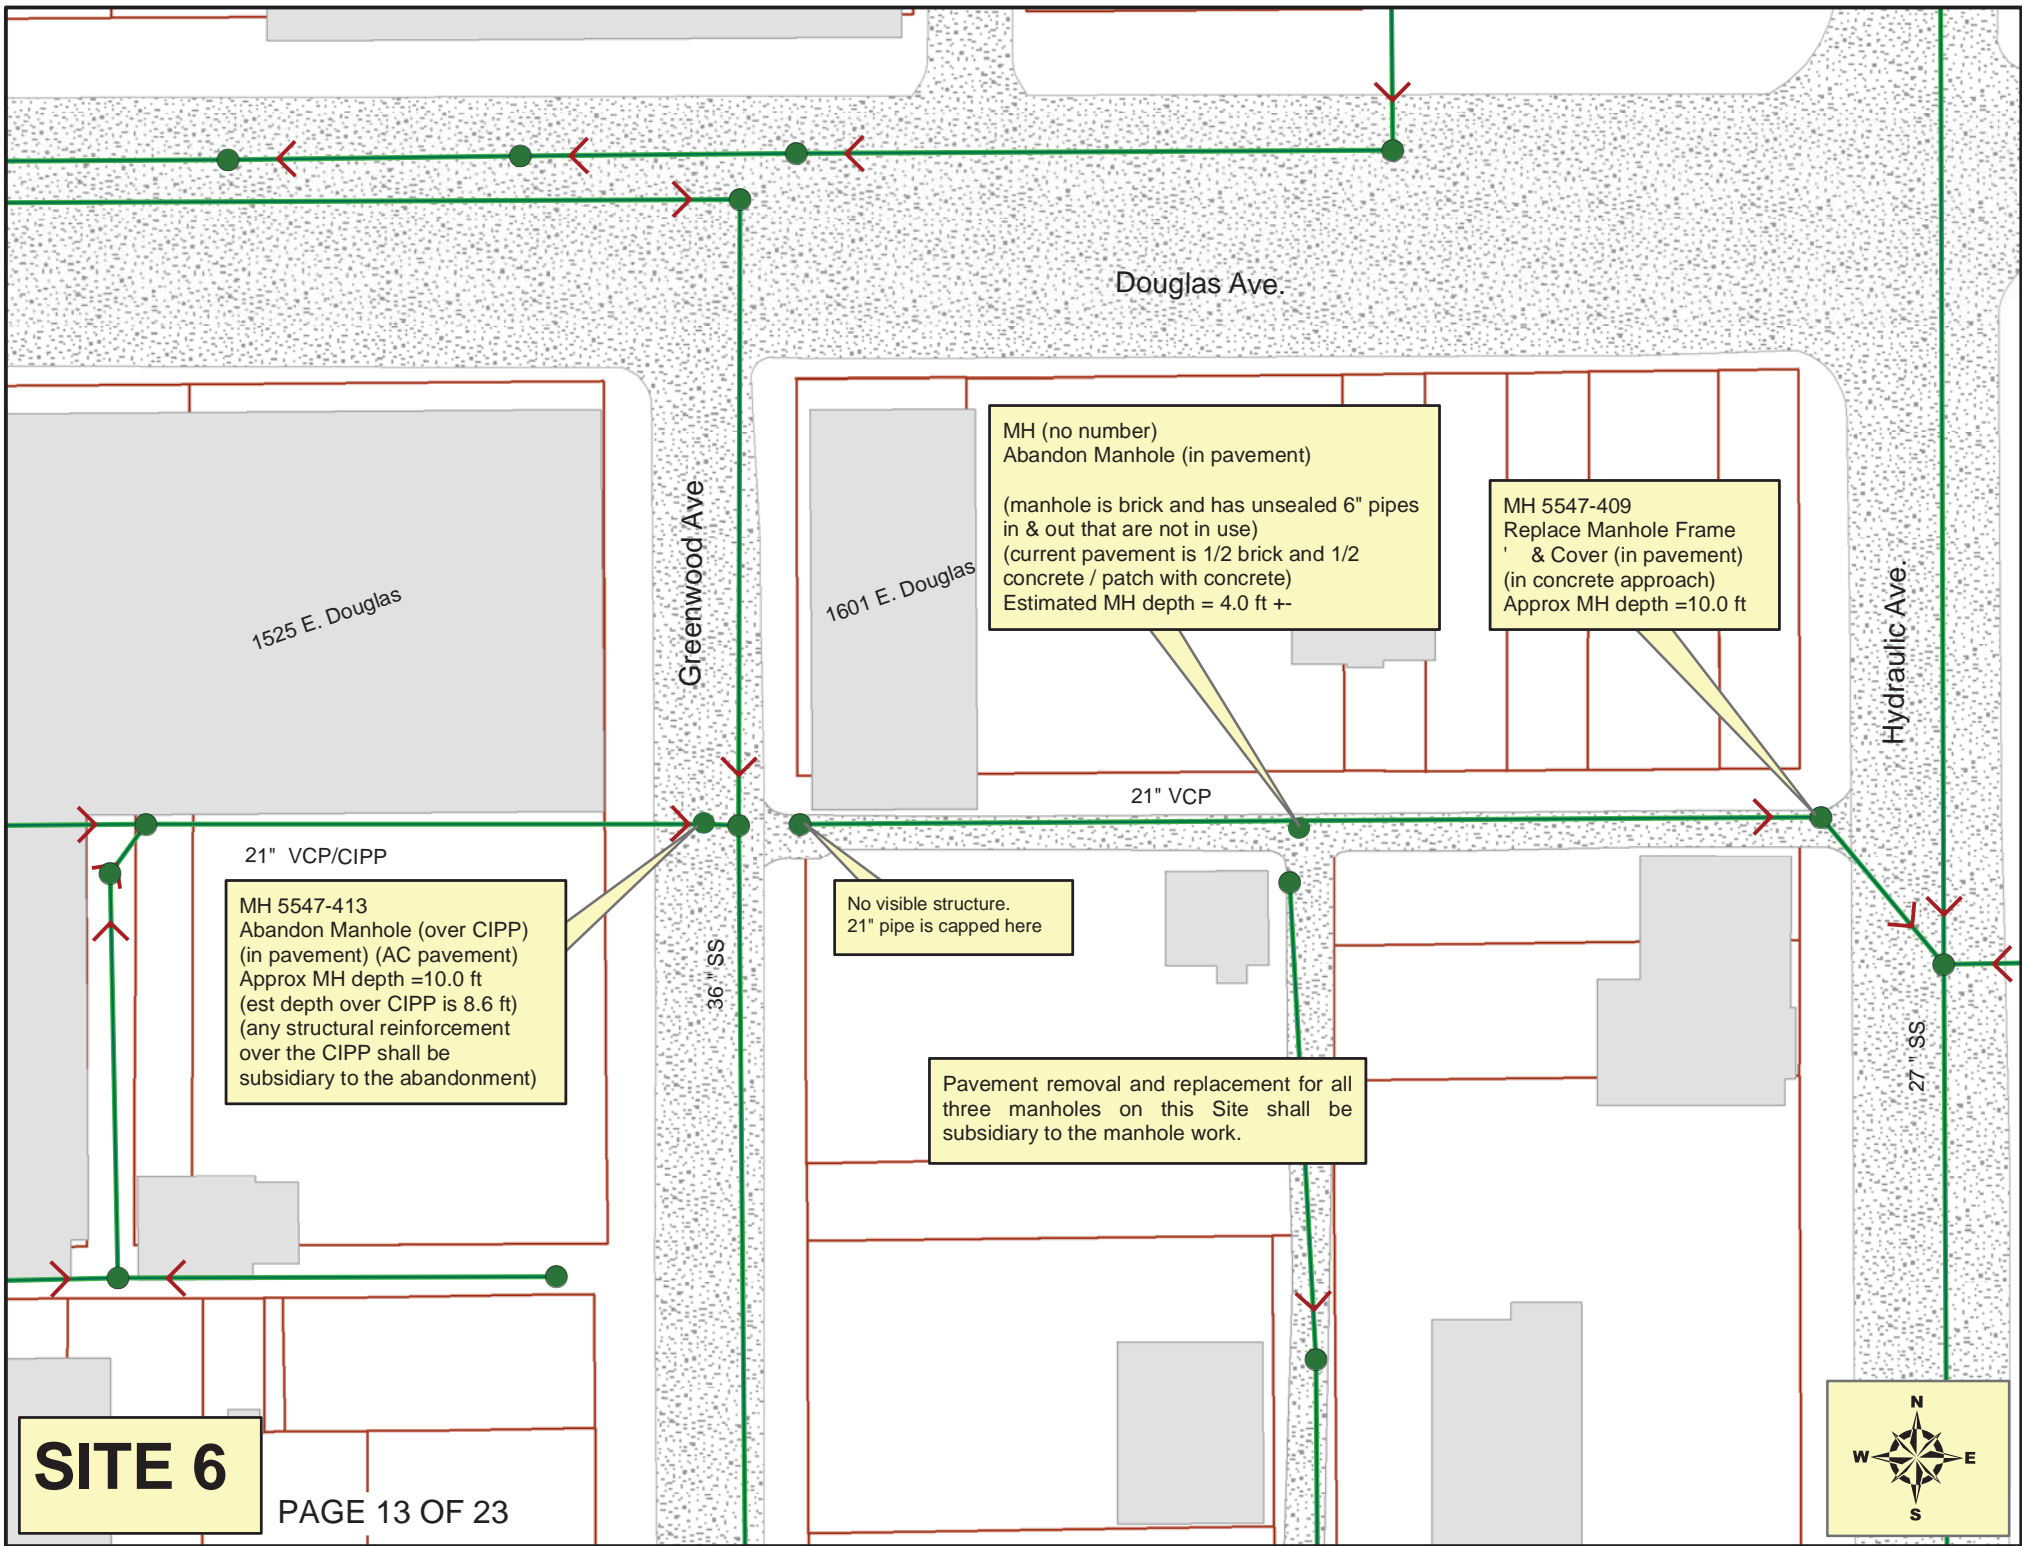
MH (no number)  
Abandon Manhole (in pavement)

(manhole is brick and has unsealed 6" pipes  
in & out that are not in use)  
(current pavement is 1/2 brick and 1/2  
concrete / patch with concrete)  
Estimated MH depth = 4.0 ft +-

MH 5547-409  
Replace Manhole Frame  
& Cover (in pavement)  
(in concrete approach)  
Approx MH depth =10.0 ft

MH 5547-413  
Abandon Manhole (over CIPP)  
(in pavement) (AC pavement)  
Approx MH depth =10.0 ft  
(est depth over CIPP is 8.6 ft)  
(any structural reinforcement  
over the CIPP shall be  
subsidiary to the abandonment)

No visible structure.  
21" pipe is capped here

Pavement removal and replacement for all  
three manholes on this Site shall be  
subsidiary to the manhole work.
