CITY OF WICHITA  
 WICHITA, KANSAS

LIONSGATE  
 PAVING & SWS

**SITE GRADING**

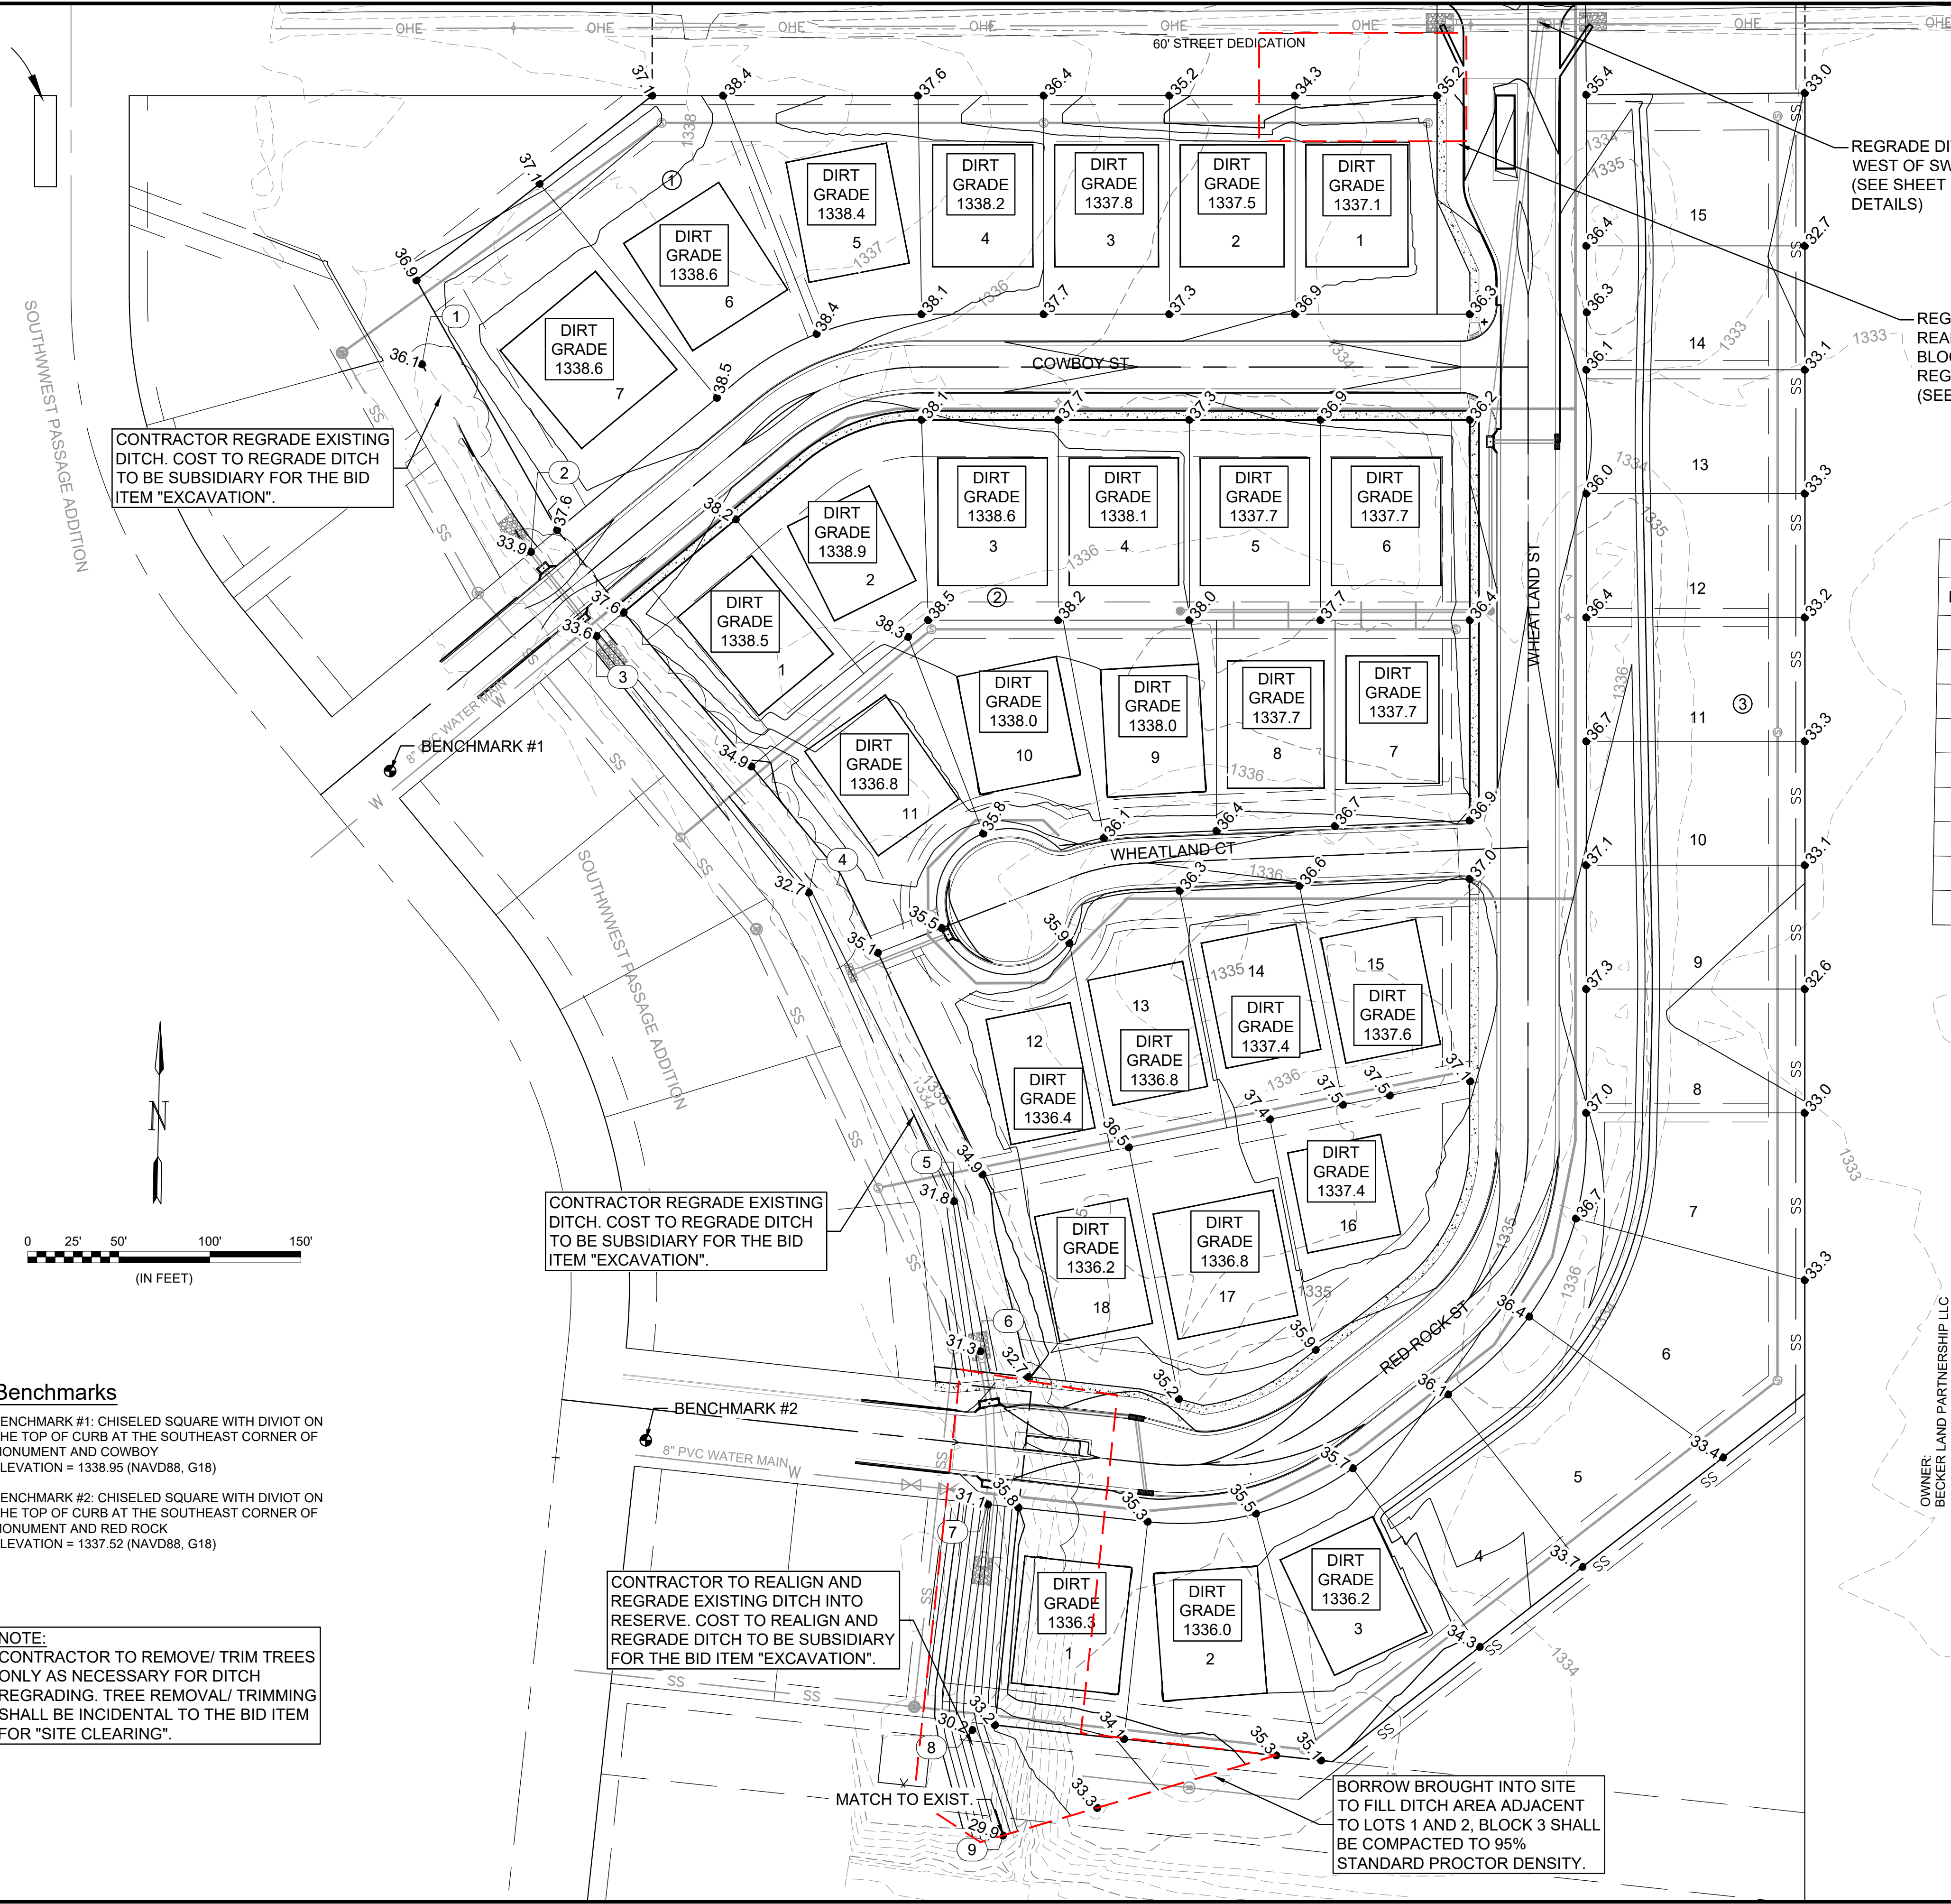
CONTRACTOR REGRADE EXISTING DITCH. COST TO REGRADE DITCH TO BE SUBSIDIARY FOR THE BID ITEM "EXCAVATION".

CONTRACTOR TO REALIGN AND REGRADE EXISTING DITCH INTO RESERVE. COST TO REALIGN AND REGRADE DITCH TO BE SUBSIDIARY FOR THE BID ITEM "EXCAVATION".

**Benchmarks**  
 BENCHMARK #1: CHISELED SQUARE WITH DIVIOT ON THE TOP OF CURB AT THE SOUTHEAST CORNER OF MONUMENT AND COWBOY ELEVATION = 1338.95 (NAVD88, G18)  
 BENCHMARK #2: CHISELED SQUARE WITH DIVIOT ON THE TOP OF CURB AT THE SOUTHEAST CORNER OF MONUMENT AND RED ROCK ELEVATION = 1337.52 (NAVD88, G18)

**NOTE:**  
 CONTRACTOR TO REMOVE/ TRIM TREES ONLY AS NECESSARY FOR DITCH REGRADING. TREE REMOVAL/ TRIMMING SHALL BE INCIDENTAL TO THE BID ITEM FOR "SITE CLEARING".

REGRADE DITCH EAST AND WEST OF SWS PIPE 5 (SEE SHEET 32 FOR DETAILS)

REGRADE DITCH AREA AND REAR PROPERTY LINE OF LOT 1, BLOCK 1 TO MATCH INTO THE REGRADE OF THE NORTH DITCH (SEE SHEET 32 FOR DETAILS)
