17-2

Television Inspection Master Report

US Manhole: 5746-483 633 S OLIVER AV Date Insp: 4/13/2007 Basin: E04C
DS Manhole: 5746-422 702 DELLROSE AV Dir Televised: Downstream to Upstream

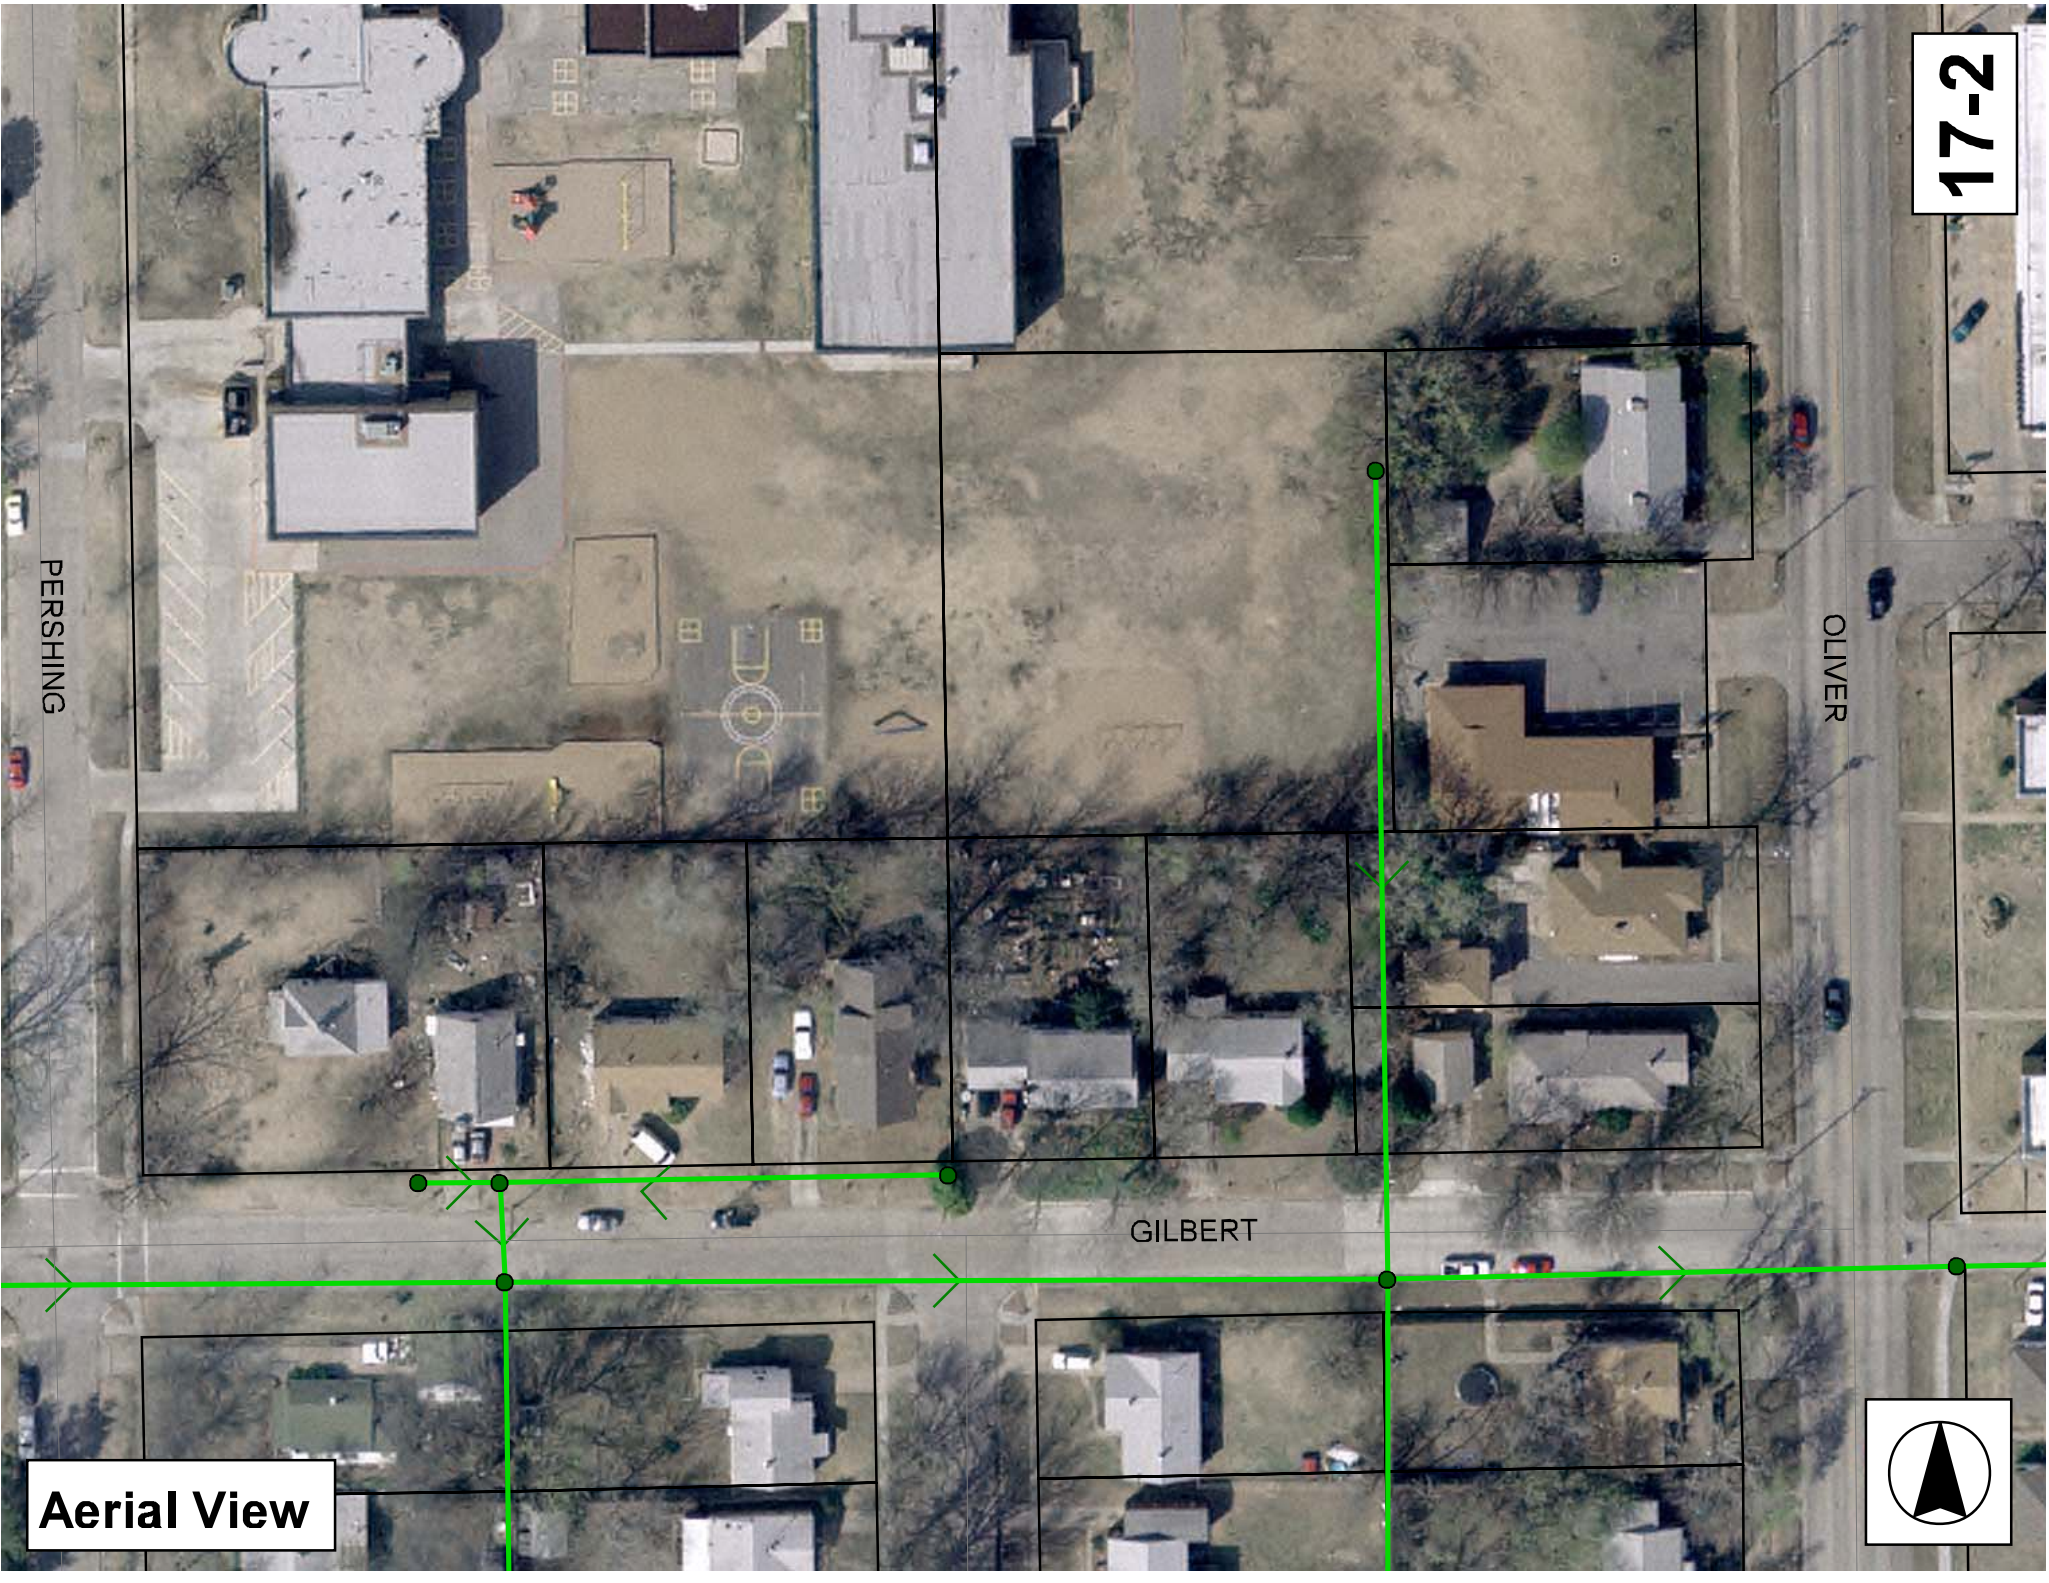
#	Counter Svc. Address	Distance	Location	Connection type:	Description	Obs Rating	Obsrvd (gpm)	Est. (gpm)	Ratings Struct	Clean	Remain (gpm)
1		0.1	DS Manhole	5746-422 /	4712 EAST GILBERT /						
2		27.1	Joint		Offset	3		0.010	20	0	0.010
3		54.0			Sealed Off Wye East	1		0.000	0	0	0.000
					4" Clay Wye Connection						
4		75.2	East		Break-In Conn	1		0.001	0	0	0.001
					4" Break In Connection						
5		121.7			Sealed Off Wye East	5		0.005	0	0	0.005
					4" Clay Wye Connection						
					FULL OF ROOTS / POSSIBLY SEALED OFF						
6		124.5	East		Break-In Conn	4		0.008	60	0	0.008
					4" Break In Connection						
					ROOTS						
7		153.5	Joint		Offset	3		0.010	20	0	0.010
8		159.5	Joint		Offset	3		0.010	20	0	0.010
9		177.3	East		Wye Service	1		0.000	0	0	0.000
					4" Clay Wye Connection						
10		232.7			Sealed Off Wye East	1		0.000	0	0	0.000
					4" Clay Wye Connection						
11		269.5	Joint		Roots	2		0.004	2	4	0.004

12		282.0	East		Wye Service	1		0.000	0	0	0.000
					4" Clay Wye Connection						
					635 SOUTH OLIVER						
13		282.4	Joint		Roots	4		0.010	10	25	0.010
14		285.4	Joint		Roots	3		0.008	5	8	0.008
15		287.8			Sealed Off Wye West	5		0.005	0	0	0.005
					6" Clay Wye Connection						
					PACKED WITH ROOTS / POSSIBLY SEALED OFF						
16		291.2	Joint		Roots	3		0.008	5	8	0.008
17		301.5	US Manhole	5746-483		1		0.000	0	0	0.000

INFILTRATION COMING IN AT MANHOLE HOOK HOLE LID / FRAME & COVER TO BE REPLACED "BY OTHERS"

MANHOLE MAY HAVE AN INCH OR SO OF DIRT SILTED-OVER THE TOP OF THE LID
