DRAINAGE PLAN

ASCENSION LUTHERAN CHURCH 2ND ADDITION

WICHITA, SEDGWICK COUNTY, KANSAS

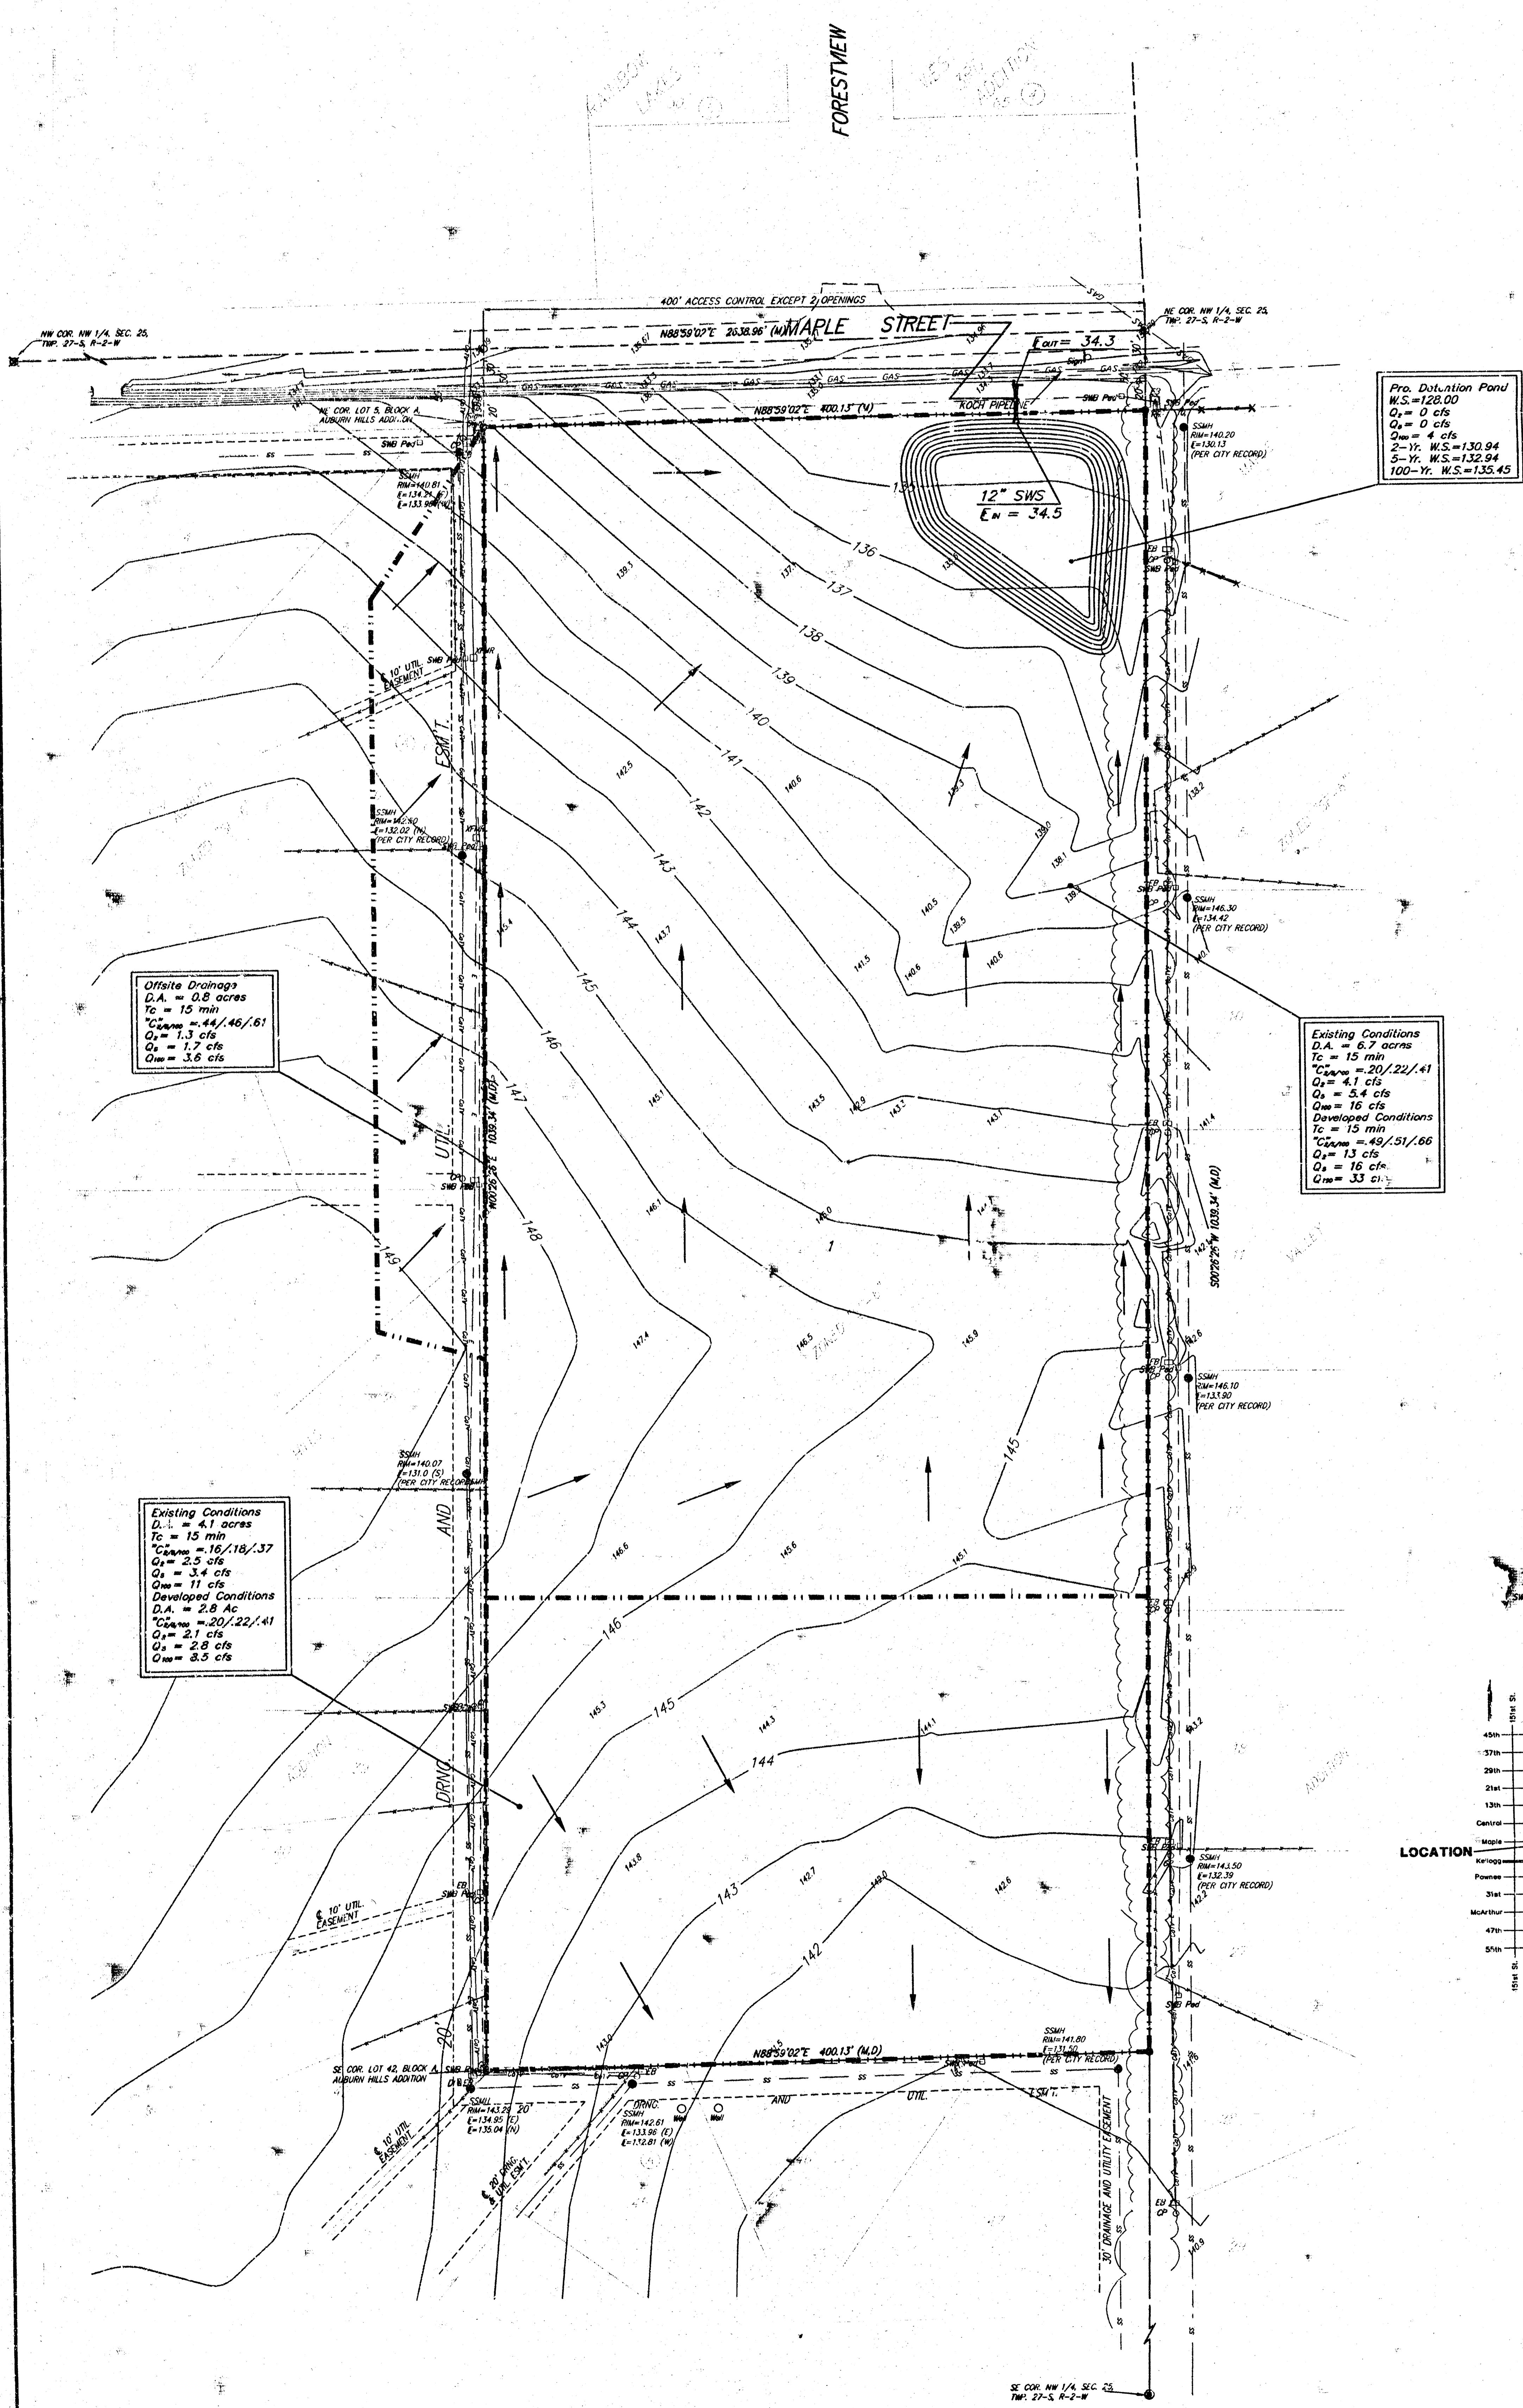
Prop. Detention Pond
 W.S. = 128.00
 Q₁ = 0 cfs
 Q₂ = 0 cfs
 Q₃ = 4 cfs
 2-Yr. W.S. = 130.94
 5-Yr. W.S. = 132.94
 100-Yr. W.S. = 135.45

Offsite Drainage
 D.A. = 0.8 acres
 T_c = 15 min
 C_u = 44/46/61
 Q₁ = 1.3 cfs
 Q₂ = 1.7 cfs
 Q₃ = 3.6 cfs

Existing Conditions
 D.A. = 6.7 acres
 T_c = 15 min
 C_u = 20/22/41
 Q₁ = 4.1 cfs
 Q₂ = 5.4 cfs
 Q₃ = 16 cfs
Developed Conditions
 T_c = 15 min
 C_u = 49/51/66
 Q₁ = 13 cfs
 Q₂ = 16 cfs
 Q₃ = 33 cfs

Existing Conditions
 D.A. = 4.1 acres
 T_c = 15 min
 C_u = 16/18/37
 Q₁ = 2.5 cfs
 Q₂ = 3.4 cfs
 Q₃ = 11 cfs
Developed Conditions
 D.A. = 2.8 Ac
 C_u = 20/22/41
 Q₁ = 2.1 cfs
 Q₂ = 2.8 cfs
 Q₃ = 8.5 cfs

Dr. Note:
 Soil Type: Vanoss (B) / Hydrologic Group "B"
