Install 2171 lf of 8" Cured-in-Place Liner
 ' 748 lf from MH 4848-283 to MH 4848-276
 ' 810 lf from MH 4848-281 to MH 4848-277
 ' 613 lf from MH 4848-277 to MH 4848-275

SITE 4

Television Inspection Master Report

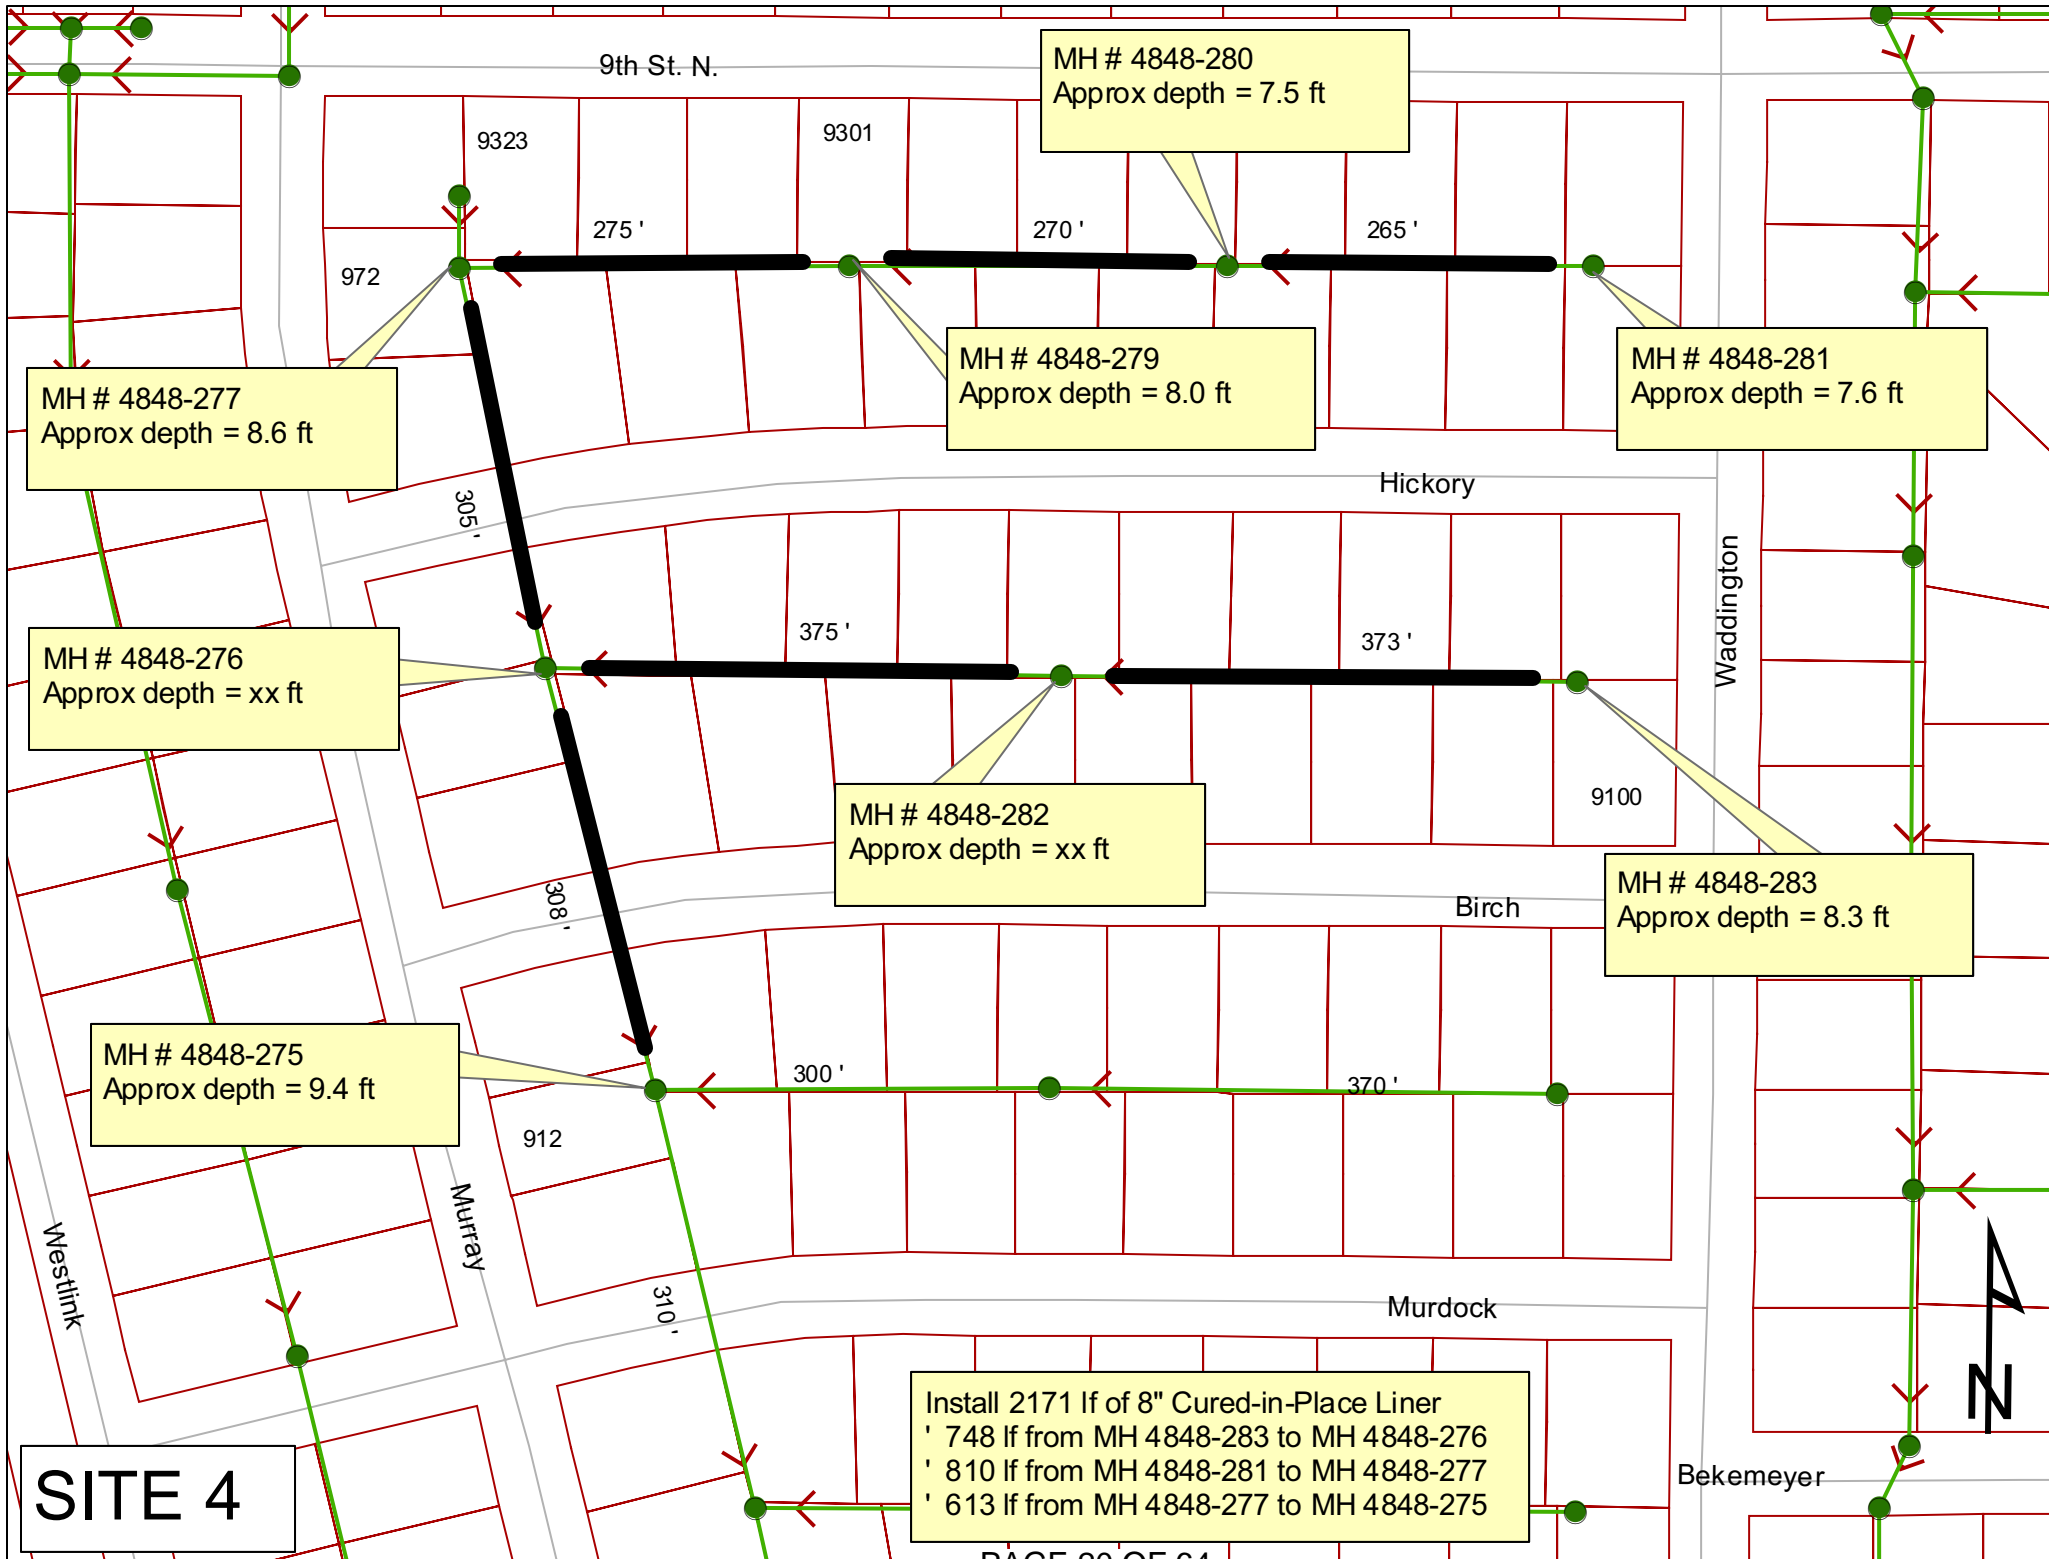
MH # 4848-277
Approx depth = 8.6 ft

MH # 4848-276
Approx depth = xx ft

MH # 4848-275
Approx depth = 9.4 ft

MH # 4848-280
Approx depth = 7.5 ft

MH # 4848-279
Approx depth = 8.0 ft

MH # 4848-281
Approx depth = 7.6 ft

MH # 4848-282
Approx depth = xx ft

MH # 4848-283
Approx depth = 8.3 ft
